ON-SITE AIR BAG INVESTIGATION

CASE NUMBER - IN97-018
LOCATION - ILLINOIS
VEHICLE - 1994 PLYMOUTH VOYAGER
CRASH DATE - MAY, 1996

1. Report No. IN97-018		2. Government Accession No.		3. Recipient's Catalog No.	
4. Title and Subtitle On-Site Air Bag Fatality Investigation Vehicle - 1994 Plymouth Voyager Location - Illinois			5. Report Date: April 28, 1999; March 18, 2002

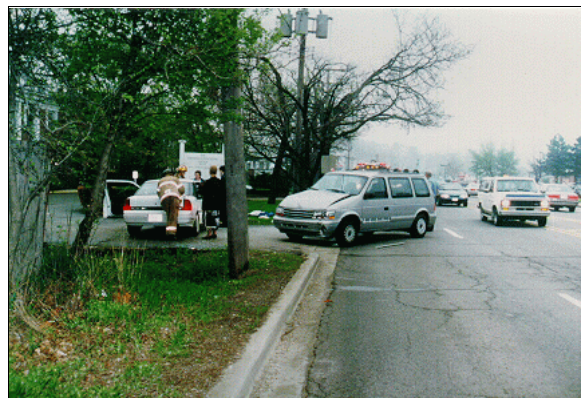
Figure 1: On-scene view of case vehicle (diagonally straddling outside lane) and Oldsmobile (toward left) at final rest positions; Note: both vehicles rotated clockwise post-impact (case photo #05)

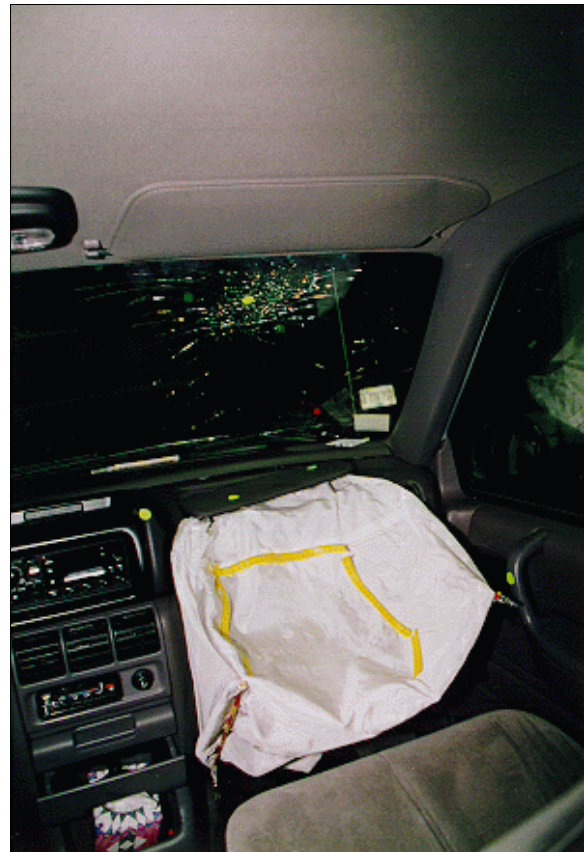
Examination of the Voyager's interior showed what appeared to be a contact (scuff) to the driver's knee bolster by the driver's right knee. The windshield on the passenger side was starred towards the top of the glass by the deploying, top mounted air bag. In addition, residue from the air bag generant was found on the windshield. Further examination of the interior revealed a brush abrasion to the right front passenger's door handle from the deploying front right air bag. Another brush abrasion was found to the right side of the center instrument panel (Figure 2). The rear view mirror was knocked off by the deploying front right top mounted air bag.

Figure 2: Vertical view of case vehicle's front right seating area showing contact evidence to top of front right passenger air bag, right side of center instrument panel, and cover flap (yellow dots); Note: windshield contacted by deploying air bag (case photo #38)

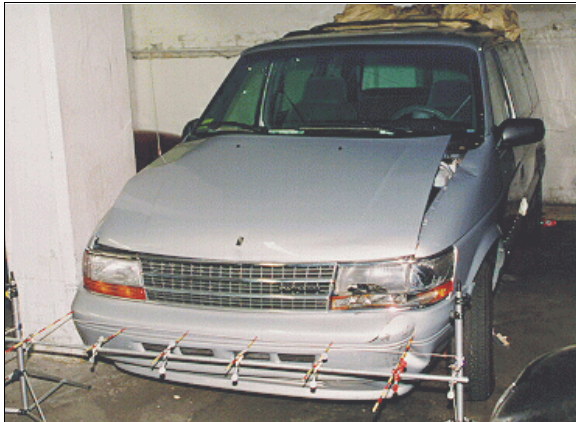
shifted slightly to the right due to the **340** degree Direction of Principal Force (**Figure 3** and **Figure 4**). The residual crush to the front bumper and bumper reinforcement bar was 10 centimeters (4 inches) to the corners (C_1 and C_6) and 6 centimeters (2.4 inches) across the center. The wheelbase was not altered. The trim along the driver's door was peeled off. This most likely occurred post-crash when the driver open her door to exit the vehicle and struck the left fender, which had sustained induced damage.

Figure 3: Case vehicle's frontal damage with contour gauge present viewed from left of center; Note: front end shifted slightly to right (case photo #16)

Based on the vehicle inspection, the CDC for the case vehicle was determined to be: **11-FDEW-1 (340 degrees)** [i.e., maximum crush was 10 centimeters (3.9 inches)]. The WinSMASH reconstruction program, missing vehicle algorithm (with CDC for the missing vehicle), was used on the case vehicle's highest severity impact. The Total, Longitudinal, and Lateral Delta V's are, respectively: 18.1 km.p.h. (11.2 m.p.h.), -17.1 km.p.h. (-10.6 m.p.h.), and +6.2 km.p.h. (+3.9 m.p.h.). The case vehicle was towed from the scene due to damage.

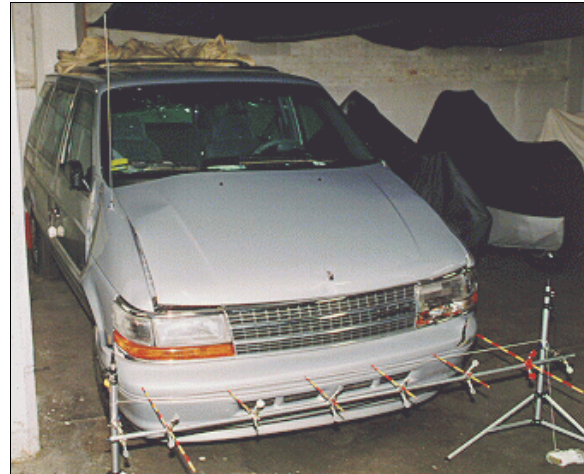
Figure 4: Case vehicle's frontal damage with contour gauge present viewed from right of center; Note: front end shifted to right (case photo #27)

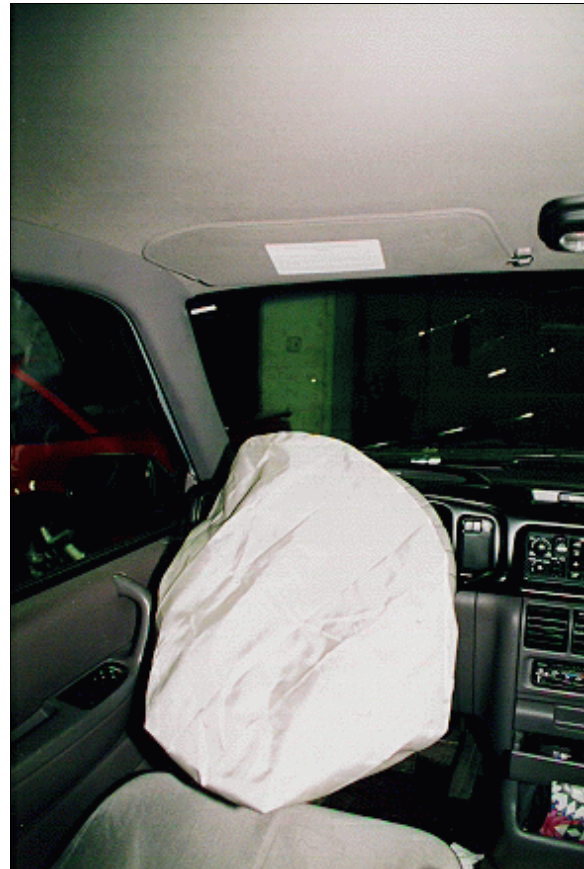
The case vehicle was equipped with a Supplemental Restraint System (SRS) that contained frontal air bags at the driver and front right passenger positions. Both air bags deployed as a result of the frontal impact with the Oldsmobile. The driver's air bag deployed from the steering wheel hub where it was mounted. The module cover consisted of symmetrical cover flaps with overall dimensions of 17.5 centimeters (6.9 inches) at the horizontal seam and 6.5 centimeters (2.6 inches) vertically. The air bag was untethered and was 63 centimeters (24.8 inches) in diameter. The driver's air bag was vented by two, 2.5 centimeter (1 inch) diameter vent ports that were located in the 11 and 1 o'clock sectors of the air bag. There was no visible evidence of direct contact to the driver's air bag (**Figure 5** below) from either occupant's involvement.

Figure 5: Vertical view of case vehicle's driver seating area; Note: no visible evidence of contact to driver's air bag (case photo #30)

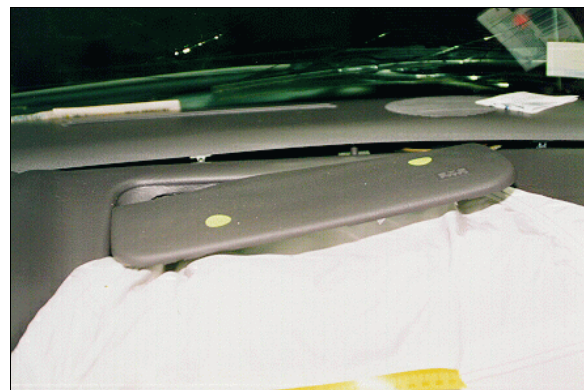
skin over a sheet metal frame/liner which acted as the hinge point for the deploying flap. The flap appeared to be shifted with the upper right corner being pushed toward the windshield and the lower left being pulled inwards. The passenger's forward movement momentarily impeded the deploying air bag, altering its normal deployment path, and causing the cover flap to shift in order for the air bag to fully deploy (**Figure 6**). The air bag was deflected in an upward direction, by the front right passenger's head, against the windshield where it contacted and fractured the windshield in a star like pattern (**Figure 2** above). The single flap's dimensions were 32 centimeters (12.6 inches) horizontally and 15 centimeters (5.9 inches) deep, toward the windshield. The design of the case vehicle's right instrument panel resulted in a 3 centimeter (1.2 inch) setback of the cover flap's leading edge relative to the forward edge of the right instrument panel.

The cover flap opened at the designated tear points which were located along the leading and outer edges of the flap. The hinged flap did not contact the windshield in this crash. There were two areas of suspected contact present on the front right air bag module's cover flap. One was toward the left leading edge and measured 5 centimeters (2.0 inches) wide and 3 centimeters (1.2 inches) deep and had the appearance of a grease smudge. The other area of suspected contact was to the front right corner and extended back along the right side. This second area was whitish, with a dimension of 7 centimeters (2.8 inches) square, and had the appearance of three finger shaped marks. Based on this and the previously mentioned altered air bag deployment path, this contractor believes that the cover flap was directly contacted during deployment. However, the medical was silent regarding any possible right hand injuries.

Figure 6: Close-up view of case vehicle's misaligned front right air bag module's cover flap, indicating the air bag's deployment path was momentarily altered/blocked (case photo #47)

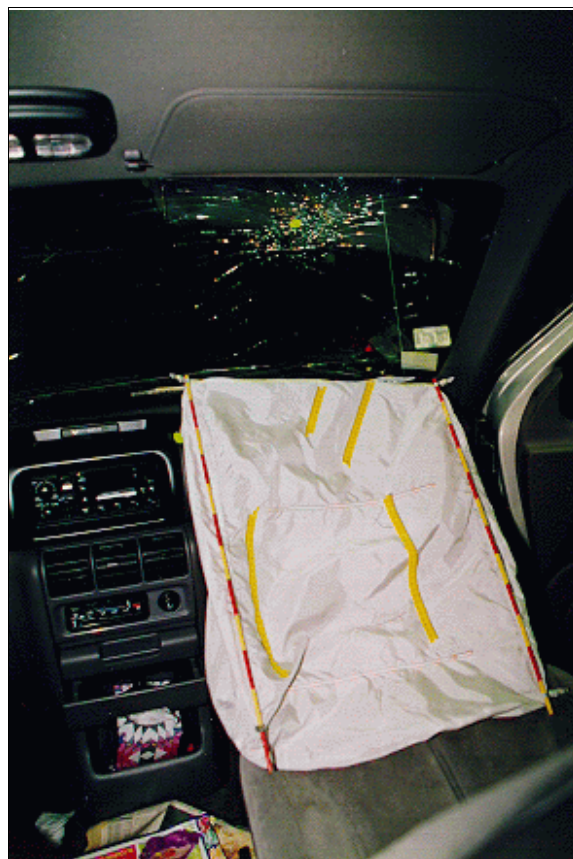
Examination of the front right passenger air bag revealed a large amount of skin to the top and the front portions of the air bag and a fair amount of black scuffing (**Figure 2** above and **Figure 7** below). The black scuffing most likely came from the underside surface of the cover

flap during the deployment sequence when the bags deployment path was momentarily impeded. The skin and black scuffing evidence at the top of the air bag was 27 centimeters (10.6 inches) wide and started 5 centimeters (2.0 inches) to the right of the left edge of the air bag and just 12 centimeters (4.7 inches) from the leading edge of the cover flap. The skin evidence extended forward (toward the passenger) 25 centimeters (9.8 inches) to the top horizontal edge of the air bag. The black scuffing continued down the front of the air bag for an additional 14 centimeters (5.5 inches) and started again 24 centimeters (9.4 inches) farther down for 7 centimeters (2.8 inches), both being 21 centimeters (8.3 inches) in from right side edge. The skin evidence started again approximately 21 centimeters (8.3 inches) down from the top horizontal edge for a distance of 26 centimeters (10.2 inches).

Figure 7: Vertical view of case vehicle's front right passenger seating area and deployed front right air bag; Note: skin evidence on front portion of air bag, highlighted by yellow tape (case photo #42)

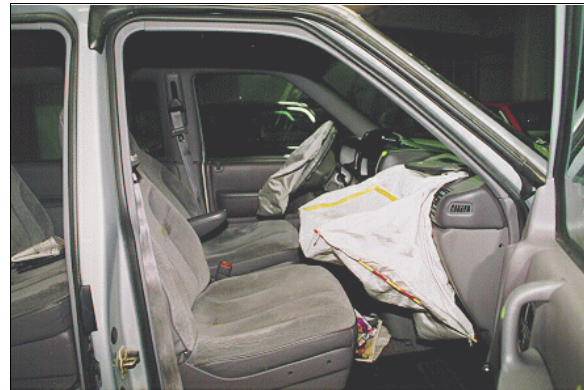
Figure 8: Case vehicle's front seating area viewed from right front door; Note: seat back and seat track positions at inspection, skin evidence to top of front right passenger's air bag, and air bag module's cover flap (case photo #35)

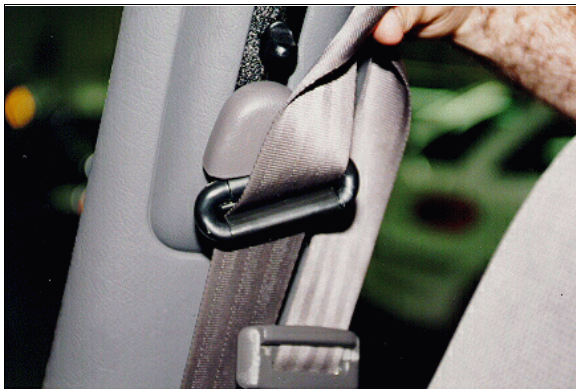
Figure 9: Close-up of "D"-ring from case vehicle's front right passenger seat belt showing heat abrasion indicating some type of usage during crash (case photo #60A)

The inspection of the front right passenger's seat belt webbing, "D"-ring, and latch plate showed evidence of loading. The upper anchorage was adjusted to the full down position. The webbing showed some evidence of fraying along the edges. The "D"-ring and latch plate that the webbing travels through, each had evidence of heat abrasion to the rounded corners. In essence, the slack from having the shoulder belt behind her allowed the front right passenger to move farther

forward, and the slack running through the “D”-ring caused the heat abrasion (**Figure 9** above). The lap belt portion of the front right passenger's continuous loop seat belt also showed that approximately 40 centimeters (15.7 inches) of webbing was smeared with blood (both sides) and slightly rippled from stretching (**Figure 10** below and see **SELECTED PHOTOGRAPHS**, specifically **Figure 13** below).

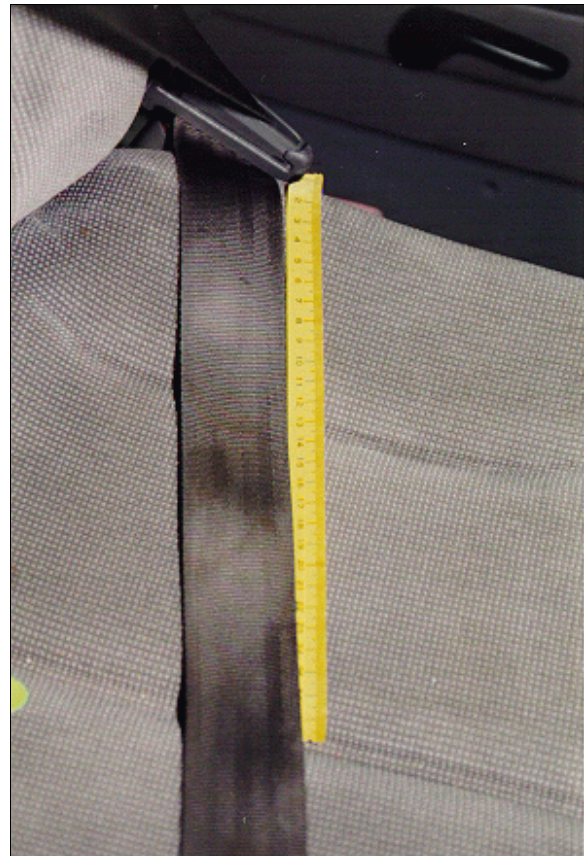
Figure 10: Close-up of blood smear on lap portion of case vehicle's front right seat belt webbing (case photo #60)

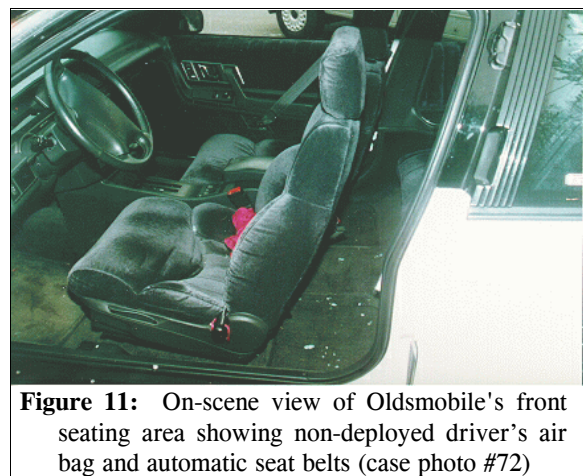
Based on an on-scene photograph and the VIN, the Oldsmobile was equipped with front bucket seats with folding backs and adjustable head restraints. The front outboard seats were equipped with automatic, three-point lap-and-shoulder restraints placed in the door frames. The Oldsmobile was also equipped with a driver air bag which did not deploy as a result of the right side impact (**Figure 11**).

Figure 11: On-scene view of Oldsmobile's front seating area showing non-deployed driver's air bag and automatic seat belts (case photo #72)

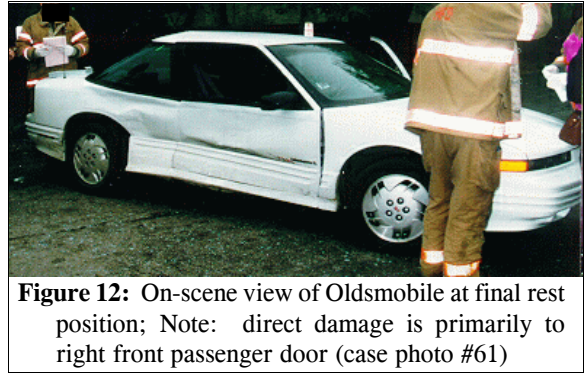
The direct damage to the Oldsmobile extended from the right "A"-pillar rearward to approximately just forward of the right rear wheel (**Figure 12** below). The right front door glazing appeared to be disintegrated from the side impact. It is unknown if there was any intrusion to the front right seating position.

Based on the available photographs, the CDC for the Oldsmobile was determined to be: **02-RPMW-2 (60 degrees)**. The WinSMASH reconstruction program, missing vehicle algorithm (with CDC only for the Oldsmobile), was used on the Oldsmobile's highest severity impact. The Total, Longitudinal, and Lateral Delta V's are, respectively: 19.2 km.p.h. (11.9 m.p.h.), -9.6 km.p.h. (-6.0 m.p.h.), and -16.6 km.p.h. (-10.3 m.p.h.). The Oldsmobile was towed from the scene due to damage.

Figure 12: On-scene view of Oldsmobile at final rest position; Note: direct damage is primarily to right front passenger door (case photo #61)

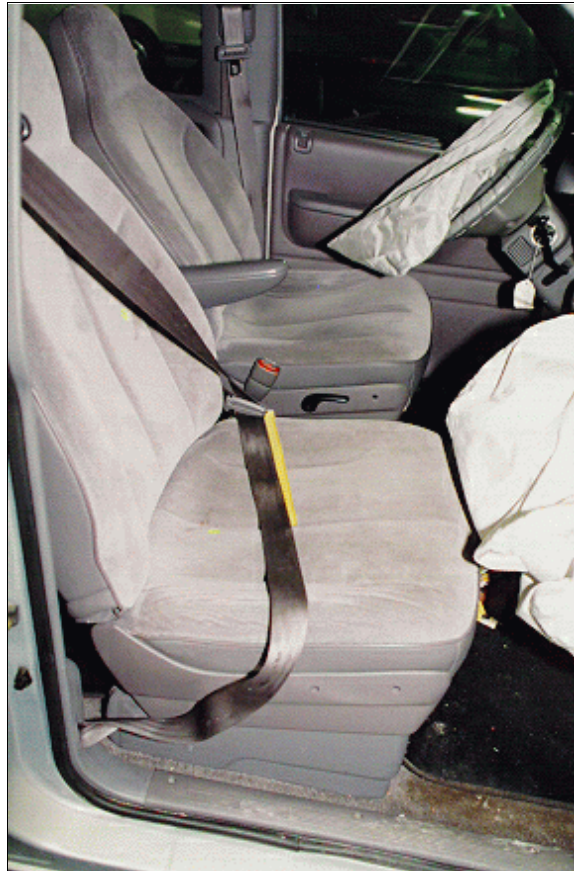
Figure 13: Case vehicle's front right seat belt showing area of blood smear (taped area) and blood spots (yellow dots) to seat cushion and seat back (case photo #34A)

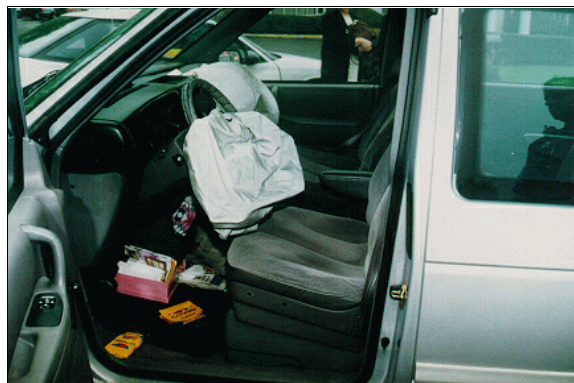
Figure 14: On-scene view of case vehicle's front seating area showing deployed front air bags and driver's seat track location (case photo #33)
