ON-SITE AIR BAG INVESTIGATION

CASE NUMBER - IN97-024
LOCATION - ALABAMA
VEHICLE - 1995 FORD CONTOUR GL
CRASH DATE - August 1997

1. Report No. IN97-024		2. Government Accession No.		3. Recipient's Catalog No.	
4. Title and Subtitle On-Site Air Bag Fatality Investigation Vehicle - 1995 Ford Contour GL Location - Alabama			5. Report Date: October 19, 2000

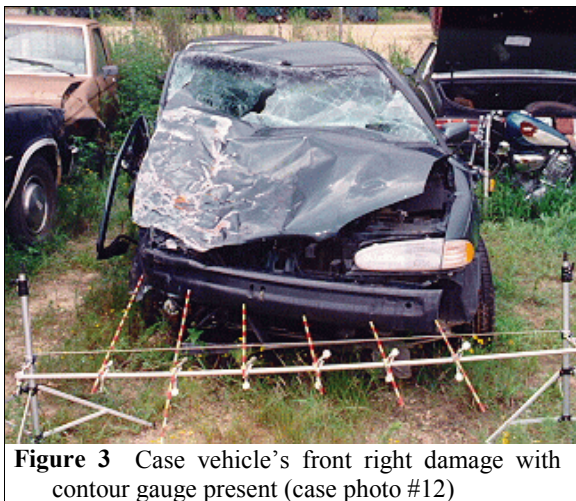
Figure 3 Case vehicle's front right damage with contour gauge present (case photo #12)

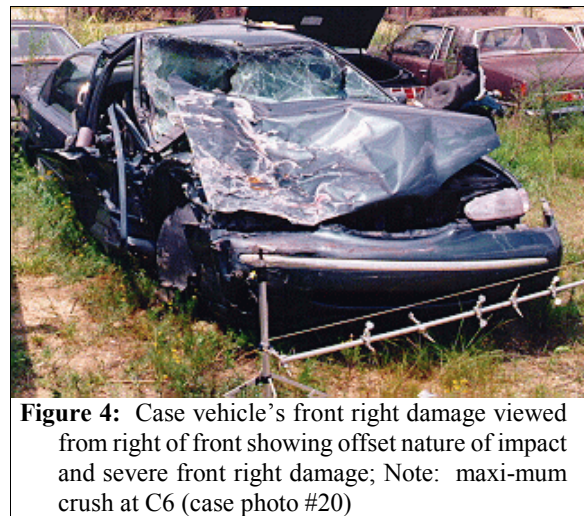
Figure 4: Case vehicle's front right damage viewed from right of front showing offset nature of impact and severe front right damage; Note: maximum crush at C6 (case photo #20)

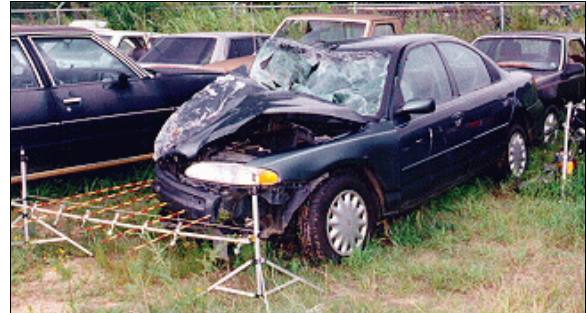
Figure 5: Case vehicle's front right damage viewed from left of front with contour gauge present showing offset nature of impact (case photo #13)

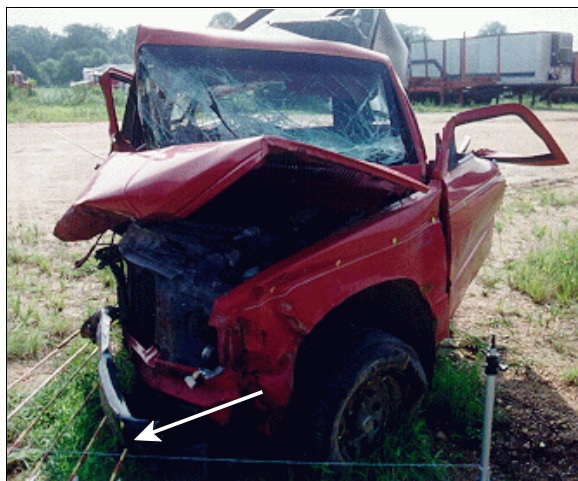
Figure 6: 1st other vehicle's front right damage showing severe rightward shift of front end; Note: position of C1 (case photo #51)

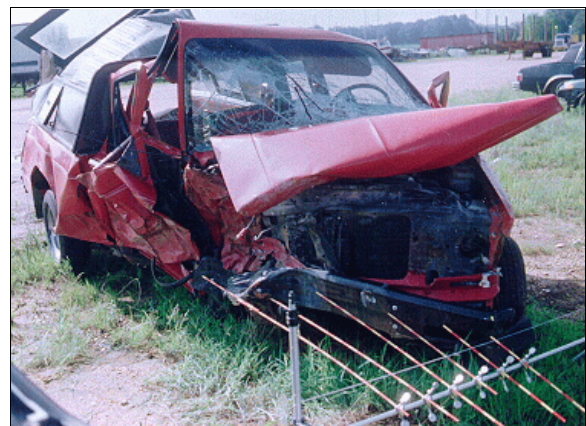
Figure 7: 1st other vehicle's front right damage, viewed from right of front, with contour gauge present showing offset nature of impact (case photo #64)

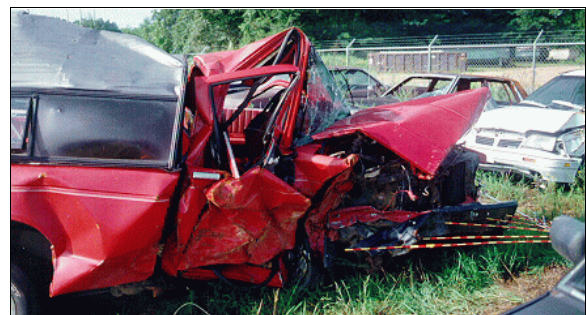
Figure 8: 1st other vehicle's right side showing right front tire which was shoved backwards under-neath damaged right "A"-pillar; Note: roof buck-ling (case photo #62)

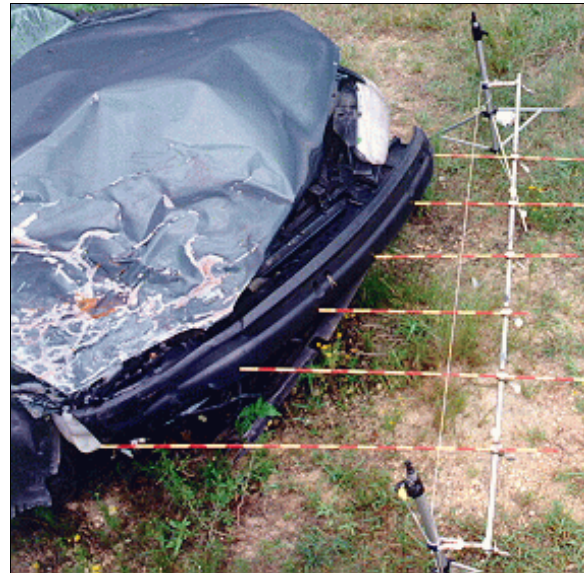
The case vehicle's contact with the Chevrolet S-10 involved the front right half. Direct contact damage to the case vehicle began at the front right bumper corner and extended leftwards a measured distance of 90 centimeters (35.4 inches) of the 148 centimeters (58.3 inches) of undeformed end width (**Figure 9**). Front bumper-level maximum crush extended rearwards a measured distance of 134 centimeters (52.8 inches) at C6, while direct contact to the right "A"-pillar was measured 250 centimeters (98.4 inches) rearward of the original bumper corner. The wheelbase on the case vehicle's left side was extended 9 centimeters (3.5 inches) while the right side was shortened 48 centimeters (18.9 inches).

Figure 9: Reference line view from right of case vehicle's front right damage with contour gauge present showing crush profile (case photo #23)

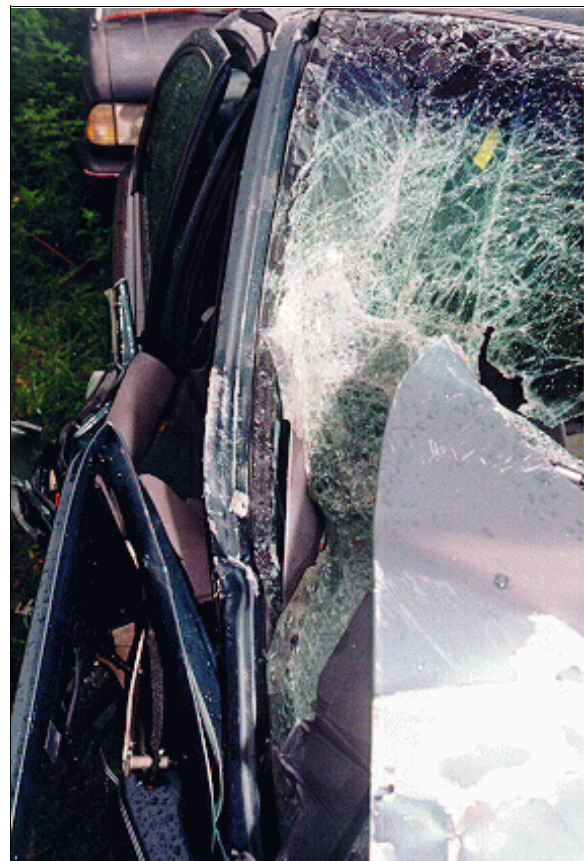
Figure 10: Close-up of direct damage to case vehicle's right "A"-pillar and holed windshield (case photo #22)

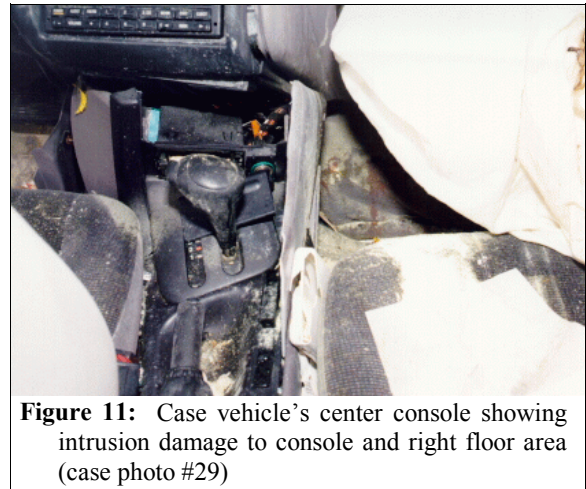
Figure 11: Case vehicle's center console showing intrusion damage to console and right floor area (case photo #29)

There was extensive intrusion to the case vehicle's interior. At the front right seat position, the roof was lowered 21 centimeters (8.3 inches), the right front door panel shoved in 17 centimeters (6.7 inches), the right instrument panel moved rearwards 9 centimeters (3.5 inches), the toe pan pushed rearward 6 centimeters (2.4 inches), and the A-pillar pushed inward 5 centimeters (2.0 inches). At the front center area (Figure 11), the center instrument panel was pushed rearward 40 centimeters (15.7 inches). At the driver's seat position, the toe pan was moved rearward 7.5 centimeters (3.0 inches), the floor pan pushed up 6 centimeters (2.4 inches), and the steering wheel pushed back 3 centimeters (1.2 inches).

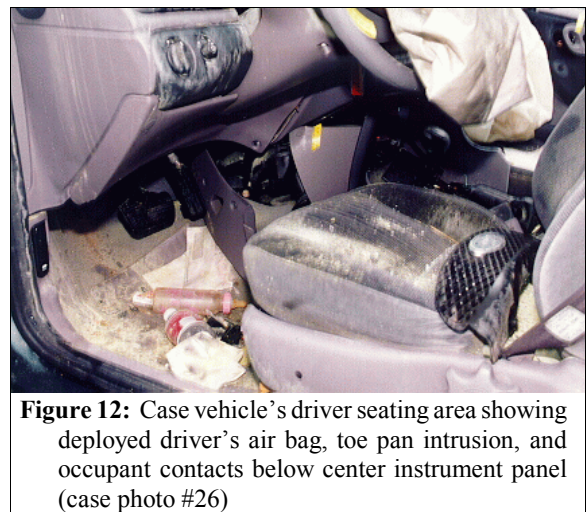
Figure 12: Case vehicle's driver seating area showing deployed driver's air bag, toe pan intrusion, and occupant contacts below center instrument panel (case photo #26)

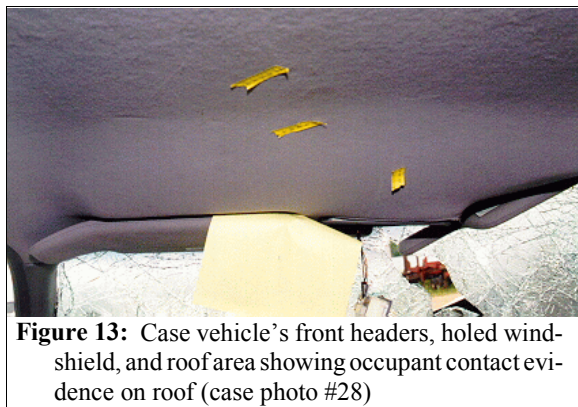
Figure 13: Case vehicle's front headers, holed windshield, and roof area showing occupant contact evidence on roof (case photo #28)

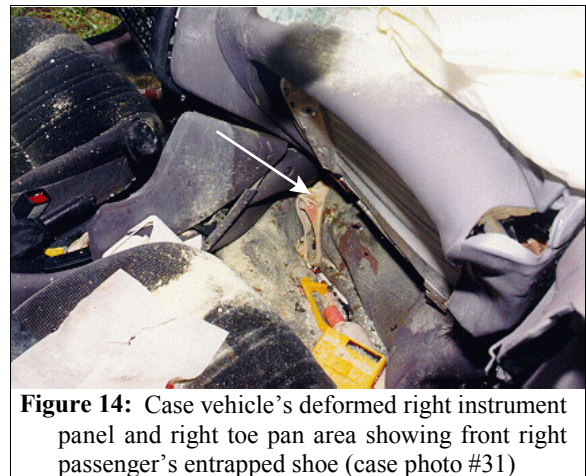
Figure 14: Case vehicle's deformed right instrument panel and right toe pan area showing front right passenger's entrapped shoe (case photo #31)

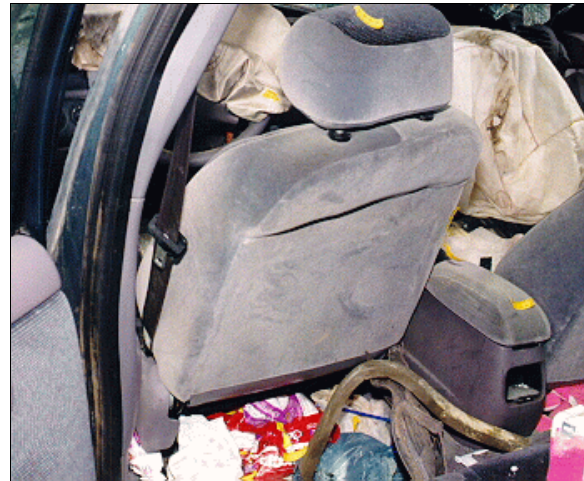
Figure 15: Back of case vehicle's driver seat showing occupant contact evidence on top of head restraint and back of center console (case photo #44)

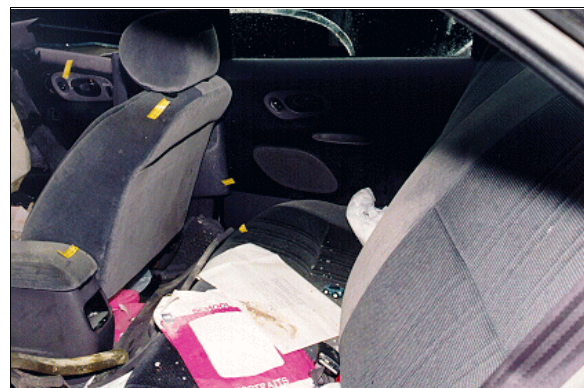
Figure 16: Case vehicle's back seating area showing occupant contact evidence on back of center console, front right seat back, lower "B"-pillar, and right front window sill (case photo #49)

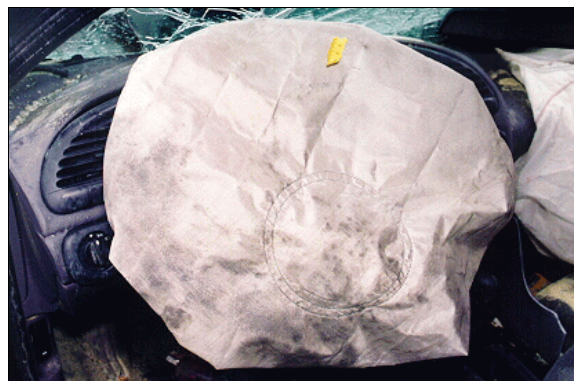
Figure 17: Case vehicle's deployed driver air bag showing contact evidence on bag's fabric near 12 o'clock position (case photo #37)

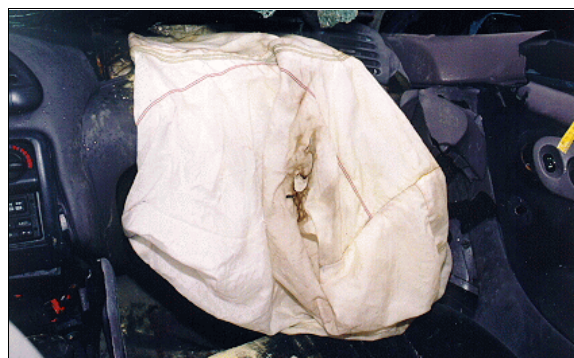
Figure 18: Case vehicle's deployed front right passenger air bag showing holed and burned area of fabric in center of air bag (case photo #40)

inches, 2.4 inches)], located 21 centimeters (8.3 inches) back from the forward seam and 8 centimeters (3.1 inches) left of the right seam. The clear fluid stains, of unknown substance, were located on the front, lower right quadrant. One stain was 2 centimeters (0.8 inches) up from the bottom seam and 20 centimeters (7.9 inches) left of the right seam, while the other fluid stain was 19 centimeters (7.5 inches) up from the bottom seam and 17 centimeters (6.7 inches) left of the right seam. In addition to the air bag contacts, the front right sun visor, the intruding windshield, the left side of the front right instrument panel, the right side of the center console, the right front door panel, and the roof liner over the front right passenger seat position were areas of other contact points.

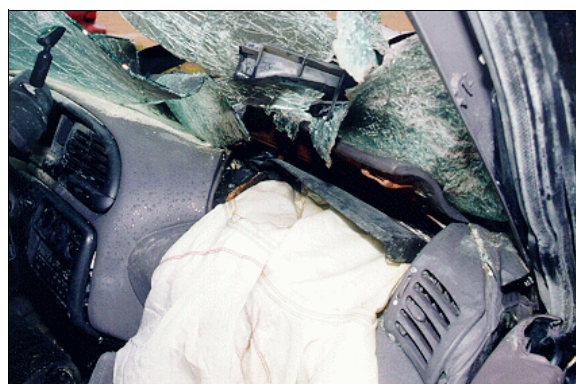
Figure 19 Case vehicle’s deployed front right passenger air bag, holed windshield, and damaged right instrument panel; Note: direct damage to right “A”-pillar (case photo #30)

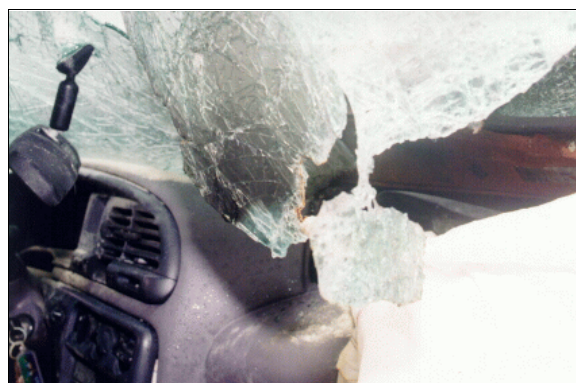
Figure 20: Close-up of case vehicle’s holed windshield showing blood on edge of broken glazing (case photo #32)

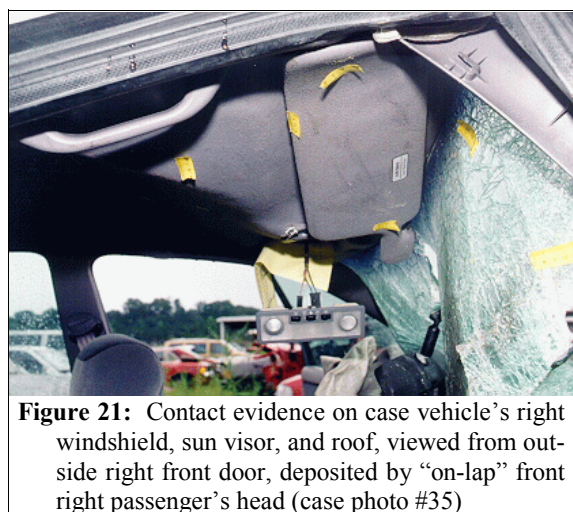
The “on-lap” front right passenger was transported by ambulance to the hospital. She sustained a critical brain injury and was pronounced dead one hour and 12 minutes post-crash. The injuries sustained by the “on-lap” front right passenger included: a critical nonanatomic brain injury and multiple soft tissue injuries to her face, neck, right shoulder and upper arm, left axillary area, and bilateral thighs. The majority of the face, neck, right shoulder, and bilateral upper arm lesions were caused by her impact with the deploying air bag. Two facial lacerations were most likely caused when she contacted the intruding windshield glazing (Figure 20 above). Abrasions to her left upper forehead resulted from a contact to the right sun visor (Figure 21).

Figure 21: Contact evidence on case vehicle’s right windshield, sun visor, and roof, viewed from outside right front door, deposited by “on-lap” front right passenger’s head (case photo #35)

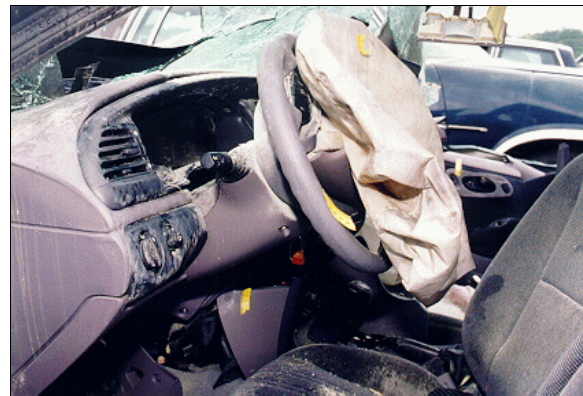
Figure 22: Case vehicle's driver seating area showing deployed driver air bag and distorted driver's seat back; Note: seat back was rotated counterclockwise from contact by back left passenger (case photo #39)

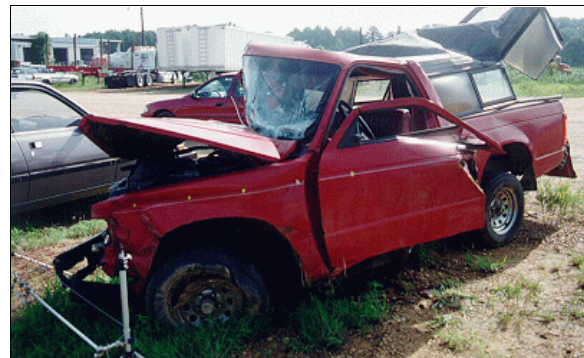
Based on the vehicle inspection, the CDCs for the Chevrolet S-10 were determined to be: **12-LYES-2 (350)** for the initial sideswiping impact (**Figure 23**) and **12-FZAW-6 (360)** for the primary impact [maximum crush was 140 centimeters (55.1 inches) at C6]. Direct damage was to the front bumper, grille, hood, right front headlamp assembly, right front fender, right front tire and wheel assembly, lower right "A" pillar, and right front door. The WinSMASH reconstruction program, damage only algorithm, was used on the Chevrolet S-10's highest severity impact. The Total, Longitudinal, and Lateral Delta Vs are, respectively: 60.8 km.p.h. (37.8 m.p.h.), -60.8 km.p.h. (-37.8 m.p.h.), and 0.0 km.p.h. (0.0 m.p.h.). The Chevrolet S-10 was towed from the scene due to damage.

Figure 23: Sideswipe damage along 1st other vehicle's left side from impact with 2nd other vehicle's left side (case photo #53)

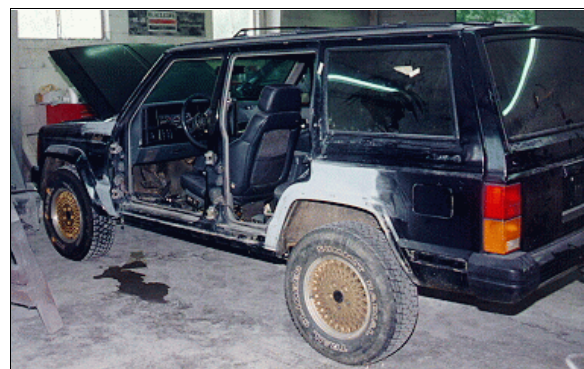
The Jeep Cherokee sustained a sideswiping type impact and was in a partial state of repair when inspected (**Figure 24**). Based on the vehicle inspection, the CDC is not estimable. Sideswipe damage to the Jeep Cherokee continued rearward along its left front door until the lower portion of

Figure 24: Left side of 2nd other vehicle, viewed from left of back; showing repairs in progress resulting from sideswiping impact by front left of 1st other vehicle (case photo #69)
