ON-SITE AIR BAG INVESTIGATION

CASE NUMBER - IN97-029

VEHICLE - 1994 DODGE GRAND CARAVAN

CRASH DATE - September 1997

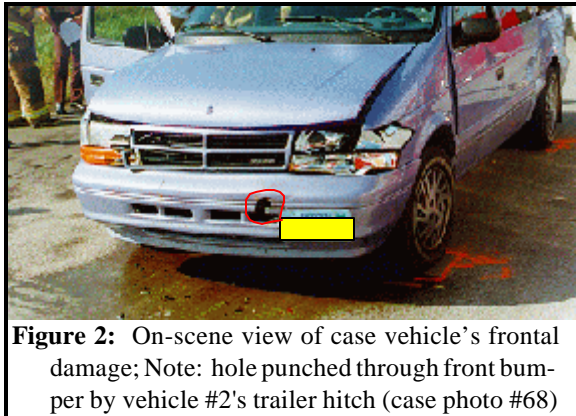
The front of the case vehicle (**Figures 2 and 3**) impacted the back of vehicle #2 (**Figure 4**), causing the case vehicle's driver and front right passenger supplemental restraints (air bags) to deploy. Both vehicles moved a short distance southward as a result of the impact. The case vehicle came to rest heading south in the outside southbound lane. Vehicle #2 was knocked forward, but the driver of vehicle #2 drove his vehicle onto the west shoulder on the south roadway prior to coming to rest heading south. The case vehicle was towed from the scene due to damage, while vehicle #2 was driven away.

Figure 2: On-scene view of case vehicle's frontal damage; Note: hole punched through front bumper by vehicle #2's trailer hitch (case photo #68)

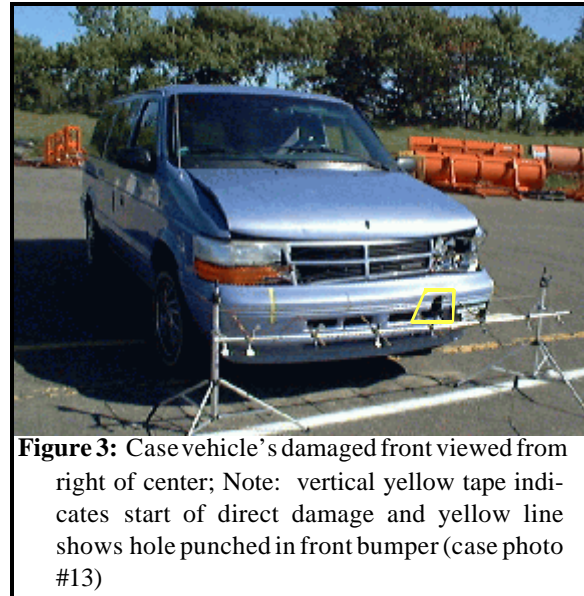
Figure 3: Case vehicle's damaged front viewed from right of center; Note: vertical yellow tape indicates start of direct damage and yellow line shows hole punched in front bumper (case photo #13)

The case vehicle's initial contact with vehicle #2 involved the left ¾ of the front end (**Figure 3**), beginning at the front left bumper corner and extending to the right a measured distance of 132 centimeters (52.0 inches). The direct contact damage extended 55 centimeters (21.7 inches) to the right of center. The case vehicle's entire front end, from bumper corner to bumper corner, sustained induced damage for a Field L of 151 centimeters (59.4 inches) with the greatest visible deformation being above bumper. The front bumper fascia, grille, and radiator were crushed rearward. The extended tow hitch/ball attached to vehicle #2's rear (**Figure 5**) penetrated through the case vehicle's plastic bumper fascia at a point approximately 40 centimeters to the left of center, and was 5 centimeters (2.0 inches) in diameter (**Figures 6 and 7**). The extended hitch/ball contacted and displaced the bottom half of the case vehicle's radiator rearward. The residual crush to the radiator was measured at 24 centimeters (9.4 inches).

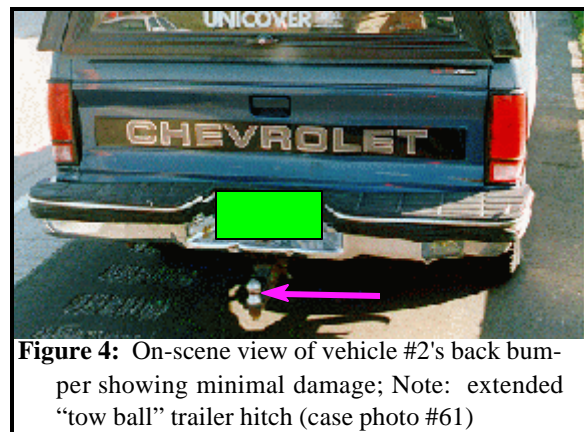
Figure 4: On-scene view of vehicle #2's back bumper showing minimal damage; Note: extended "tow ball" trailer hitch (case photo #61)

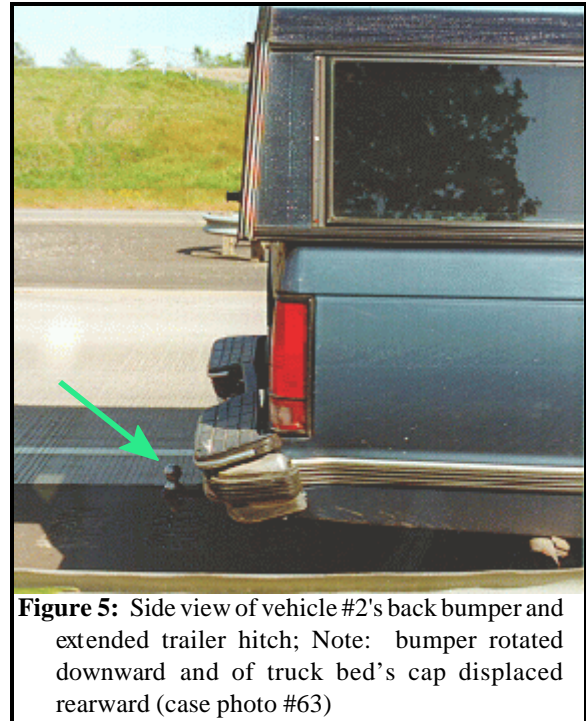
Figure 5: Side view of vehicle #2's back bumper and extended trailer hitch; Note: bumper rotated downward and of truck bed's cap displaced rearward (case photo #63)

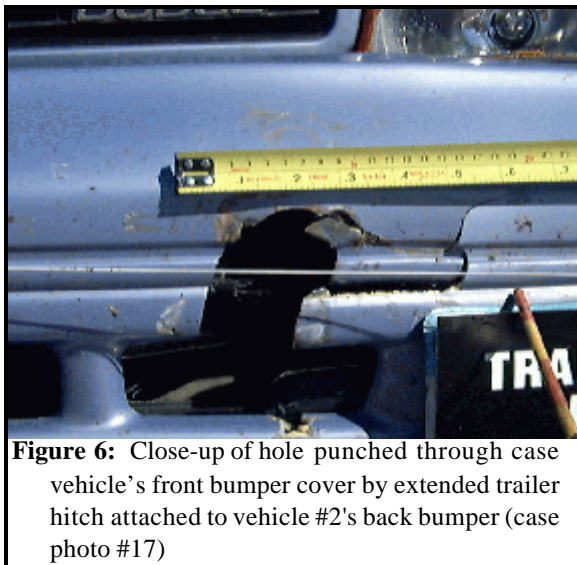
Figure 6: Close-up of hole punched through case vehicle's front bumper cover by extended trailer hitch attached to vehicle #2's back bumper (case photo #17)

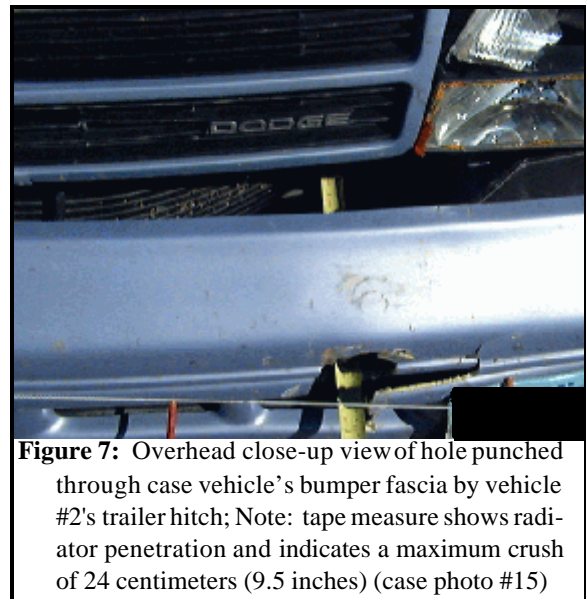
Figure 7: Overhead close-up view of hole punched through case vehicle's bumper fascia by vehicle #2's trailer hitch; Note: tape measure shows radiator penetration and indicates a maximum crush of 24 centimeters (9.5 inches) (case photo #15)

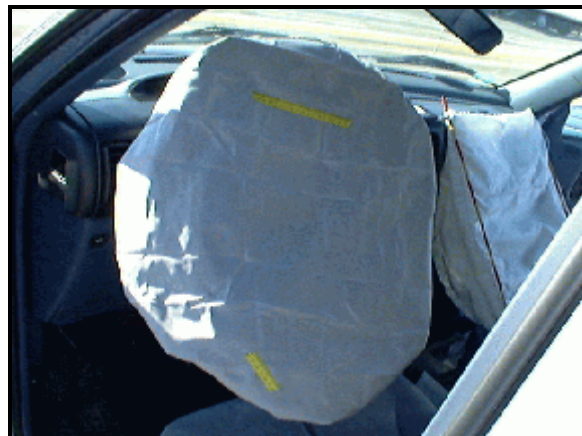
Figure 8: Case vehicle's driver air bag with tape indicating areas of skin and cloth transfer; Note: steering wheel rotated approximately 90 degrees counterclockwise (case photo #21)

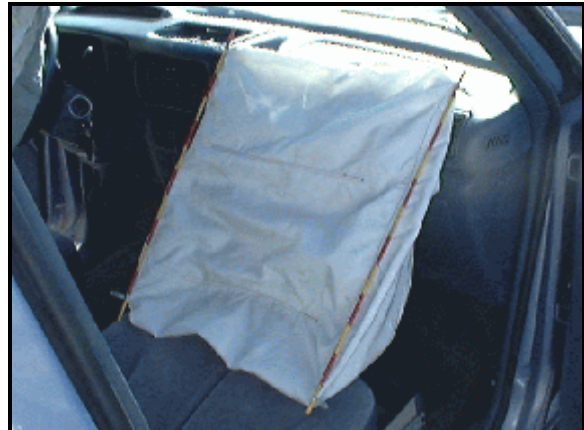
The front right passenger air bag (**Figure 9**) was mounted on the top of the right instrument panel. The air bag deployed from a single symmetrical rear hinged cover flap. The cover flap opening in an upward direction. The cover flap was made of a vinyl skin

Figure 9: Front surface of case vehicle's front right passenger air bag showing no evidence of contact (case photo #29)

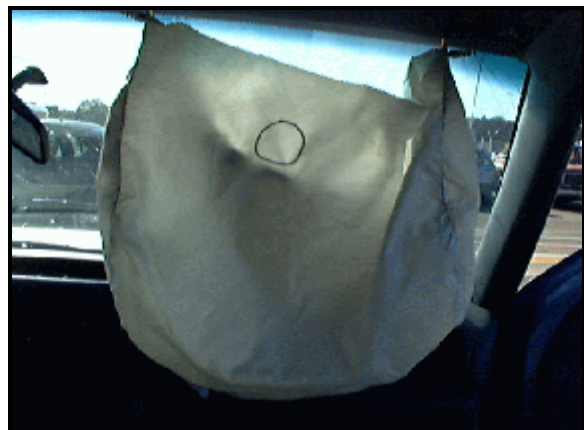
Examination of the front right passenger air bag revealed a small skin transfer to the center of the bottom portion of the air bag only. There was no evidence of contact to the front portion of the front right passenger's air bag (**Figure 9**). The skin evidence on the bottom of the air bag was approximately 4 centimeters (1.6 inches) in diameter (**Figure 10**). The skin evidence started 11 centimeters (4.3 inches) down from the bottom horizontal edge of the air bag and 18 centimeters (7.1 inches) in from the left edge of the air bag. The top portion of the air bag had two long parallel black marks from the cover flap and another to the lower right front portion of the air bag. There was a black scuff to the top portion of the air bag towards the left side from contact with the lower right corner of the rearview mirror (see **SELECTED PHOTOGRAPHS, Figures 14 and 15**).

Figure 10: Underside (bottom) of case vehicle's front right passenger air bag showing area of skin transfer (circled area) from front right passenger's face (case photo #33)

chest simultaneously contacted the bottom portion of the air bag as it deployed (**Figure 10**). As the air bag reached maximum expansion, it thrust the front right passenger backwards into his seat back where he came to rest in an upright position.

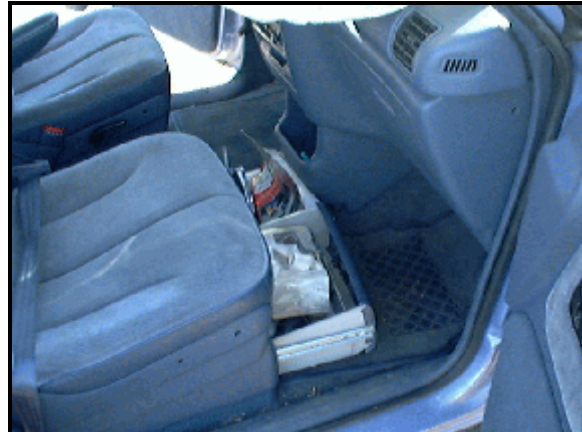
Figure 11: Case vehicle's front right seat with glove box beneath seat pulled outward showing box of tissues; envision front right passenger's close proximity to air bag module while leaning forward to get a tissue (case photo #43)

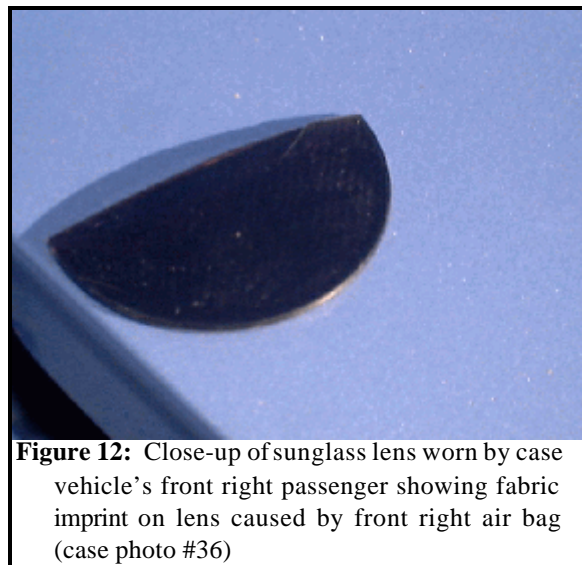
Figure 12: Close-up of sunglass lens worn by case vehicle's front right passenger showing fabric imprint on lens caused by front right air bag (case photo #36)

A close examination (**Figure 12**) of the front right passenger’s broken sunglass lens shows conclusive evidence (i.e., stitching pattern from air bag’s fabric) that direct contact was made with the fabric of the deploying air bag. At final rest the front right passenger was unconscious leaning against his seat back facing forward.

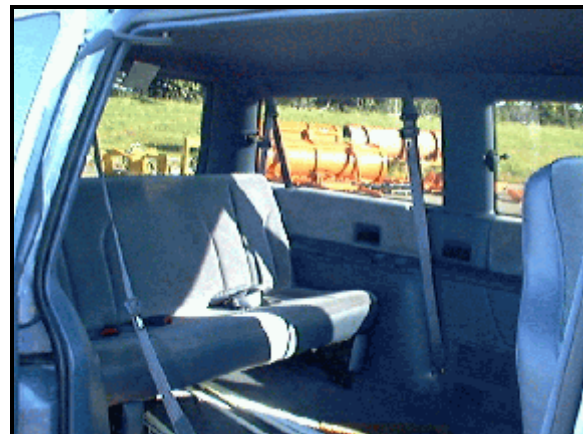
Figure 13: Case vehicle's back seat area where three child passengers were seated; Note: outboard three-point safety belts and removed center bench seat which made more room (case photo #54)

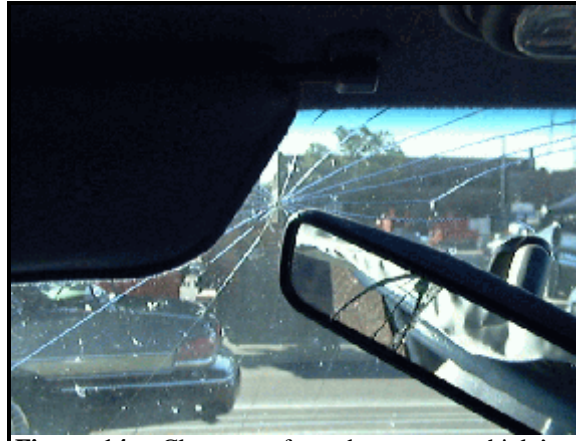
The hood sustained minor damage to the leading edge. The windshield had a spider web crack just left of center from the rearview mirror being knocked into it (see **SELECTED PHOTOGRAPHS, Figure 14**). The rearview mirror was struck by the front right passenger air bag during its deployment. The front end damage to the case vehicle had the appearance of an underride type impact. Neither of the front tires were physically restricted from the front end damage. Maximum crush to the bumper was only 3 centimeters (1.2 inches) at C₁. The wheelbase was unaltered from the crash. The left fender sustained induced damage from the frontal impact which also knocked out the left headlight assembly.

Figure 14: Close-up of crack to case vehicle's windshield caused by contact from rearview mirror (case photo #47)

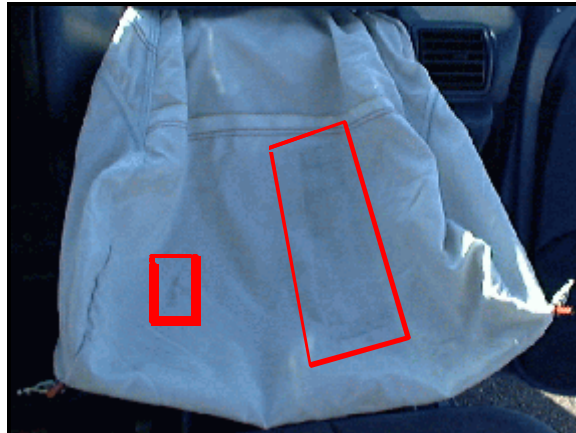
Figure 15: Top surface of case vehicle's front right air bag showing no contact from front right passenger, but contact evidence is present from rearview mirror (small highlight) and cover flap transfer (large highlight) (case photo #31)

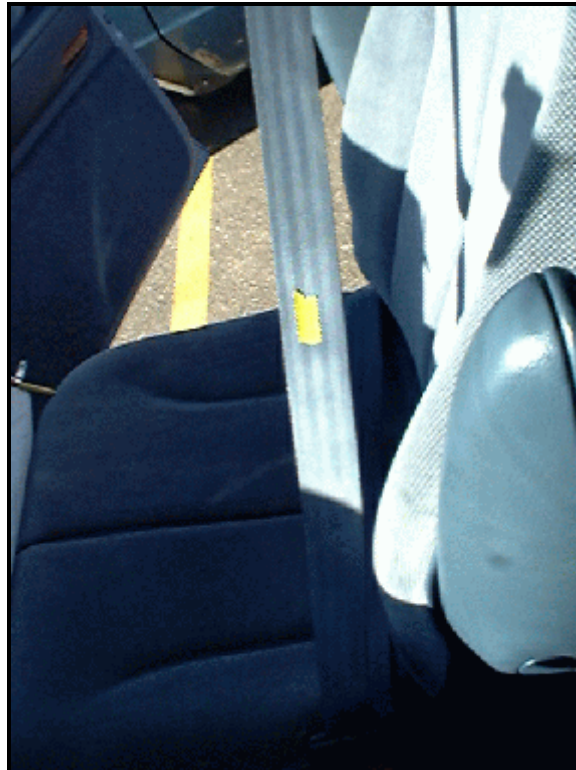
Figure 16: Blood spots on shoulder portion of case vehicle's front right seat belt; Note: spots to left of yellow tape (case photo #39)

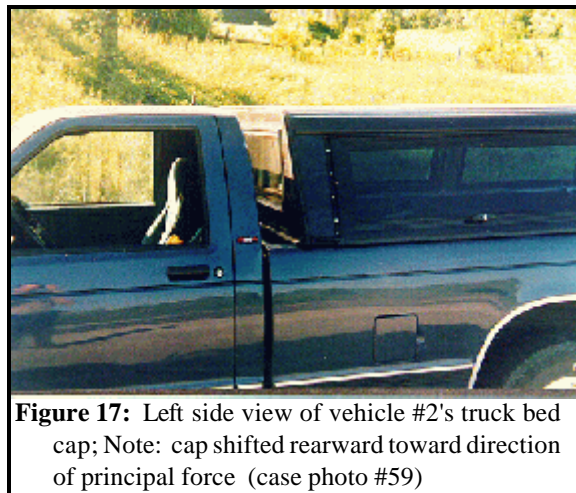
Figure 17: Left side view of vehicle #2's truck bed cap; Note: cap shifted rearward toward direction of principal force (case photo #59)
