Remote Investigation/Non-contact deployment Dynamic Science, Inc. / Case Number:DS97029 1996 Ford Aspire Colorado December, 1997 This document is disseminated under the sponsorship of the Department of Transportation in the interest of information exchange. The United States Government assumes no responsibility for the contents or use thereof.

## Dynamic Science, Inc. Accident Investigation Case Number: DS97029

Description: This case was initiated in response to a report of a fire-initiated air bag

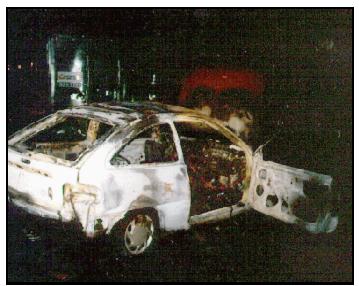
This incident occurred in December 1997 at approximately 0600 hours. The case vehicle, an unoccupied 1996 Ford Aspire 2-door hatchback, was parked in an industrial area parking lot. This vehicle was equipped with both driver's side and passenger's side frontal air bags. The vehicle was equipped with air bag sensors at the right front and left front of the vehicle, and a safing sensor in the center of the instrument panel. There was crash-related damage found on the right front fender and on the front bumper. The damage is not related to the fire nor the subsequent air bag deployment.

Figure 1. Exterior, case vehicle

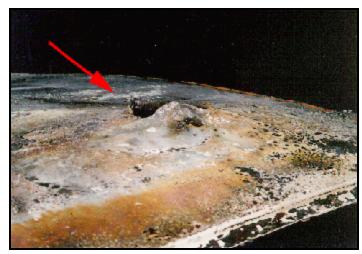
A fire was deliberately set in the passenger compartment. It appears that gasoline was used to set the fire. The fire caused the driver's side air bag to deploy. During the deployment, portions of the driver's frontal air bag module were propelled through the roof, causing a 10-15 cm (4-6 in.) hole in the roof. Portions of the module were found on the ground approximately 30-38 m (100-125 ft) directly behind the vehicle. The interior of the vehicle was badly burned and it is unclear at this time if the passenger's side air bag deployed.

Figure 3. Exterior, close up of hole in roof.

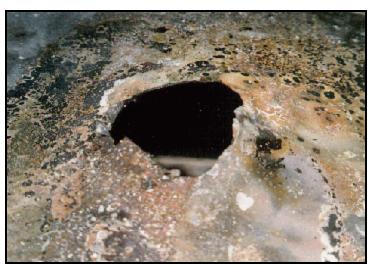
Figure 4. Close up of exit point.

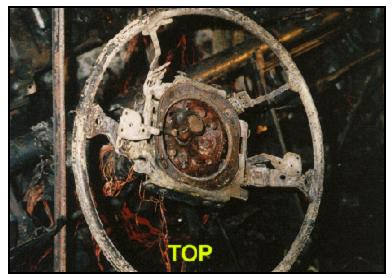
Figure 5. Steering wheel

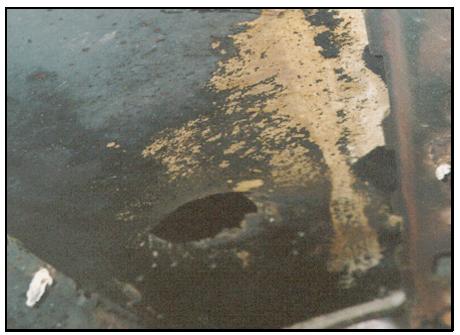
Figure 6. Exit point, interior view
