**CALSPAN ON-SITE DEPOWERED AIR BAG
DEPLOYMENT INVESTIGATION**

CALSPAN CASE NO. CA 97-030

SUBJECT VEHICLE - 1998 PONTIAC FIREBIRD

CRASH DATE - SEPTEMBER, 1997

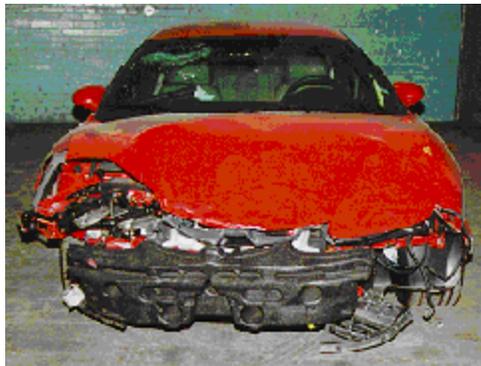
Figure 1. View of the damaged frontal plane of the 1998 Pontiac Firebird

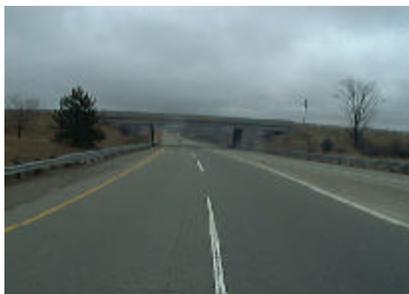
Figure 2. Approach of the Pontiac Firebird

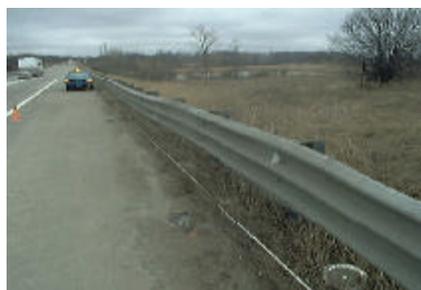
Figure 3. View of the impacted thri-beam guardrail

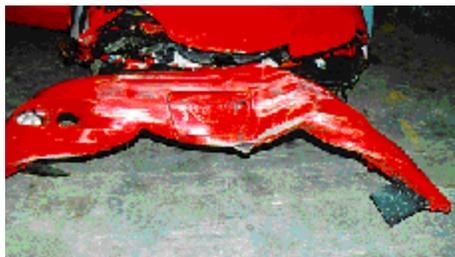
The initial impact with the guardrail resulted in moderate frontal damage to the Firebird which extended across the entire bumper fascia. Maximum crush was located 87.6 cm (34.5 in) right of the left front bumper corner and measured 33.1 cm (13.0 in). The resultant direction of force was within the 11 o’clock sector and yielded a Collision Deformation Classification (CDC) of 11-FDEW-1. **Figures 4, 5 and 6** identify the damage sustained by the initial impact to the Firebird.

Figure 4. View of the damaged front bumper of the Firebird

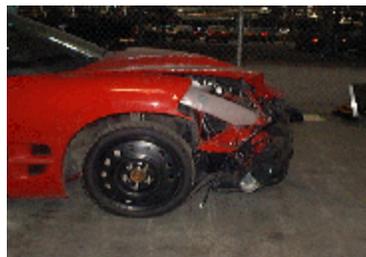
Figure 5. Right side view of the crush damage sustained by the Firebird

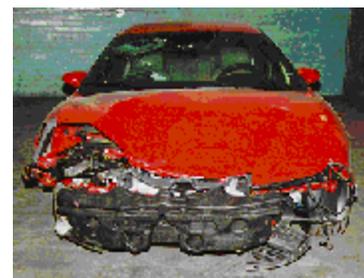
Figure 6. View of the damaged frontal plane of the Firebird

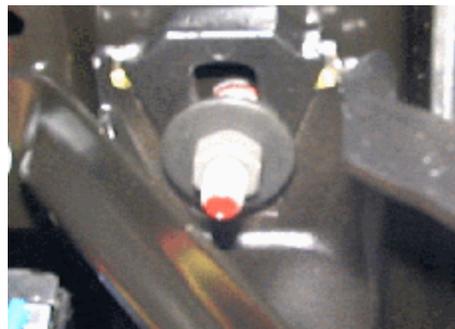
A vinyl transfer was noted on the center face of the air bag (refer to **Figure 7**) which resulted from contact to the inside of the module cover flap. It measured 25 cm (10 in) below the top most seam of the air bag and 38 cm (15 in) from the air bag's right seam. The transfer measured 14 cm (5.5 in) right of the location point. Shear capsule compression or steering wheel rim deformation was not present as identified in **Figures 8 and 9**.

Figure 8. Left side shear capsule showing no movement

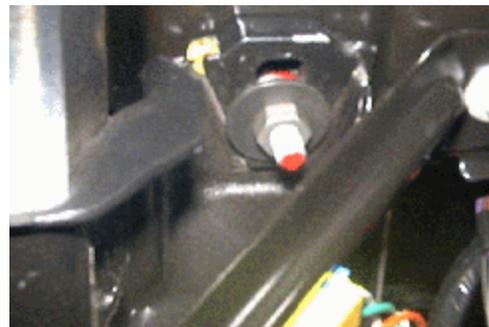
Figure 9. Right side shear capsule showing no movement

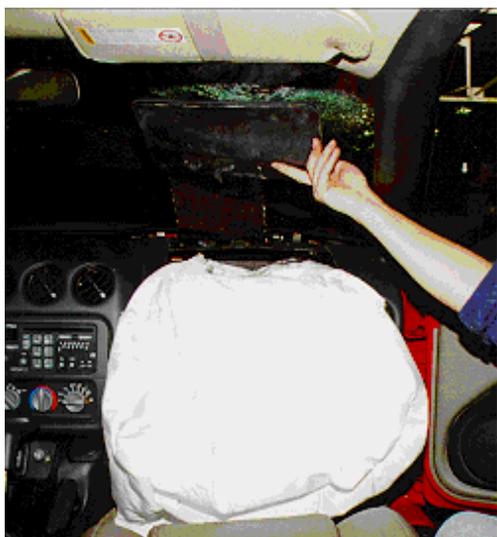
The front right air bag module was encased in the right side instrument panel and deployed the depowered air bag from a mid-mount position. The module cover flap measured 22.3 cm (8.8 in) in height and 34.3 cm (13.5 in) in width and displayed the acronym “SRS” in the lower right corner of the flap. The module cover flap was secured to the module by a fabric mesh tether that measured 18.5 cm (7.3 in) in height and 19.0 cm (7.5 in) in length. The top aspect of the cover flap sustained abrasions resultant of contact with the right side windshield as it opened to deploy the air bag. GM personnel present at the inspection indicated that the air bag was designed to initially deploy longitudinally until restricted by the available tethers which resulted in subsequent vertical deployment of the front right air bag. The air bag was tethered by two straps which were located at the 6 and 12 o’clock positions and extended the width of the air bag. Two vent ports were located at the 3 and 9 o’clock positions, adjacent to the instrument panel. An identification tag on the front left air bag displayed the identification: **Figure 10** identifies the deployed front right air bag and its cover flap extended to the damaged windshield.

Figure 10. View of the passenger compartment with deployed air bag and air bag module cover flap extended to the damaged windshield

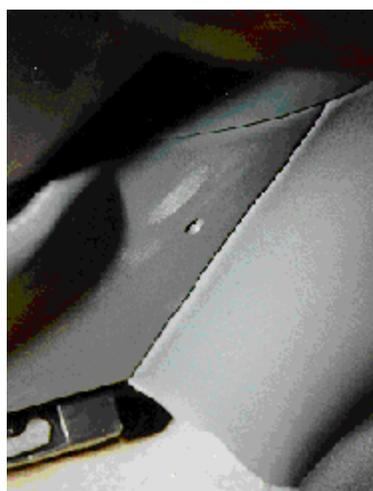
Figure 11. Right aspect of the left side knee bolster showing abrasions which resulted from driver knee contact

Intrusion or integrity damage to the interior of the Firebird was not present. Damage to the passenger compartment was resultant of occupant contact and the deployed air bags. An abrasion was located on the left side knee bolster and was positioned 5 cm (2 in) from the bolster’s right perimeter and 3.0 cm (1.2 in) below its top aspect (refer to **Figure 11**). The abrasion measured 3.0 cm (1.2 in) vertically and resulted from contact with the driver’s right knee. Damage to the right side windshield resulted from contact with the front right air bag module cover flap as it opened to deploy the air bag and consisted of a oval shaped spiderweb-type fracture.

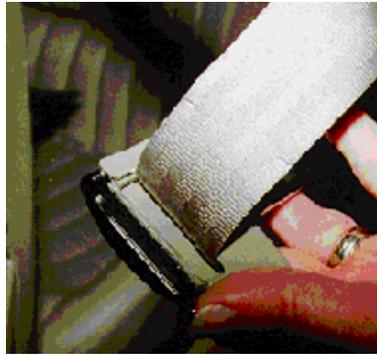
Figure 12. Belt webbing loading for the left front 3-point belt system

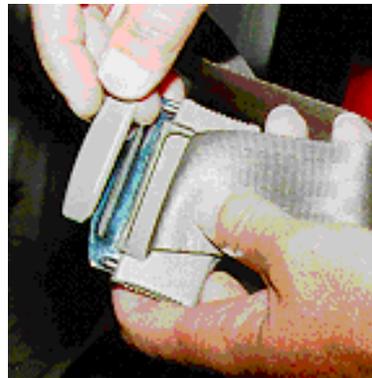
Figure 13. Disjoined plastic binding on the left front latchplate
