ON-SITE AIR BAG INVESTIGATION

CASE NUMBER - IN97-033
LOCATION - TEXAS
VEHICLE - 1997 CHEVROLET CAMARO Z28
CRASH DATE - May, 1997

1. <i>Report No.</i> IN97-033		2. <i>Government Accession No.</i>		3. <i>Recipient's Catalog No.</i>	
4. <i>Title and Subtitle</i> On-Site Air Bag Fatality Investigation Vehicle - 1997 Chevrolet Camaro Z28 Location - May, 1997			5. <i>Report Date:</i> 10/21/1998; 1/12/1999; 3/19/2002

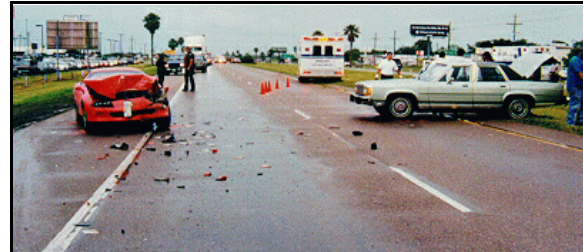
Figure 1: On-scene view looking east in the outside westbound lane; case vehicle and Ford were westbound and are shown at final rest--case vehicle at left and Ford straddling median (case photo #54)

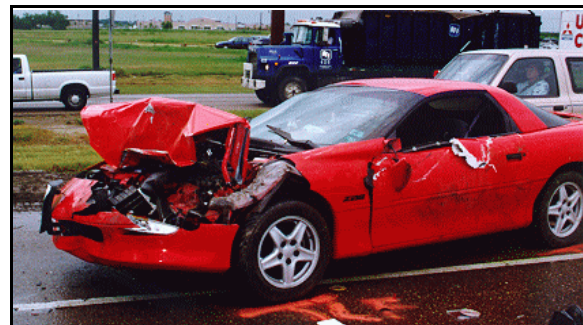
The front of the case vehicle (Figures 2 and 3) impacted the back of the Ford, slightly under

Figure 2: On-scene view of case vehicle at final rest; Note: underride type damage to front and swiping type damage to left side (case photo #58)

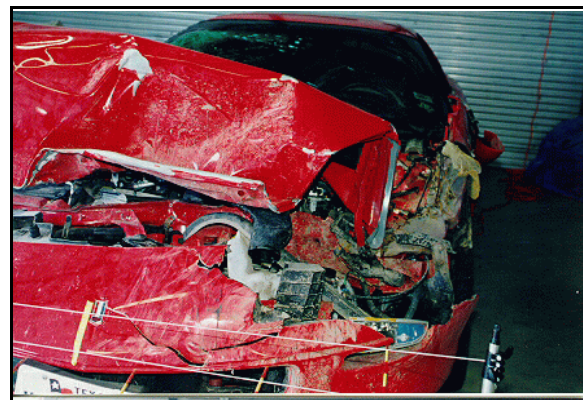
Figure 3: Close-up showing direct damage width to case vehicle's front left bumper (case photo #14)

The initial contact involved the front left half of the case vehicle's bumper against the back right half of the Ford's bumper (**Figure 3** above and **Figure 10** below). The case vehicle's direct contact damage consisted of under riding type damage to the front bumper and hood, beginning 2 centimeters (0.8 inches) right of the center and extending 72 centimeters (28.4 inches) to the front left bumper corner. The impact was primarily a wide engagement that extended backwards (i.e., maximum crush) 16 centimeters (6.3 inches) from the bumper and 27 centimeters (10.6 inches) above the bumper. Direct damage from the second impact started 39 centimeters (15.4 inches) behind the left front axle (**Figure 4** above) and moved rearward down the left side a distance of 145 centimeters (57.1 inches), stopping just before the left "B"-pillar. The CDCs for the case vehicle were determined to be: **12-FYEW-1 (0)** and **11-LPMS-1 (320)**. The WinSMASH reconstruction program, missing vehicle algorithm, was used on the case vehicle's highest severity impact. The Total, Longitudinal, and Lateral Delta Vs are, respectively: 17.8 km.p.h. (11.1 m.p.h.), -17.8 km.p.h. (-11.1 m.p.h.), and 0 km.p.h. (0 m.p.h). The case vehicle's hood, bumper fascia, bumper, grille, left fender, left wheel assembly, left headlight assembly, and left front door were all deformed, in the two impacts. The driver's door glazing was disintegrated from the impact with the Chevrolet pickup. The case vehicle's left front tire was not deflated, but it was physically restricted. The wheelbase on the left side was shortened 2 centimeters (0.8 inches). There was no evidence of intrusion to the case vehicle's interior.

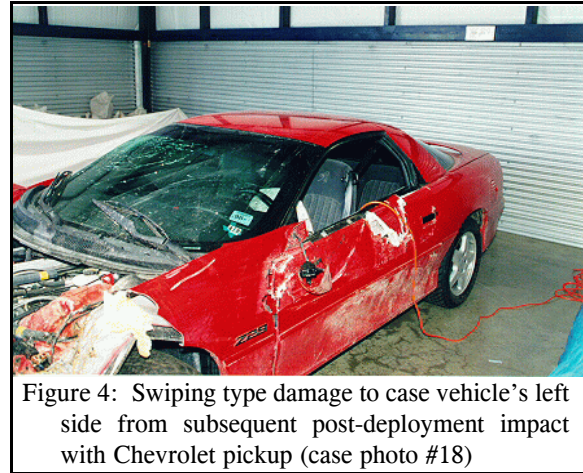
Figure 4: Swiping type damage to case vehicle's left side from subsequent post-deployment impact with Chevrolet pickup (case photo #18)

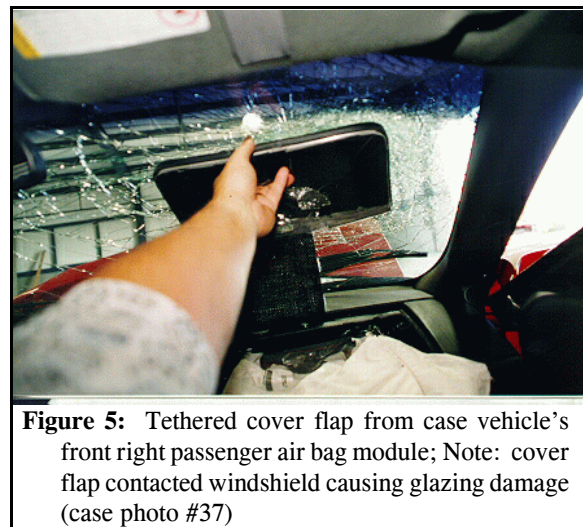
Figure 5: Tethered cover flap from case vehicle's front right passenger air bag module; Note: cover flap contacted windshield causing glazing damage (case photo #37)

The cover flap opened at the designated tear points along the outer edges of the flap. The cover flap contacted the windshield fracturing it in a elongated spider web pattern (Figures 5 and 7). The cover flap had scrapes and small tears to its vinyl top from impacting and cracking the windshield.

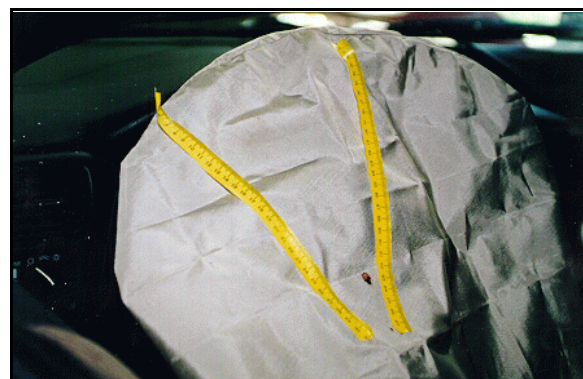
An inspection of the driver's air bag revealed what appeared to be a skin transfer and a blood spot to the upper left side of the air bag in the 10-11 o'clock area (**Figure 6**). One contact

Figure 6: Skin evidence and a blood drop on case vehicle's driver air bag (case photo #27)

area began 7 centimeters (2.8 inches) to the left of the center of the air bag and extended for 8 centimeters (3.2 inches). A second area was 14 centimeters (5.5 inches) in length and started 3 centimeters down from the top edge. In addition, there was a blood spot towards the center of the air bag, 34 centimeters (13.4 inches) down from the top edge and was 1 centimeter (0.4 inches) in width. An inspection of the driver air bag module's cover flaps revealed no visible evidence of direct contact from the driver.

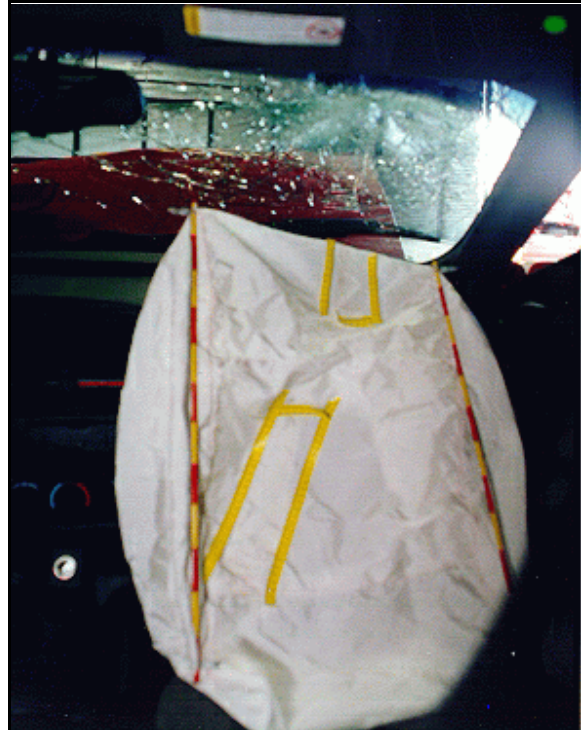
Examination of the front right passenger air bag revealed two areas of brown skin, one to the top--which continued onto the front portion (Figures 7 and 8), and the other solely on the front portion of the air bag. The examination also revealed a yellowish and purple cloth transfer to the top portion, from the clothes the front right passenger was wearing. The skin evidence that was on both the top and front of the air bag is described first. On the top of the air bag the skin area was 10 centimeters (3.9 inches) wide, started 15 centimeters (5.9 inches) to the right of the left edge of the air bag, and was 7 centimeters (2.8 inches) in length. On the front of the air bag, the skin evidence extended downward 10 centimeters (3.9 inches) from the top horizontal edge of the air bag and was 15 centimeters (5.9 inches) in from the left vertical edge. The second skin transfer

Figure 7: Vertical view of case vehicle's front right passenger air bag showing skin transfers to air bag; Note: sun visor contact and windshield damaged from cover flap (case photo #33)

area (**Figure 7** above) started 21 centimeters (8.3 inches) down from the top horizontal edge (front) and extended downward an additional 27 centimeters (10.6 inches), angling toward the front left corner. The top of second skin area was located 10 centimeters (3.9 inches) in from right side edge and was 8 centimeters wide (3.2 inches).

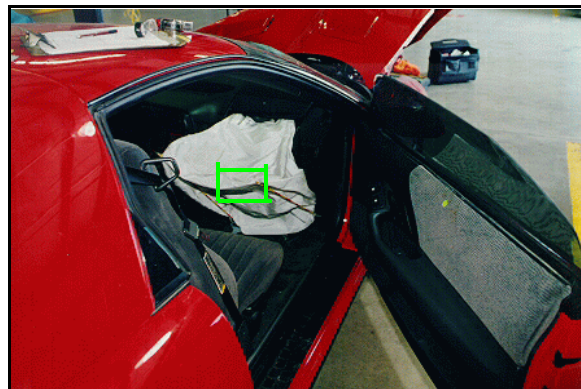
Figure 8: Skin transfer to top of case vehicle's front right passenger air bag viewed from outside right front door; Note: blood smear (green dot) on right front door's window sill (case photo #34)

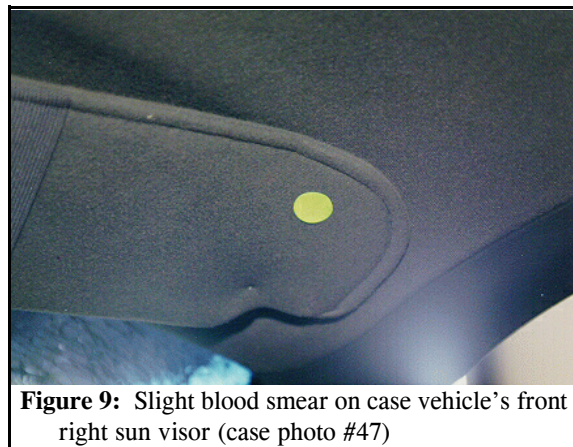
The case vehicle's driver steered to the right and braked, attempting to avoid the crash. As a result of these attempted avoidance maneuvers and the nonuse of her available safety belts, the front right passenger moved slightly forward and to her left just prior to impact. This movement put her forward excursion very close to the instrument panel. The case vehicle's primary impact with the Ford, not only deployed the front right air bag, but thrust the front right passenger further forward and slightly upward towards the 360 degree Direction of Principal Force (Direction of Principle Force). The top of the deploying front right passenger air bag contacted the passenger's chin and neck, lifting her upwards into the sun visor (**Figure 9**). The passenger's interaction with the deploying air bag resulted in her spinal cord injury, cervical fracture, and brain lesions. The contact to the sun visor most likely caused a parietal scalp hematoma.

Figure 9: Slight blood smear on case vehicle's front right sun visor (case photo #47)

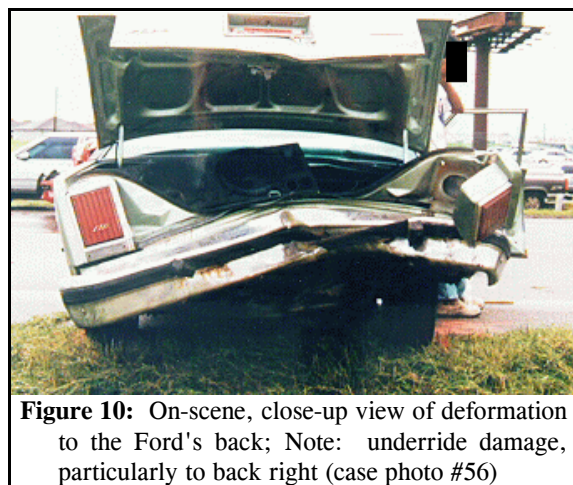
Based on the available photographs, the direct damage to this vehicle was to the back right half (**Figure 10**). The CDC for the Ford is estimated as: **07-BZEW-1 (200)**. The WinSMASH reconstruction program, missing vehicle algorithm, was used on the Ford's highest severity impact. The Total, Longitudinal, and Lateral Delta Vs are, respectively: 17.0 km.p.h. (10.6 m.p.h.), +16.0 km.p.h. (+9.9 m.p.h.), and +5.8 km.p.h. (+3.6 m.p.h). The back bumper, trunk lid, right quarter panel, and the right rear taillight assembly were all obviously deformed.

Figure 10: On-scene, close-up view of deformation to the Ford's back; Note: underride damage, particularly to back right (case photo #56)
