ON-SITE AIR BAG INVESTIGATION

CASE NUMBER - IN97-035
LOCATION - ALABAMA
VEHICLE - 1994 PONTIAC GRAND PRIX
CRASH DATE - October, 1997

1. <i>Report No.</i> IN97-035	2. <i>Government Accession No.</i>	3. <i>Recipient's Catalog No.</i>	
4. <i>Title and Subtitle</i> On-Site Air Bag Fatality Investigation Vehicle - 1994 Pontiac Grand Prix Location - Alabama		5. <i>Report Date:</i> January 22, 2001; March 21, 2002

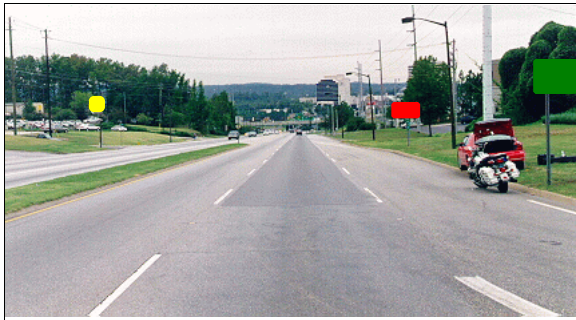
Figure 1: Southward travel path in outside southbound travel lane for all three involved vehicles—case vehicle, Chevrolet pickup, and Chevrolet van (case photo #03)

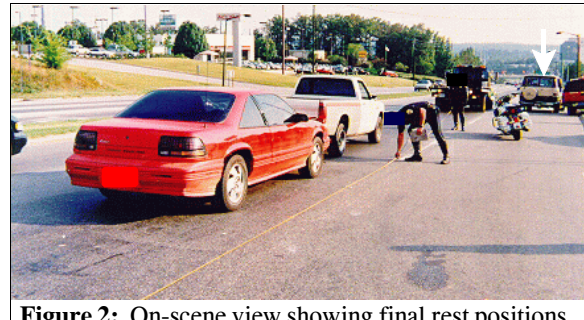
Figure 2: On-scene view showing final rest positions for case vehicle (red coupe) and Chevrolet pickup (white) in outside southbound through lane; Note: Chevrolet van (arrow) was driven ahead to rest in southbound merging lane (case photo #04)

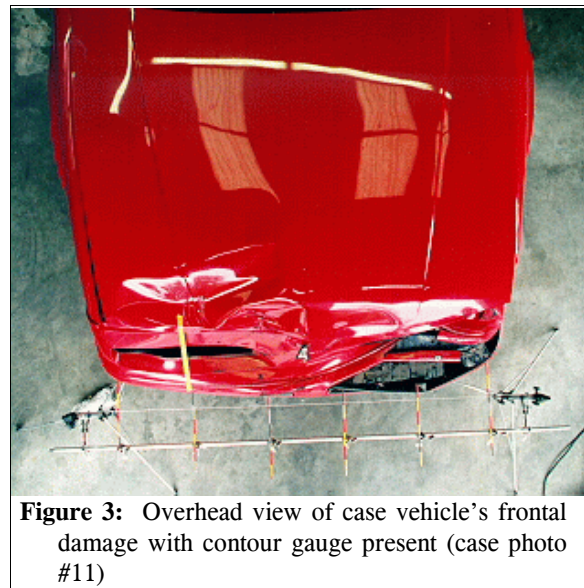
Figure 3: Overhead view of case vehicle's frontal damage with contour gauge present (case photo #11)

The front (**Figure 3** above and **Figures 4** and **5**) of the case vehicle struck and underrode the back (**Figure 2** above and **Figures 6** and **7**) of the Chevrolet pickup, knocking the pickup forward and causing the case vehicle's driver and front right passenger supplemental restraints (air bags) to deploy. Subsequently, the front of the Chevrolet pickup impacted the back of the Chevrolet van. The case vehicle came to rest in the outside southbound through lane near the

The case vehicle's contact with the Chevrolet pickup involved approximately the left two-thirds of the Grand Prix's front bumper contacting and underriding the right two-thirds of S-10 pickup's back bumper. The Grand Prix's direct damage began 41 centimeters (16.1 inches) to the right of the front bumper's center and extended, a measured distance of 112 centimeters (44.1 inches), to the left along the front bumper (Figures 3 and 5 above). The impact was a wide engagement and, above the bumper, extended a total distance of 40 centimeters (15.8 inches) backwards from the reference line onto the hood while at the same time compressing the front of the case vehicle downward. Adjusted for free space, the maximum crush above the bumper was measured as 18 centimeters (7.1 inches) at C_1 . Part of the case vehicle's bumper fascia was peeled back (Figure 3 above) from the plastic honeycombed bumper reinforcement while underriding the S-10 pickup's bumper. The wheelbase on the case vehicle was not shortened on either its left or right sides. The case vehicle's plastic molded, one piece, front bumper assembly (includes grille), hood, left fender and front left headlight and turn signal assemblies were all directly damaged and crushed rearward. The case vehicle's front tires were not restricted, deflated, or damaged during the crash. The right headlight and turn signal assemblies sustained induced damage as well the left fender.

Based on the vehicle inspection, the CDC for the case vehicle was determined to be: **12-FDEW-1 (0)**. The WinSMASH reconstruction program, damage only algorithm, was used on the case vehicle's highest severity impact. The Total, Longitudinal, and Lateral Delta V's are, respectively: 22.8 km.p.h. (14.2 m.p.h.), -22.8 km.p.h. (-14.2 m.p.h.), and 0 km.p.h. (0 m.p.h.). Because of the underride-type impact, these results, although, reasonable, should be considered suspect. The case vehicle was towed due to damage.

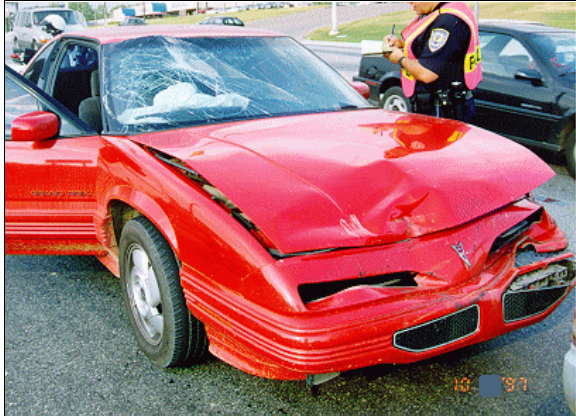
Figure 4: On-scene view of case vehicle at final rest; Note: damage to right half of hood and right windshield's glazing (case photo #09)

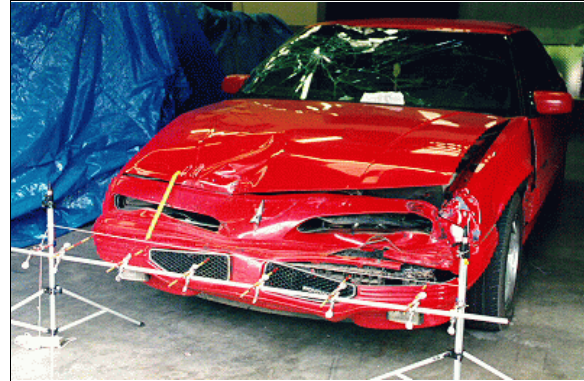
Figure 5: Case vehicle's frontal damage viewed from left of front with contour gauge present; Note: yellow tape indicates end of direct damage width (case photo #12)

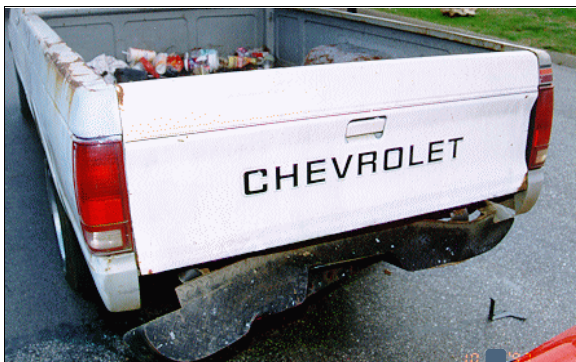
Figure 6: On-scene photo of Chevrolet pickup's damaged back (case photo #56a)

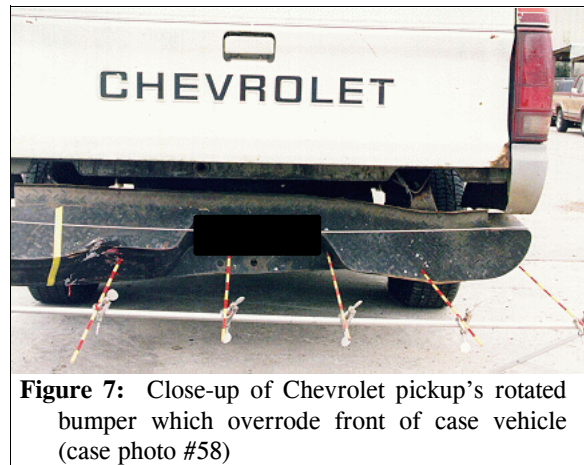
Figure 7: Close-up of Chevrolet pickup's rotated bumper which overrode front of case vehicle (case photo #58)

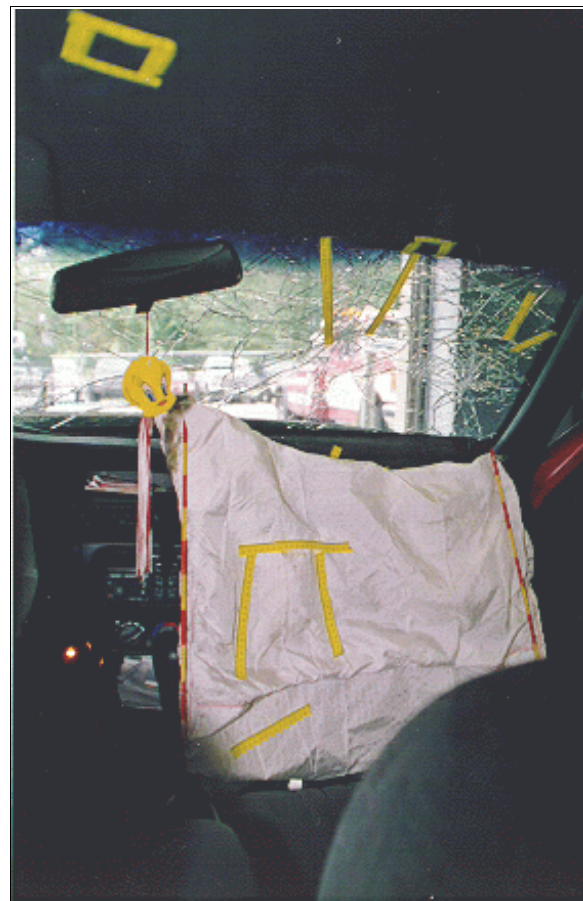
Inspection of the case vehicle's interior revealed an oil smudge and hair in the center of the right windshield's glazing (Figure 8), a skin transfer on the glove compartment's door, an

Figure 8: Vertical view of case vehicle's front right passenger seating area showing contact (i.e., yellow tape) areas on deployed air bag, windshield's glazing, front right header, and roof (case photo #34)

indentation and hair on the front right header (**Figure 8** above), an oil smudge at the junction of the right “A”-pillar and windshield (**Figure 9**), blood drops on the roof just behind the rearview mirror (**Figure 8** above) and over the front right passenger seating area, and blood on the driver’s seat cushion (**Figure 10**), particularly along the right side of the cushion near the center console near where the front right passenger’s head came to rest. In addition, there was a blood smear on the driver’s seat belt webbing (**Figure 10**) and left “B”-pillar that was most likely deposited by the driver after she touched the front right passenger and exited the vehicle. The windshield also was cracked from contact with the front right passenger air bag module’s cover flap. The back right side of the rearview mirror was contacted by the deploying front right passenger air bag. There was no visible evidence of intrusion the case vehicle’s interior.

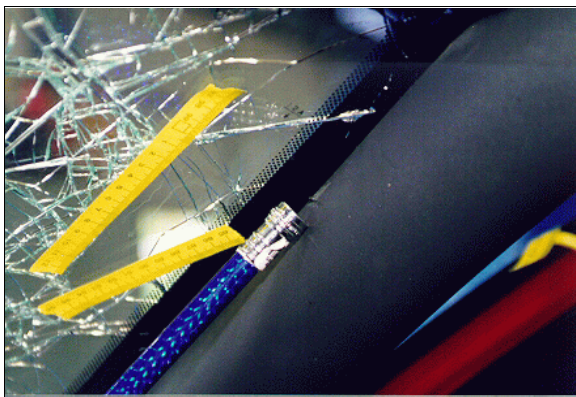
Figure 9: Close-up of gouge to case vehicle’s right “A”-pillar from head of pencil’s metal eraser (case photo #40)

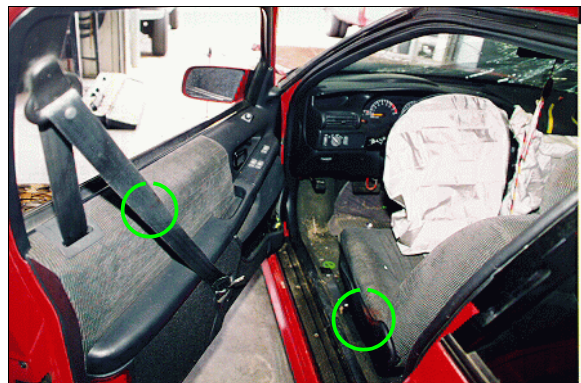
Figure 10: Interior view of case vehicle’s driver seating area showing blood transfers on webbing of driver’s automatic seat belt and on left side of seat cushion (Case Photo #21)

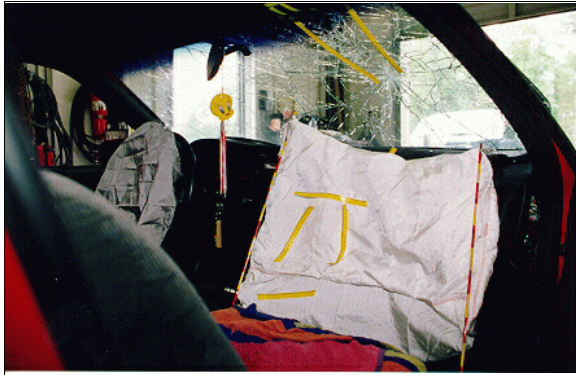
Figure 11: Case vehicle's front right seating area showing deployed front air bags and contact (yellow tape) on deployed front right air bag and windshield's glazing (case photo #50)

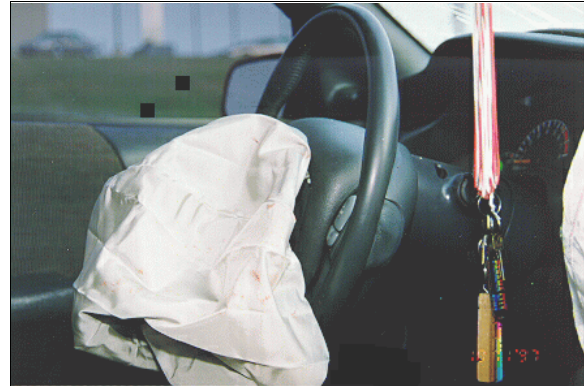
Figure 12: Case vehicle's deployed driver air bag showing black cover flap transfers and blood splatter on part of air bag's front surface (case photo #30)

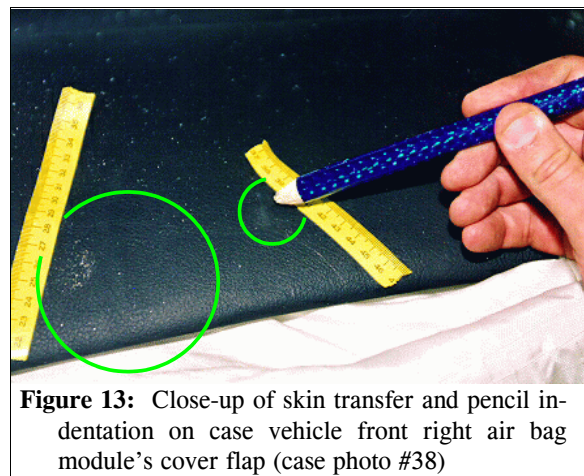
Figure 13: Close-up of skin transfer and pencil indentation on case vehicle front right air bag module's cover flap (case photo #38)

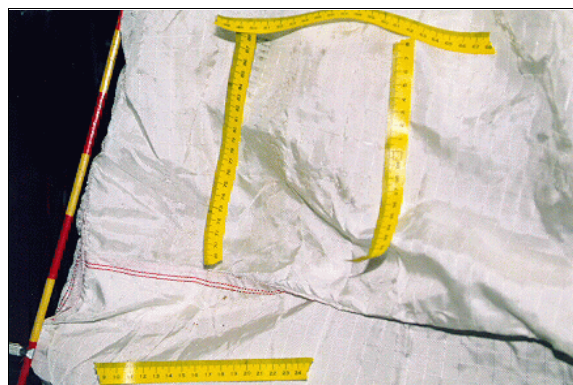
Figure 14: Close-up of skin transfer to front surface of case vehicle's deployed front right passenger's air bag from contact by front right passenger's neck (case photo #36)

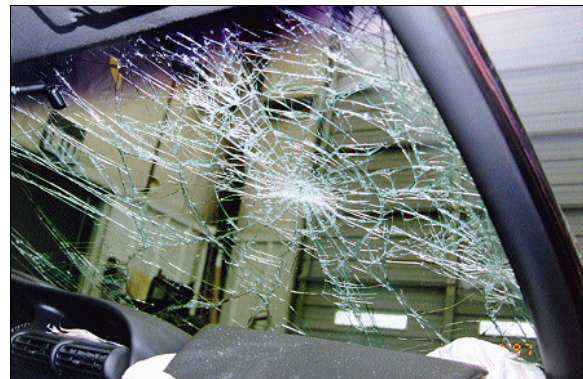
Figure 15: Case vehicle's right windshield glazing showing contacts to glazing and front right header by front right passenger's head (case photo #33a)

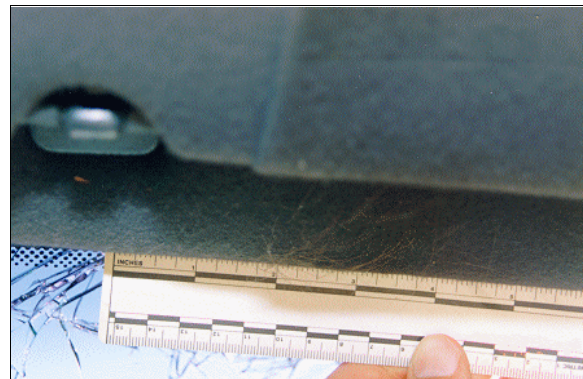
Figure 16: Close-up police photo of case vehicle's front right header showing clump of front right passenger's hair embedded in header (case photo #44)

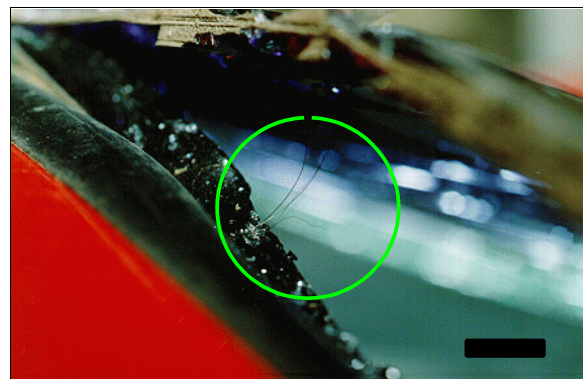
Figure 17: Close-up police photo of exterior of case vehicle's front right header area showing hair stuck between the header and separated glazing (case photo #46)

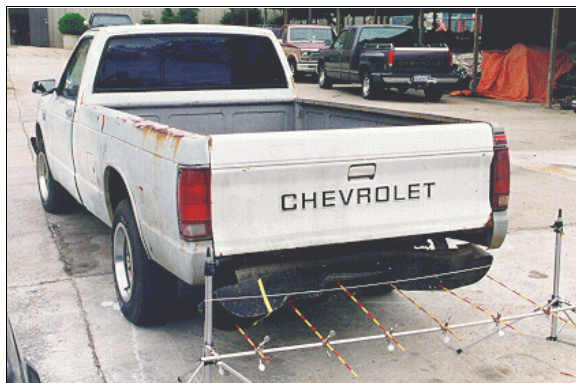
Figure 18: Chevrolet pickup's damaged back with contour gauge present; Note: bumper rotated under truck bed allowing case vehicle to underride (case photo #56)

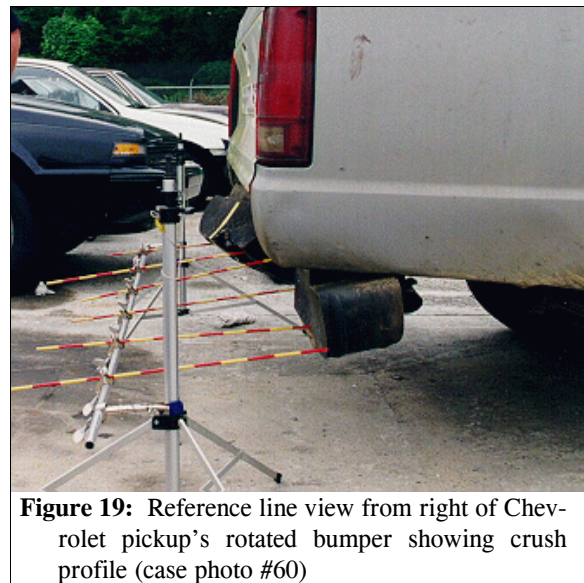
Figure 19: Reference line view from right of Chevrolet pickup's rotated bumper showing crush profile (case photo #60)

The Chevrolet pickup sustained both back and frontal impacts. The Chevrolet pickup's initial impact was to the back and involved the front of the case vehicle. Direct damage involved only the add-on rear bumper, causing it to rotate down and under the truck bed and enabling the case vehicle's front end to underride this vehicle. Direct damage began 19 centimeters (7.5 inches) to the right of the back left bumper corner and extended, a measured distance of 125 centimeters (49.2 inches) to the right bumper corner (**Figure 18**). Maximum crush was measured for the initial impact as 35 centimeters (13.8 inches) at C₅ (**Figure 19**).

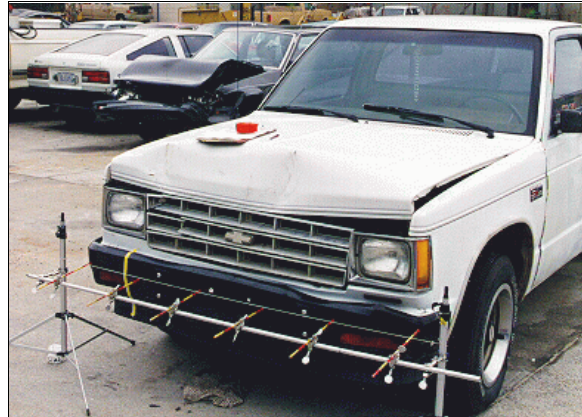
Figure 20: Chevrolet pickup's frontal damage from impacting back of Chevrolet van; Note: yellow tape indicates end of direct damage (case photo #64)

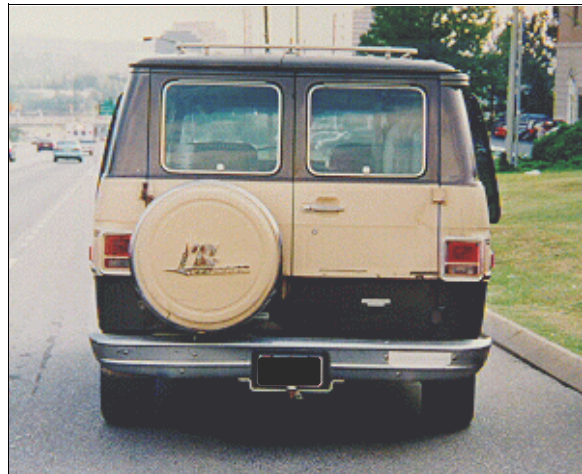
The Chevrolet van sustained an impact to its back from the front of the Chevrolet pickup. Based on the on-scene police photograph, there was no apparent visible damage but, presumably, the left rear door where the spare tire was attached to it was deformed (**Figure 21**) The maximum crush was estimated to be 3 centimeters (1.2 inches). Based on the available photographs, the CDC for Chevrolet van was determined to be: **06-BYMW-1 (180)**. The Chevrolet van was driven from the scene.

Figure 21: On-scene photo of Chevrolet van's final rest position in southbound merge lane; Note: damage limited to left rear door and spare tire (case photo #69)
