REDESIGNED AIR BAG REPORT

CASE NUMBER - IN97-050

VEHICLE - 1998 CHEVROLET CAVALIER LS

CRASH DATE - November, 1997

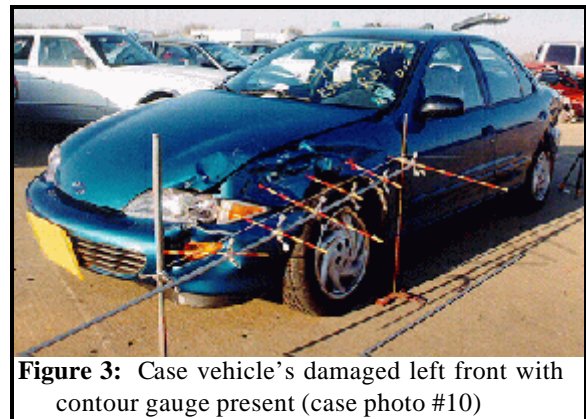
Figure 3: Case vehicle's damaged left front with contour gauge present (case photo #10)

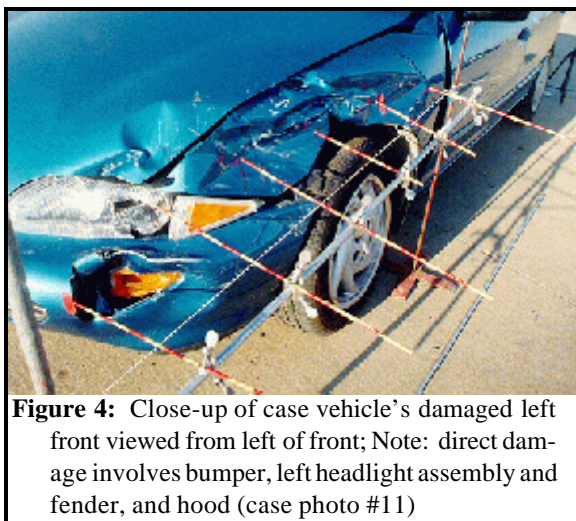
Figure 4: Close-up of case vehicle's damaged left front viewed from left of front; Note: direct damage involves bumper, left headlight assembly and fender, and hood (case photo #11)

Based on the case vehicle's inspection, direct contact extended from the bumper corner to the axle (i.e., the front overhang; **Figures 4 and 5** above), with induced damage causing the entire left fender to be deformed. The front bumper cover was folded inward at the apex of the corner, the front left turn signal and headlight assembly were shattered, and the left side of the engine cover was buckled inward. Maximum crush was 12 centimeters (4.7 inches). The CDC for the first (deployment) impact was determined to be: **11-LFEW-2 (-20)**. The WinSMASH reconstruction program, damage only algorithm, was used on the case vehicle's highest severity impact. The Total, Longitudinal, and Lateral Delta Vs are, respectively: 10.9 km.p.h. (6.8 m.p.h.), -10.3 km.p.h. (-6.4 m.p.h.), and +3.7 km.p.h. (+2.3 m.p.h.). The case vehicle's second (nondeployment) impact involved the left quarter panel, with direct contact restricted to the rear overhang, and the maximum crush was 9 centimeters (3.5 inches). The CDC for the second impact (**Figure 8** above) was determined to be: **09-LBEW-1 (-90)**. The case vehicle was towed from the scene due to disabling damage.

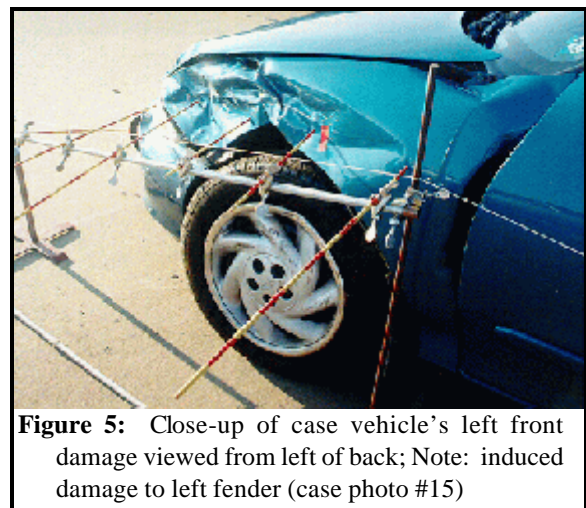
Figure 5: Close-up of case vehicle's left front damage viewed from left of back; Note: induced damage to left fender (case photo #15)

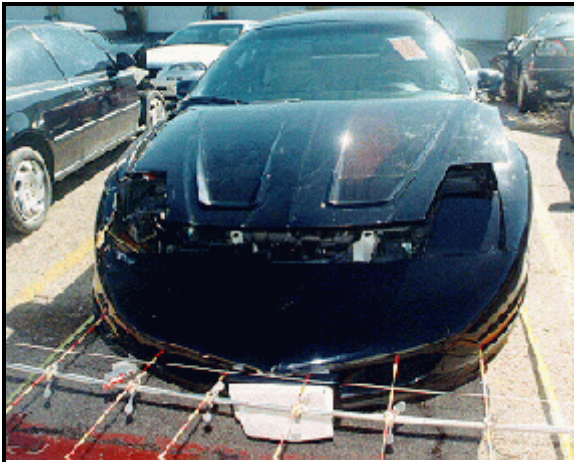
Figure 6: Vehicle #2's frontal damage with contour gauge present at bumper level; Note: damage was primarily to front right corner (case photo #36)

The inspection of vehicle #2 indicated that this vehicle's front was equipped with a markedly rounded (**Figure 6** above) bumper cover [i.e., 33 centimeters (13 inches) free space at the bumper corners] composed of flexible plastic and rigid plastic fenders. The first impact caused substantial tearing of the bumper cover and shattering/cracking of the right fender at the front right corner. In addition, the right headlight and turn signal assemblies were shattered, and there was minor bending of the engine cover (**Figure 7** above). Crush was measured at the metallic bumper under the plastic bumper cover, indicating a maximum crush of 7 centimeters (2.8 inches) at the front right bumper corner. The CDC for the first impact (nondeployment) was determined to be: **02-FREE-1 (+70)**. The WinSMASH reconstruction program, damage only algorithm, was used on vehicle #2's highest severity impact. The Total, Longitudinal, and Lateral Delta Vs are, respectively: 8.6 km.p.h. (5.3 m.p.h.), -2.9 km.p.h. (-1.8 m.p.h.), and -8.1 km.p.h. (-5.0 m.p.h.). Vehicle #2's second impact involved the area of the right rear wheel, "C"-pillar, and quarterpanel, and the maximum crush was 5 centimeters (2.0 inches). The CDC for the second impact (**Figure 9** above) was determined to be: **03-RZEW-1 (+90)**. Vehicle #2 was towed from the scene due to disabling damage.

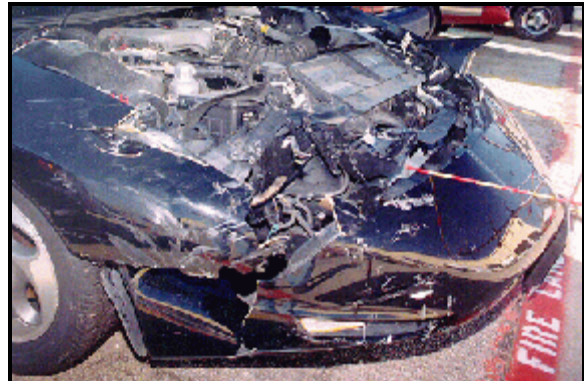
Figure 7: Close-up of vehicle #2's front right damage viewed from right of front; Note: contour gauge present above bumper level (case photo #45)

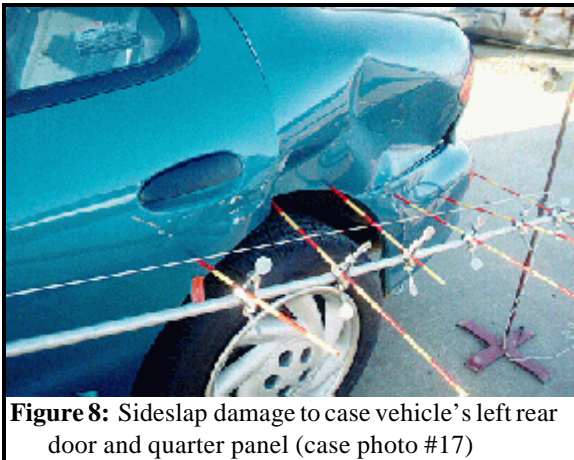
Figure 8: Sideslap damage to case vehicle's left rear door and quarter panel (case photo #17)

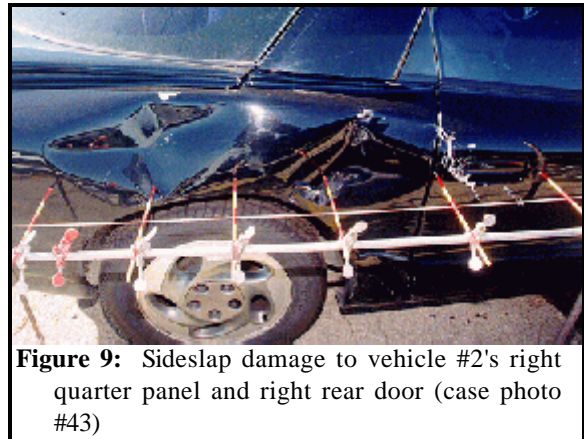
Figure 9: Sideslap damage to vehicle #2's right quarter panel and right rear door (case photo #43)

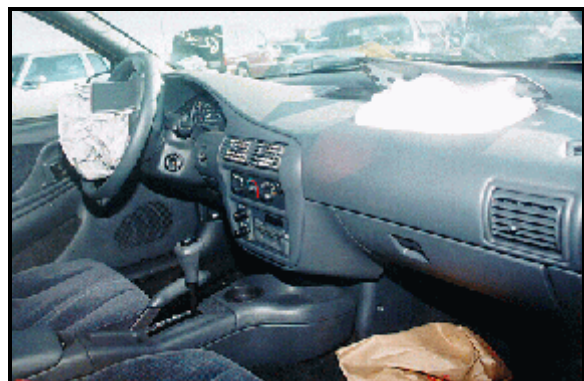
Figure 10: Case vehicle's front seating area showing deployed driver and front right air bags and floor-mounted automatic transmission (case photo #28)

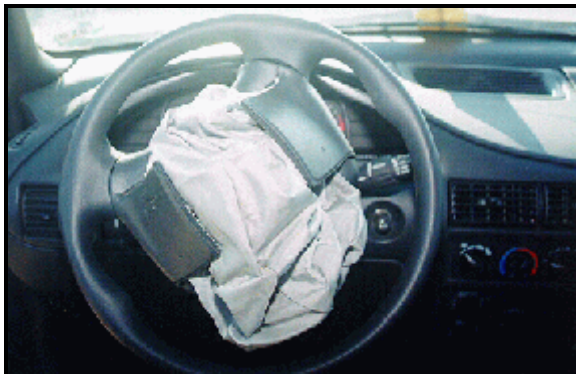
Figure 11: Case vehicle's deployed driver air bag showing "I"-type cover flaps without evidence of damage or occupant contact (case photo #25)

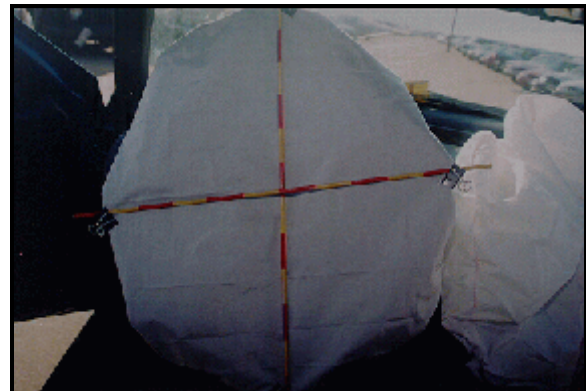
Figure 12: Case vehicle's deployed driver air bag showing some scuff marks just left of center and near the 6:30 o'clock position (case photo #27)

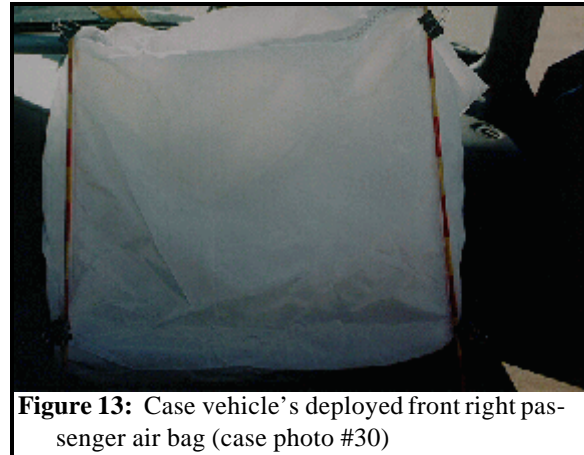
resulted in a 12 centimeter (4.7 inch) setback of the leading edge of the cover flap relative to the protruding right instrument panel. An inspection of the front right air bag module's cover flap and air bag revealed that the cover flap opened at the designated tear points and, while there was no evidence of damage during the deployment to the air bag, there were scuffs on the front right air bag module's cover flap from its impact with the windshield. The front right air bag was designed with two tethers, but the front right air bag had no vent ports. The deployed front right air bag was rectangular with a height of approximately 40 centimeters (15.7 inches) and a width of approximately 50 centimeters (19.7 inches). There was no contact evidence readily apparent on the front of the air bag (Figure 13), but there were some scuffs on the backside of the air bag from contact with the windshield.

Figure 13: Case vehicle's deployed front right passenger air bag (case photo #30)

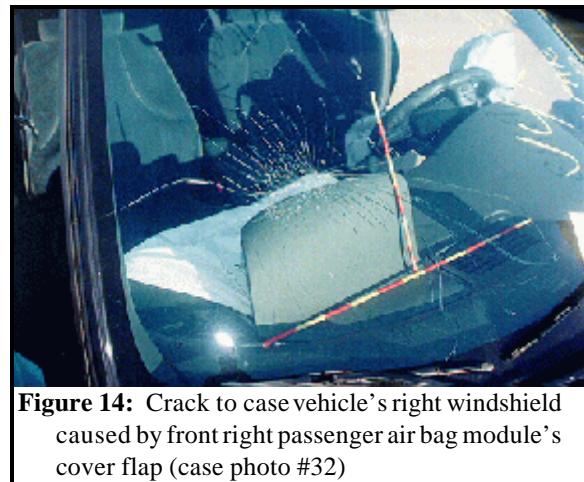
There was a small scuff on the knee bolster to the left of the steering column, indicating probable contact by the driver's left knee, and there was no other evidence of contact anywhere in the vehicle. There was a horizontal area of spiderweb cracking in the windshield directly above the cover flap (Figure 14).

Figure 14: Crack to case vehicle's right windshield caused by front right passenger air bag module's cover flap (case photo #32)
