**TRANSPORTATION SCIENCES
Crash Research Section**

**CALSPAN ON-SITE REDESIGNED AIR BAG INVESTIGATION
CALSPAN CASE NO. CA97-51
VEHICLE: 1998 FORD TAURUS SE
LOCATION: STATE OF PENNSYLVANIA
CRASH DATE: NOVEMBER 1997**

1. <i>Report No.</i> CA97-51	2. <i>Government Accession No.</i>	3. <i>Recipient's Catalog No.</i>	
4. <i>Title and Subtitle</i> Calspan On-Site Redesigned Air Bag Investigation Vehicle: 1998 Ford Taurus SE Location: Pennsylvania		5. <i>Report Date:</i> April, 2000

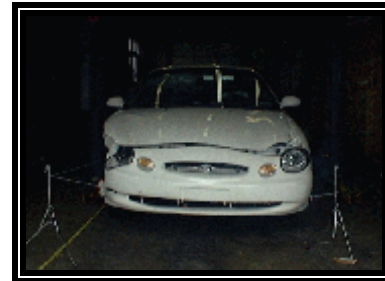
This investigation focused on the performance of the deployed redesigned frontal air bag system in a 1998 Ford Taurus SE (**Figure 1**), 4-door sedan. This deployment crash occurred as the driver of the Taurus entered a 4-leg intersection and impacted the left front fender area of a 1995 Mercury Tracer in an “L”-configuration impact sequence. The crash severity was minor with velocity changes estimated in the 16-18 km/h (10-12 mph) range. The L-configuration impact resulted in opposing post-crash deflections of the vehicles which caused a secondary sideslap impact. Both vehicles departed the northwest quadrant of the intersection and struck fixed objects as they came to rest. The latter frontal impacts were minor in severity and were not injury producing events. The driver of the Taurus was not wearing the manual belt system. He initially loaded the deployed redesigned front left air bag which protected the driver from probable contact against the steering assembly. He was not injured as a result of the crash.

Figure 1. Frontal view of the 1998 Ford Taurus.

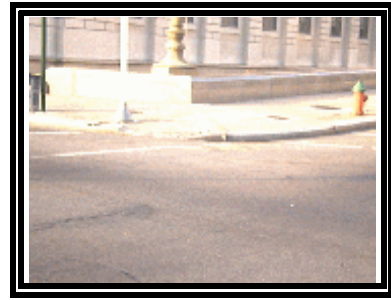
Figure 2. View from the initial impact location to the northwest quadrant of the intersection.

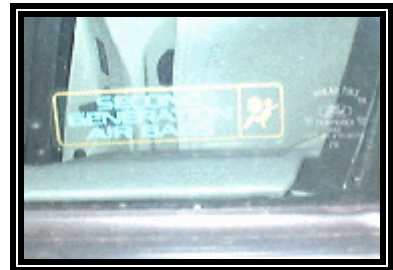
The 1998 Ford Taurus, 4-door sedan, was manufactured in 11/97 and was identified by vehicle identification number (V.I.N.) 1FAFP52U8WA (production number omitted). The fourth character (F) of the V.I.N. identified the redesigned frontal air bag system. In addition, labels were affixed to the lower rear aspect of the left front and right front door window glazing (**Figure 3**), adjacent to the “B”-pillar, identified that the vehicle was equipped with “SECOND GENERATION AIR BAGS”.

Figure 3. “SECOND GENERATION AIR BAG” label affixed to the right front door glazing.

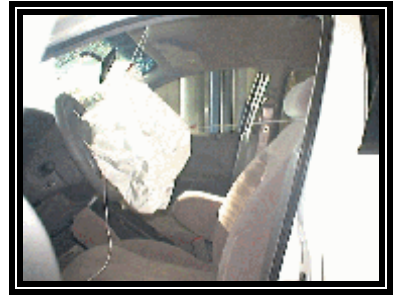
The driver of the Ford Taurus was seated in a mid track position with the seat back reclined to an angle of 17 degrees. He was not wearing the manual 3-point lap and shoulder belt system. The initial frontal impact sequence deployed the redesigned frontal air bag system. The driver responded to the 1 o'clock direction of force by moving forward and laterally to his right. He initially contacted the deployed redesigned front left air bag with his face and chest. The air bag protected the driver from contact against the steering assembly and possible injury (**Figure 8**).

Figure 8. Profile view of the driver's trajectory and the deployed front left air bag.
