CALSPAN ON-SITE DEPOWERED AIR BAG DEPLOYMENT INVESTIGATION

CALSPAN CASE NO. CA97-052

VEHICLE - 1998 CHEVROLET SUBURBAN

CRASH DATE - NOVEMBER, 1997

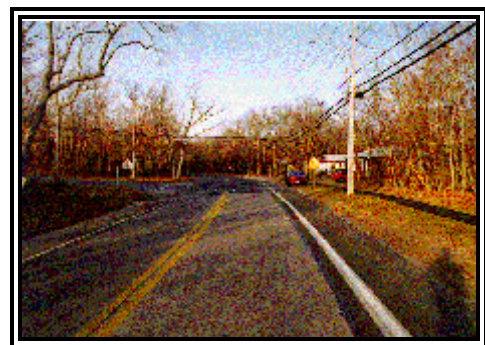
This three-vehicle crash occurred in the nighttime hours of November 1997. At the time of the crash, it was dark with street lighting and it was raining. The roads were wet. The crash occurred in the northbound lane of a two-lane north/south roadway located in a residential neighborhood. At the crash scene, the road grade was level and there was a gradual left curve for northbound traffic. There was a two lane road intersecting from the west, approximately 13 m (42 ft) south of the area of impact and a two lane road intersecting from the east, approximately 28 m (92 ft) north of the impact area. The primary roadway was 10 m (33 ft) in width, delineated by white fog lines and a double yellow center line. The speed limit in the area of the crash was 48 km/h (30 mph). **Figure 1** is a northbound trajectory view of the crash scene.

Figure 1: Northbound trajectory view.

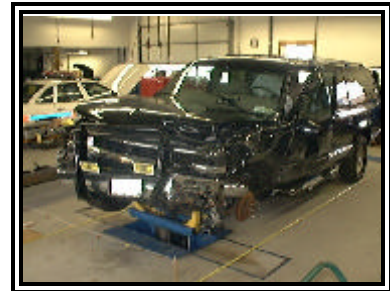
The Collision Deformation Classification (CDC) of the Chevrolet Suburban was 12-FLEW-03, **Figure 2**. The direct contact damage was 46 cm (18 in) in width, began 46 cm (18 in) left of center and extended to the left corner of the front bumper. The maximum deformation at the left corner was approximately 79 cm (31 in). The crush profile (less assumed free space) was as follows: C1=79 cm (31 in), C2=30 cm (12 in), C3=16 cm (6 in), C4=0, C5=0, C6=0. The Suburban's change in velocity (delta V) calculated by the Barrier Model of the WINSMASH program was 27.6 km/h (17.2 mph). The damaged components include: the front bumper, grille, hood, left front fender and wheelhouse, left front suspension and left frame rail. There was intrusion into the foot well of the driver's space. The windshield was cracked on the left lower aspect from the exterior impact force. The left side damage continued onto the left front door which was deformed rearward into the left B-pillar causing the door to be jammed shut. The left rear door could be opened slightly but was restricted by the front door's deformation. The impact cut and aired out the left front tire and circumferentially fractured the aluminum wheel rim.

Figure 2: Left front view of the Chevrolet Suburban.

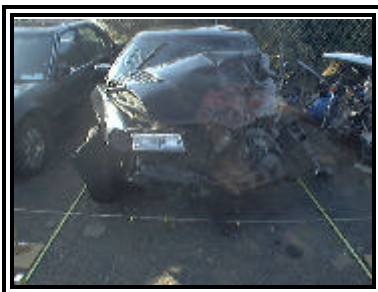
Figure 3: Front view of the Chevrolet Lumina.

Figure 3 is a front view of the 1991 Chevrolet Lumina. The CDC of the Chevrolet Lumina could not be coded (99-9999-99). The areas of direct contact in the two impacts directly overlapped and it was not possible to distinguish the damage extent associated to the two impacts. Overall, the vehicle's direct contact damage was 96 cm (38 in) in width beginning 18 cm (7 in) right of center and extended to the left corner of the front bumper. The entire front structure of the vehicle was displaced laterally 51 cm (20 in) to the left. The maximum deformation at the left front corner (less assumed free space) was approximately 76 cm (30 in).

The damaged components included: the front bumper fascia and reinforcement, hood, left front fender and wheel house, left front suspension and left unitized frame rail.

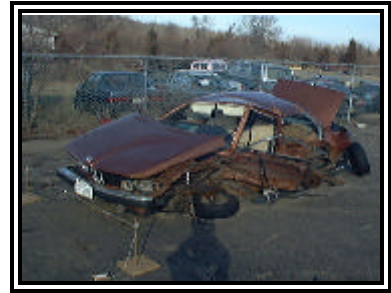
The CDC of the 1977 BMW 320i (**Figure 4**) was 11-LDAW-03. The front of the Chevrolet Lumina contacted the outboard 10 cm (4 in) of the left corner of the front bumper and continue down the left side of the vehicle. The direct contact damage extended 363 cm (143 in) longitudinally, from the left front corner, along the side of the vehicle. The impact deformed the left front suspension rearward into the left side of the firewall buckling the A-pillar and roof. The left front wheel rim was displaced from the axle. The windshield was displaced from the frame and fractured. All left side windows were shattered. The left front door's hinge pillar and the floor pan intruded into the occupant space.

Figure 4: Left front view of the BMW 320i.

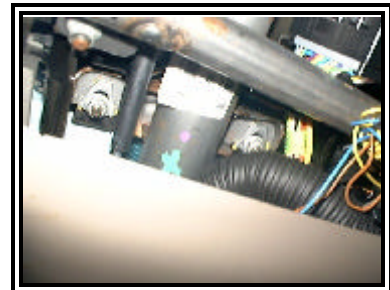
The Chevrolet Suburban was equipped with a Supplemental Restraint System that consisted of depowered driver and front passenger air bags. The driver air bag module was configured in the typical manner in the center hub of the steering wheel. The steering wheel was a tilt wheel adjusted to its most vertical position. It is likely that this adjustment of the rim occurred during the post-impact egress of the driver. The 4-spoke steering wheel rim was not deformed. Inspection of the steering columns' shear capsules indicated there was no movement of the column from occupant (driver) loading. **Figure 5** is a view of the shear capsules taken from underneath the instrument panel. The steering wheel was located (out of the field of view) at the bottom of the figure.

Figure 5: View of the steering column shear capsules.

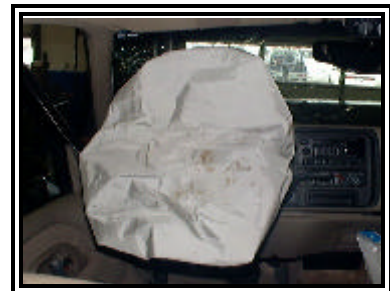
The driver air bag module cover flaps were designed as an I-configuration that opened as designed during the deployment sequence. The symmetrical flaps measured 10.8 cm (4.3 in) vertically by 7.6 cm (3.0 in) horizontally. The driver air bag was a tethered bag, 61 cm (24 in) in diameter, **Figure 6**. The two internal tether straps sewn to the center of the air bag's front surface were located at the 3 and 9 o'clock positions. When the bag was extended during the inspection, the tether straps allowed the deflated bag to extend 30 cm (12 in) from the module. There were two 2.5 cm (1.0 in) diameter vent ports located at the 11 o'clock/1 o'clock on the back side of the bag. The lower right quadrant of the air bag face was

Figure 6: Driver air bag.

spattered/soiled with dried salsa. There was no residual evidence of any other occupant contact.

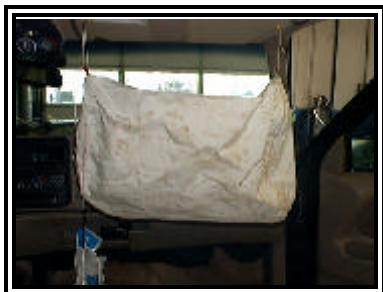
Figure 7: Front passenger air bag.

The H-configuration cover flaps measured 6.6 cm (2.6 in) vertically by 32.4 cm (12.8 in) horizontally. In its deflated state, the front passenger air bag measured 36 cm (14 in) vertically by 56 cm (22 in) horizontally at its extended face. The face of the bag extended 61 cm (24 in) from the module. The air bag was not tethered and was vented by two 5.7 cm (2.3 in) diameter ports located on the side panels in the 3/9 o'clock positions. The only evidence on the air bag fabric was dried salsa that covered the entire face of the bag. There was an additional concentration of dried salsa on the bottom left corner of the fabric. There was no residual evidence of any other occupant contact.
