## REMOTE REDESIGNED AIR BAG REPORT

CASE NUMBER - IN97-055  
LOCATION - MISSOURI  
VEHICLE - 1998 OLDSMOBILE 88 LS  
CRASH DATE - December, 1997

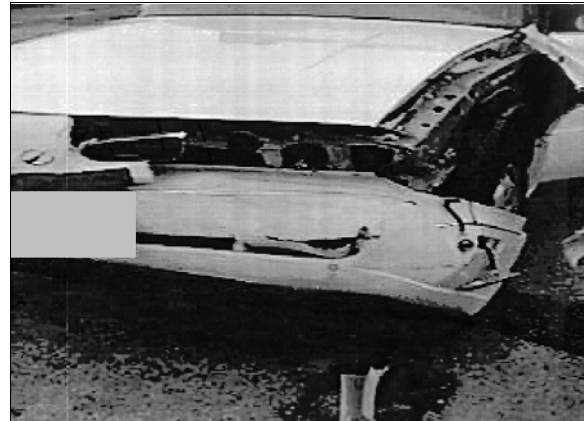
The front left corner (**Figure 1** below) of the case vehicle was most likely impacted by the front left corner of the Geo, causing the case vehicle's driver and front right supplemental restraints (air bags) to deploy. The case vehicle most likely rotated slightly counterclockwise and came to rest within the "Tee" intersection heading in a northeasterly direction. According to the available evidence, the Geo came to rest within the "Tee" intersection heading essentially westward.

**Figure 1:** Insurance photo of damage to case vehicle's front left bumper; Note: left fender was pulled outwards from impact (case photo #01)

Based on the available poor quality insurance photographs, the CDC for the case vehicle was estimated to be: **01-FYEW-1 (30)**. No reconstruction program was used on this crash because the NASS, CDS, SMASH protocol requires that actual vehicular crush measurements be obtained; however, this contractor's visually estimated Delta V is between 13 km.p.h. (8 m.p.h.) and 19 km.p.h. (12 m.p.h.). The case vehicle was towed from the scene but not due to damage.

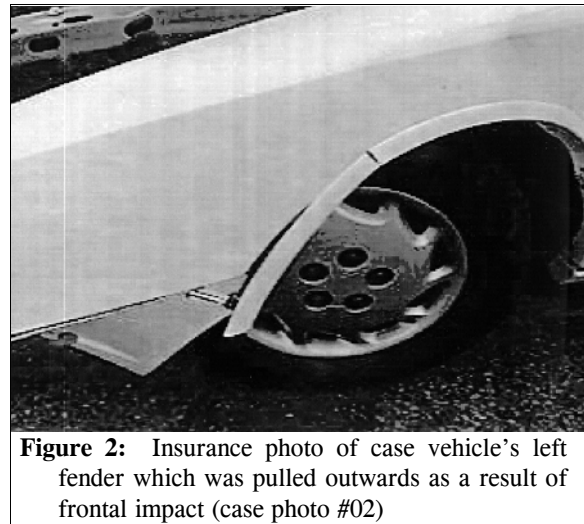
**Figure 2:** Insurance photo of case vehicle's left fender which was pulled outwards as a result of frontal impact (case photo #02)

The case vehicle's initial contact with the Geo involved the front left bumper corner. The corner was most likely impacted by the front left bumper corner of the Geo. The angled impact peeled the left fender away from the case vehicle's body (**Figure 2**). Maximum crush was estimated as 10 centimeters (3.9 inches) at C<sub>1</sub> (**Figure 1**). The case vehicle's front bumper, bumper fascia, grille, left headlight and turn signal assemblies, and left fender were directly damaged and crushed rearward.

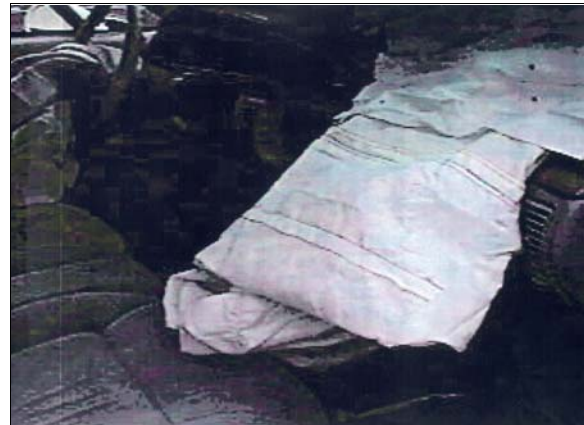
The front right passenger's air bag was located in the top of the instrument panel (**Figure 3**). Because this case is a remote investigation, the existence, number, and size of tethers or vent ports could not be assessed nor could the shape or size of the front right passenger's air bag be described. The investigating police officer made no mention of any evidence of contact or damage to the air bag's fabric.

**Figure 3:** Insurance photo of case vehicle's front seating area showing deployed driver's and front right passenger's air bags (case photo #04)

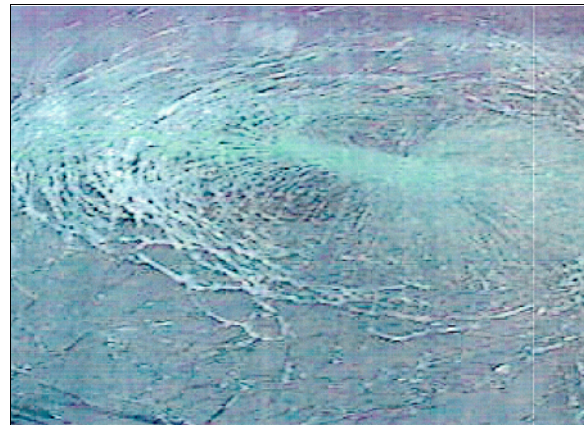
Based on the available photographs, the case vehicle's interior revealed a crack to the right windshield's glazing (**Figure 4**) that most likely resulted from contact by the front right air bag module's cover flap. The available evidence is inadequate to ascertain the existence or non-existence of any other evidence of occupant contact on the interior surfaces of the case vehicle.

**Figure 4:** Insurance photo of spider web type crack to case vehicle's right windshield; Note: windshield's glazing was broken by front right air bag module's cover flap (case photo #03)
