TRANSPORTATION RESEARCH CENTER

DEPOWERED AIR BAG REPORT

CASE NUMBER - IN97-057
LOCATION - Texas
VEHICLE - 1998 DODGE NEON
CRASH DATE - November, 1997

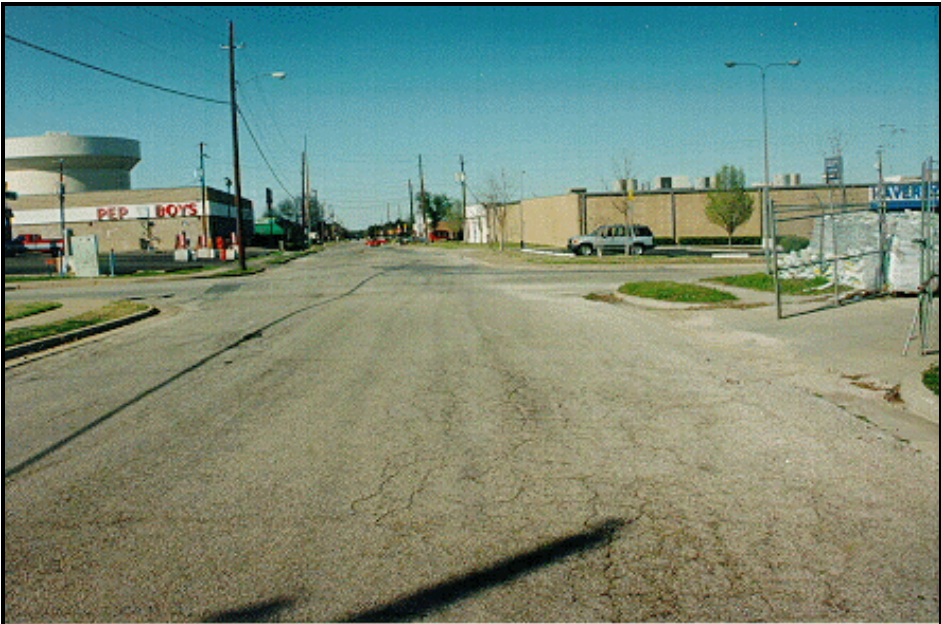
Figure 1: Case vehicle’s northbound approach toward impact within the intersection (case photo #1)

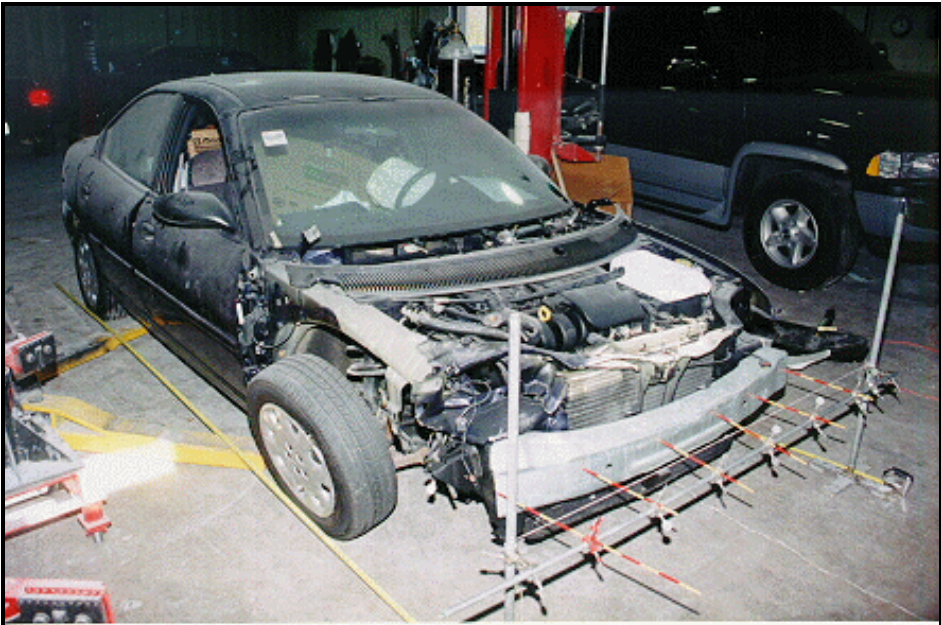
The case vehicle was a front-wheel-drive 1998 Dodge Neon, four-door sedan (VIN: 1B3ES47CKTD-----). Anti-lock brakes were an option for this vehicle, but it is not known if this vehicle was so equipped. Direct contact was limited to the right half of the front, including the bumper, grille, the leading edge of the right fender, and the front right corner of the engine hood, with induced damage across the entire front (see **Figures 2, 3 and 4**). The CDC was determined to be **01-FZEW-1**. The ROLDMIS reconstruction program was used on the case vehicle's highest severity impact because vehicle #2 was not inspected. The Total, Longitudinal, and Lateral Delta Vs are, respectively: 17 km.p.h. (11 m.p.h.), -16 km.p.h. (-10 m.p.h.) and -6 km.p.h. (-4 m.p.h.). The steering wheel was not deformed, and there was no evidence that the nonadjustable steering column had moved (see **Figure 5**). The driver's air bag was located in the steering wheel hub with a single flap. The flap opened along the seams, and there was no evidence of damage to the flap or the air bag. The deployed driver's air bag was round with diameter 58 centimeters (23 inches). There was an area of dark-colored scuffs on the front of the air bag in the lower left quadrant (see **Figure 6**). There were no other marks on the air bag, nor any other evidence of occupant contact anywhere in the vehicle.

Figure 2: Case vehicle’s front and right side with bumper cover, grille, hood, and right fender removed (case photo #16)

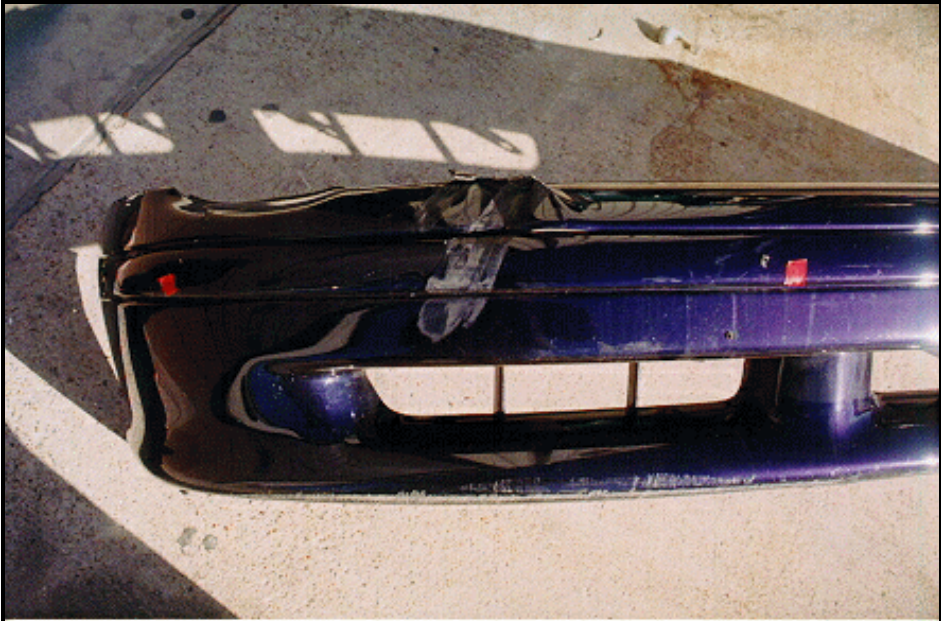
Figure 3: Closeup of direct contact on front right corner of case vehicle's bumper cover (case photo #19)

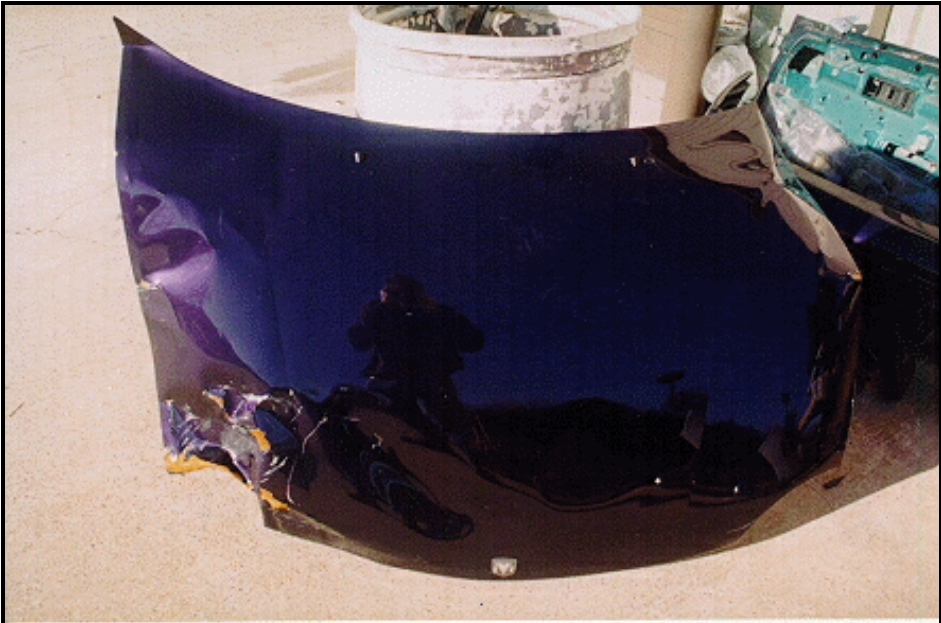
Figure 4: Case vehicle's engine hood; note: damage to front right corner area (case photo #20)

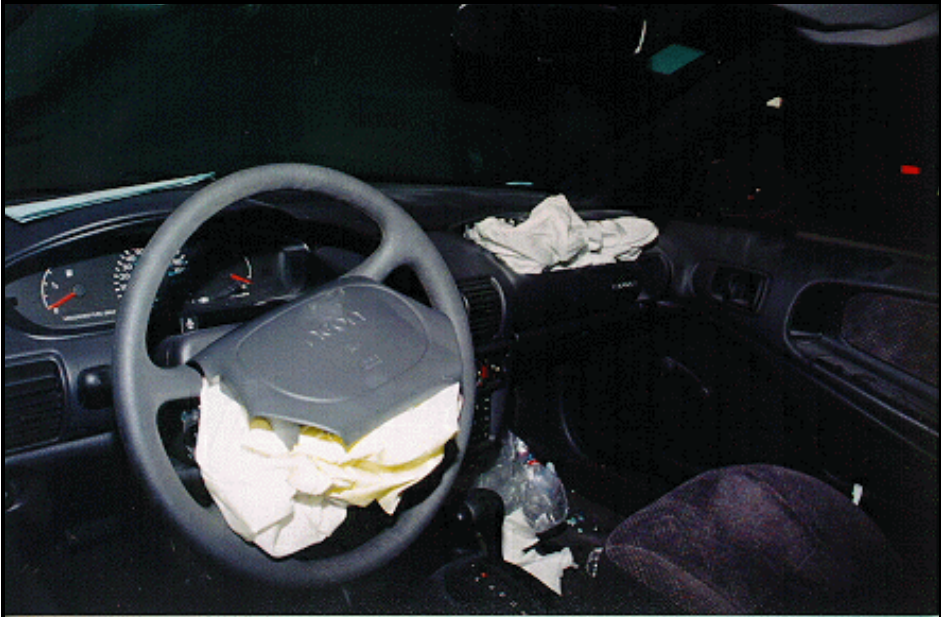
Figure 5: Case vehicle's steering wheel and driver's air bag module (case photo #23)

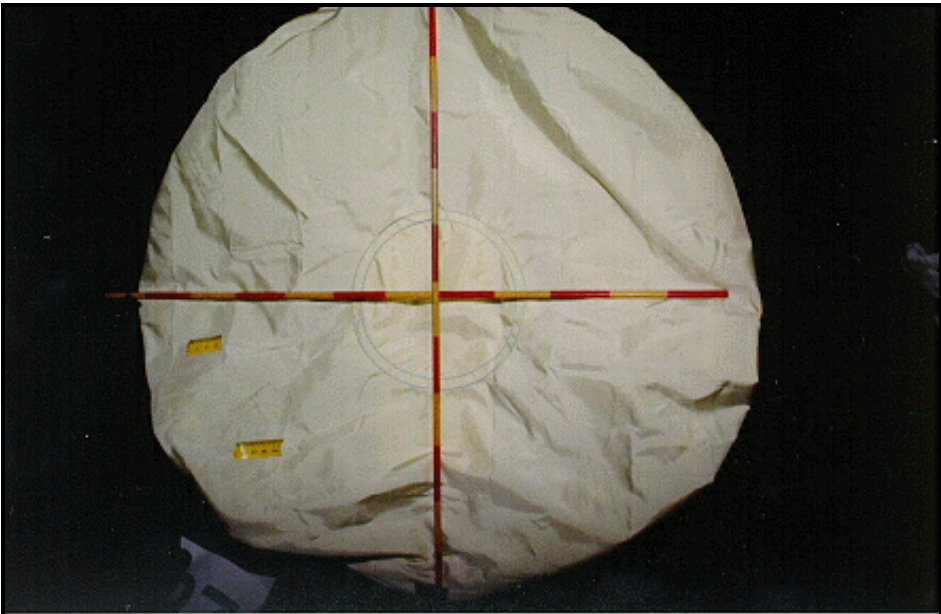
The case vehicle's driver did not attempt any avoidance maneuvers. The impact deployed the air bags and caused her to move forward and to the right, toward the center of the instrument panel. Because she was wearing her lap-and-shoulder safety belt, her motion was restricted, and she encountered the deployed air bag in an upright posture. Because the air bag cushioned her, she did not load the safety belt webbing with the full force of her inertial motion. Her right leg impacted the rigid plastic knee bolster on the lower edge of the center instrument panel and the side of the center console in the driver's foot well, causing the contusions in her right knee area. The driver's air bag impacted her left wrist, causing the sprain. The combined effects of the impact and subsequent counterclockwise rotation could have caused the alleged lumbar strain.

Figure 6: Case vehicle's driver side air bag; note: contact evidence in left lower quadrant (case photo #27)

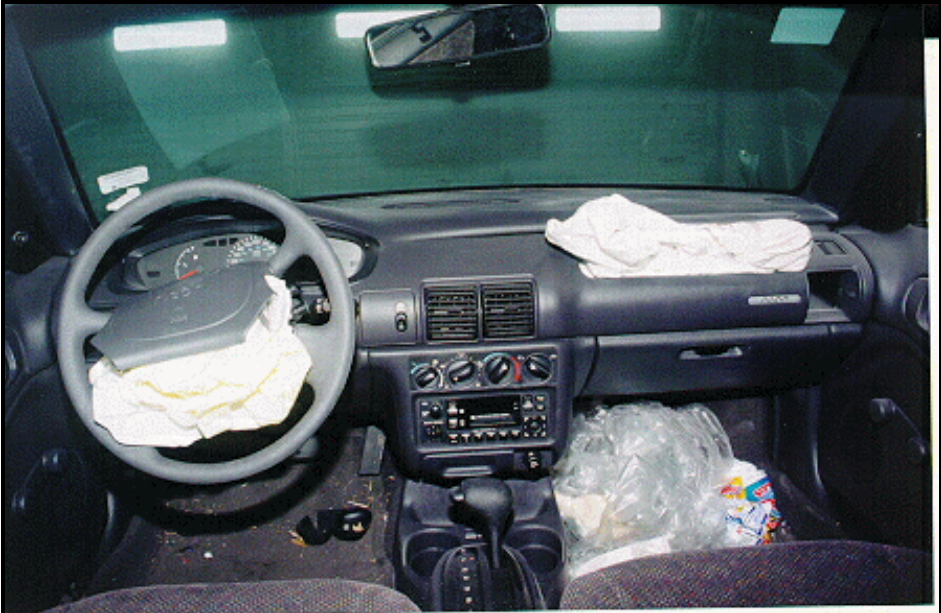
Figure 7: Case vehicle's instrument panel, center console, and deployed air bags (case photo #22)
