REDESIGNED AIR BAG REPORT

CASE NUMBER - IN97-058

VEHICLE - 1998 PONTIAC GRAND AM SE

CRASH DATE - December, 1997

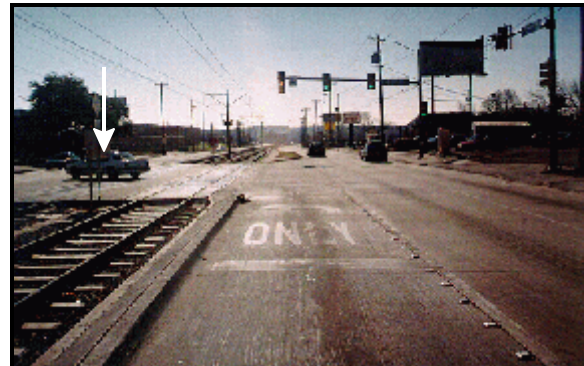
Figure 1: Case vehicle's southward travel path in left-hand turn lane approaching "Tee" intersection; Note: case vehicle turned left like exemplar vehicle (arrow) and crossed two sets of railroad tracks, just prior to impact (case photo #02)

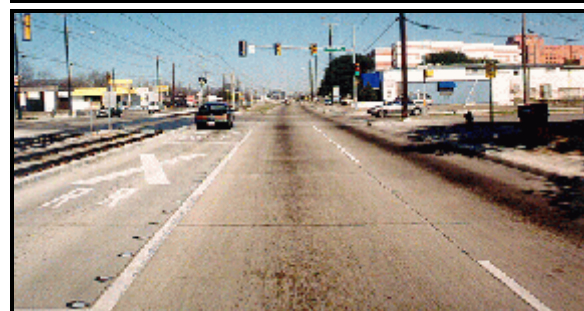
Figure 2: Vehicle #2's northward travel path in inside northbound through lane approaching "Tee" intersection (case photo #09)

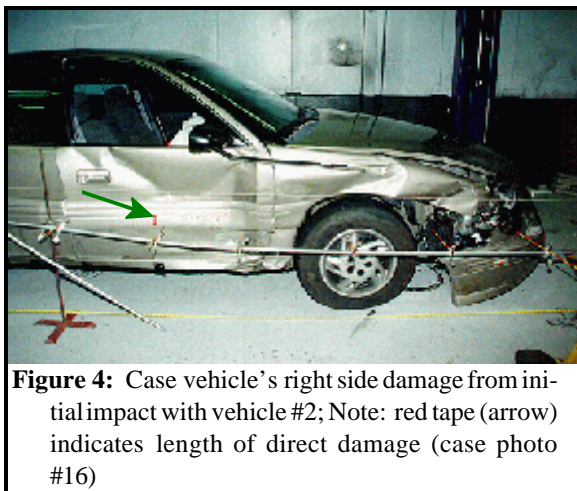
Figure 4: Case vehicle's right side damage from initial impact with vehicle #2; Note: red tape (arrow) indicates length of direct damage (case photo #16)

The right fender and right front door of the case vehicle (**Figures 3 through 5 and Figure 6** below) were impacted by the front of vehicle #2 (**Figures 7 and 8** below), causing the case vehicle's driver and front right passenger supplemental restraints (air bags) to deploy. The case vehicle began an approximate 200 degree counterclockwise rotation during separation from the first impact with vehicle #2 to final rest, with the heading direction changing from the east-southeast to nearly due west. Vehicle #2 began an approximate 100 degree clockwise rotation during separation from the case vehicle, with its heading direction changing from the north to east-southeast. After the first impact occurred and during each vehicle's respective rotation, a second, sideslap impact occurred. The right back corner of the case vehicle (**Figure 9** below) impacted the forward half of vehicle #2's left front door (**Figures 10 and 11** below).

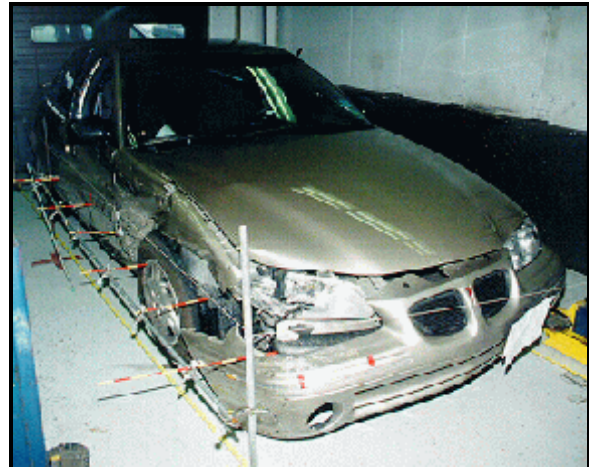
Figure 3: Case vehicle's right side damage with contour gauge present viewed from left of front (case photo #14)

be: **02-RYAW-2 (+50)** [maximum crush was 13 centimeters (5.1 inches)]. The WinSMASH reconstruction program, damage only algorithm, was used on the case vehicle's highest severity impact. The Total, Longitudinal, and Lateral Delta Vs are, respectively: 39.2 km.p.h. (24.4 m.p.h.), -25.2 km.p.h. (-15.7 m.p.h.), and -30.0 km.p.h. (-18.6 m.p.h.). The CDC for the second, sideslap collision was determined to be: **05-RBEE-1 (+160)** [maximum crush was 1 centimeter (0.4 inches)]. The WinSMASH reconstruction program, damage only algorithm, was also used on the case vehicle's second highest severity impact. The Total, Longitudinal, and Lateral Delta V results are, respectively: 4.7 km.p.h. (2.9 m.p.h.), +4.5 km.p.h. (+2.8 m.p.h.), and -1.6 km.p.h. (-1.0 m.p.h.). The case vehicle was towed due to disabling damage.

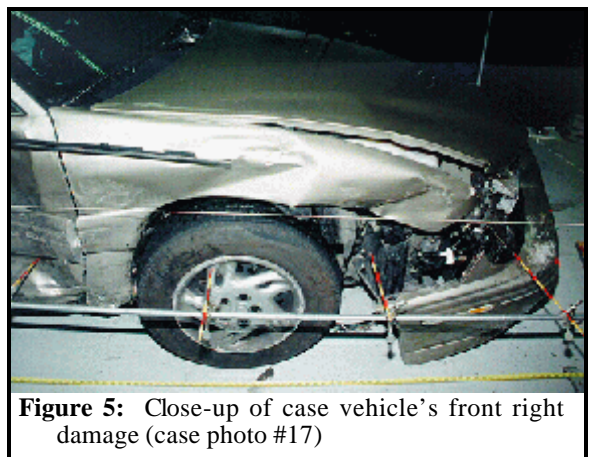
Figure 5: Close-up of case vehicle's front right damage (case photo #17)

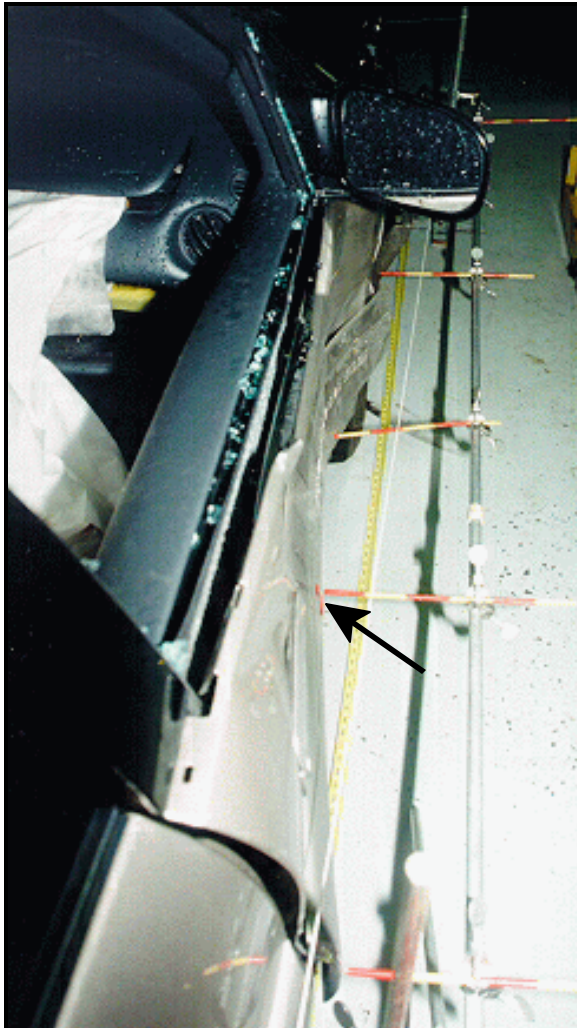
Figure 6: Case vehicle's right side damage viewed along right reference line from back; Note: red tape (arrow) marks length of direct damage and disintegrated right front glazing (case photo #21)

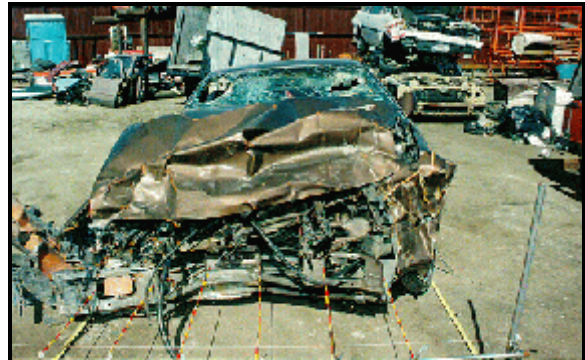
Figure 7: Vehicle #2's frontal damage with contour gauge present from initial impact with case vehicle (case photo #47)

Based on the vehicle inspection, the CDC for vehicle #2's initial impact was determined to be: **12-FDEW-2 (-10)** [maximum crush was 60 centimeters (23.6 inches)]. The WinSMASH reconstruction program, damage only algorithm, was used on vehicle #2's highest severity impact. The Total, Longitudinal, and Lateral Delta Vs are, respectively: 38.2 km.p.h. (23.7 m.p.h.), -37.7 km.p.h. (-23.4 m.p.h.), and +6.6 km.p.h. (+4.1 m.p.h.). The CDC for the second, sideslap collision was determined to be: **11-LPMW-1 (-40)** [maximum crush was 2 centimeters (0.8 inches)]. The WinSMASH reconstruction program, damage only algorithm, was used on the case vehicle's second highest severity impact. The Total, Longitudinal, and Lateral Delta Vs are, respectively: 4.6 km.p.h. (2.9 m.p.h.), -3.5 km.p.h. (-2.2 m.p.h.), and +3.0 km.p.h. (+1.9 m.p.h.). Vehicle #2 was towed due to disabling damage.

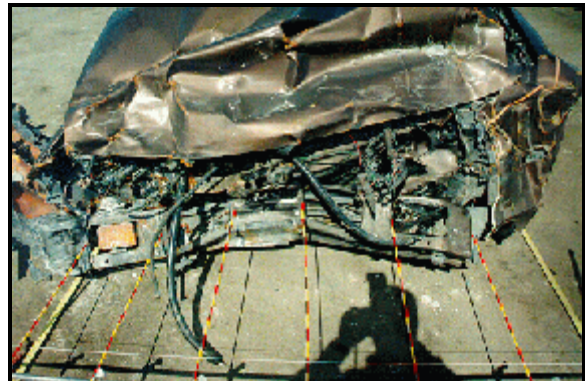
Figure 8: Close-up of vehicle #2's frontal damage with contour gauge present (case photo #48)

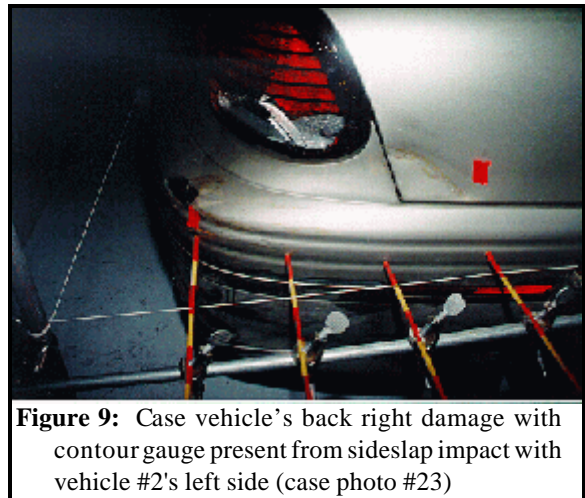
Figure 9: Case vehicle's back right damage with contour gauge present from sideslap impact with vehicle #2's left side (case photo #23)

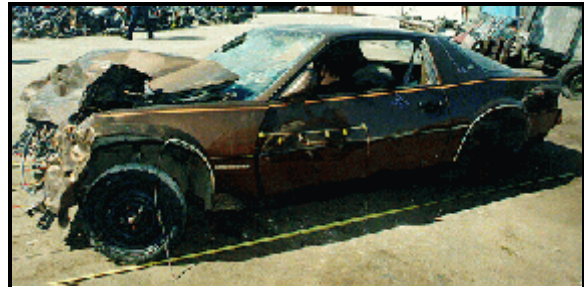
Figure 10: Vehicle #2's driver door damaged from sideslap impact with case vehicle (case photo #51)

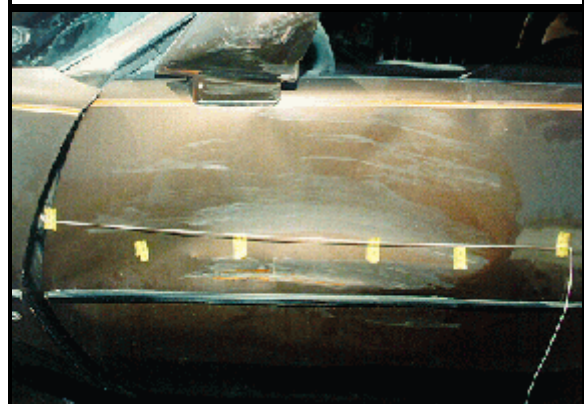
Figure 11: Close-up of damage to vehicle #2's driver door from sideslap impact with case vehicle (case photo #53)

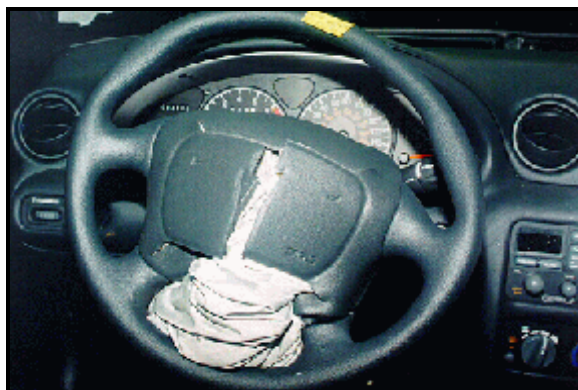
The case vehicle's driver air bag was located in the steering wheel hub. The module cover consisted of 'I'-configuration cover flaps made of thick vinyl with overall dimensions of 9 centimeters (3.5 inches) at the upper horizontal seams and 10 centimeters (3.9 inches) vertically. An inspection of the air bag module's cover flaps and air bag revealed that the cover flaps opened at the designated tear points, and there was no evidence of damage during the deployment to the air bag or the cover flaps (**Figure 12**); although, the top half of the steering wheel rim was bent forward 5 centimeters (2.0 inches).

Figure 12: Case vehicle's steering wheel-mounted driver air bag module showing "I" configuration cover flaps without evidence of damage or occupant contact (case photo #33)

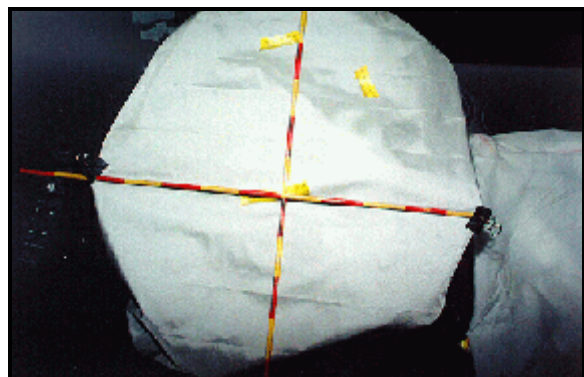
Figure 13: Case vehicle's deployed driver air bag; Note: yellow tape identifies possible contact points (case photo #29)

The driver's air bag was designed without any tethers. The driver's air bag had two vent ports, approximately 3 centimeters (1.2 inches) in diameter, located at the 3 and 9 o'clock positions. The deployed driver's air bag was round with a diameter of 52 centimeters (20.5 inches). Inspection of the driver air bag fabric revealed two scuffs (**Figure 13** above), one above the bag's horizontal midline and the other below the horizontal midline.

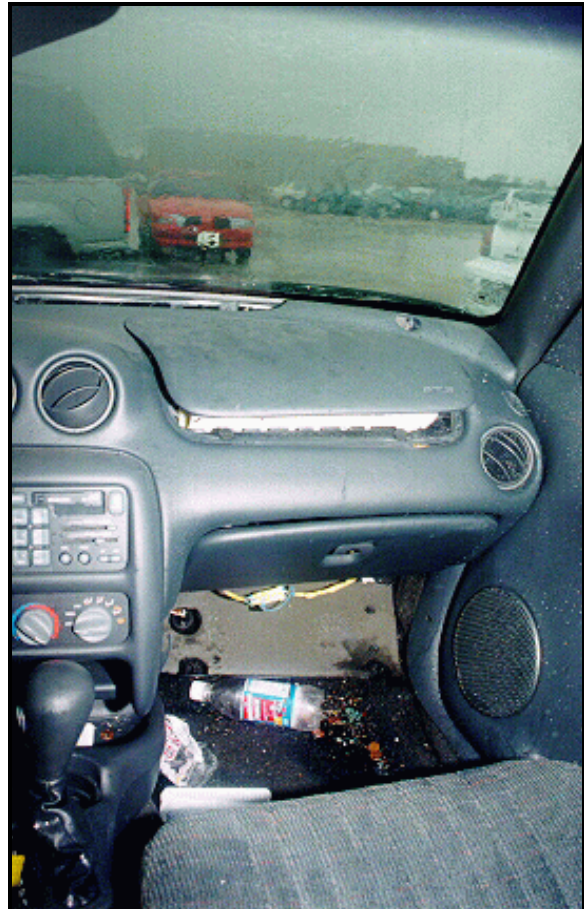
The front right passenger's air bag was located in the top of the instrument panel. There was a single, asymmetrical, modular cover flap. The cover flap was made of a thick vinyl over a thick cardboard type frame. The flap's dimensions were: 37 centimeters (14.6 inches) along the horizontal seams, forward and at the rear (i.e., toward the windshield), 21 centimeters (8.3 inches) along the right vertical seam, and 26 centimeters (10.2 inches) along the left vertical seam. The profile of the case vehicle's instrument panel/dash resulted in a 6 centimeter (2.4 inch) setback of the leading edge of the cover flap relative to the protruding right instrument panel. An inspection of the front right air bag module's cover flaps and air bag revealed that the cover flaps opened at the designated tear points, and there was no evidence of damage during the deployment to the air bag or the cover flaps (**Figure 14**).

Figure 14: Case vehicle's front right passenger seat-ing area showing front right air bag module's cover flap without evidence of damage or occupant contact; Note: floor-mounted, automatic transmission selector lever (case photo #35)

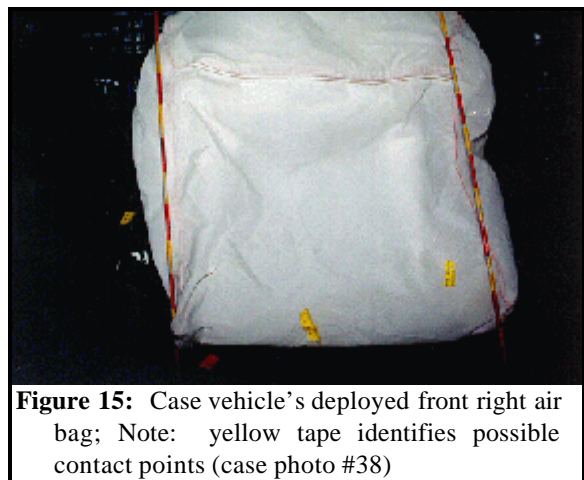
The front right passenger's air bag was designed with two tethers, with each tether strap 5 centimeters (2.0 inches) wide. The front right air bag had no vent ports. The deployed passenger air bag was rectangular with a height of approximately 46 centimeters (18.1 inches) and a width of approximately 48 centimeters (18.9 inches). Inspection of the front right passenger air bag fabric (**Figure 15**) revealed a small transfer at the bottom center and contact marks at the bottom right corner. The only other evidence of occupant contact on the interior surfaces involved the windshield-mounted rearview mirror, which was knocked out of position, and the center console which may have been contacted by the driver.

Figure 15: Case vehicle's deployed front right air bag; Note: yellow tape identifies possible contact points (case photo #38)

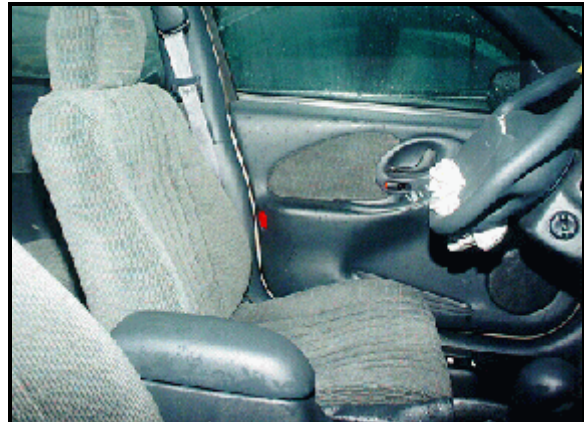
Based on the available evidence, the case vehicle's driver made no known pre-crash avoidance maneuvers. As a result and independent of the use of their available safety belts, the driver's and front right passenger's pre-impact body positions shifted slightly to their right haunches during the case vehicle's left turn maneuver from a southbound to an anticipated eastbound travel path. The case vehicle's primary impact with vehicle #2 enabled the case vehicle's driver and front right passenger to continue forward and rightward toward the +50 degree Direction of Principal Force, as the case vehicle decelerated. In addition, the driver's body rotated slightly counterclockwise and moved slightly upward, resulting (most likely) in his right hand striking and displacing the interior rearview mirror. The initial impact also caused the case vehicle to rotate counterclockwise, causing the driver to move further to the right. Because he was using his lap-and-shoulder, safety belt system, his forward motion was restricted, and he encountered the deployed air bag in a right-of-center alignment, most likely with his face and chest. The acute angle of the case vehicle's right side impact most likely delayed the system sensors from reading a longitudinal deceleration of sufficient magnitude to reach the air bag system's deployment threshold. As a result, when the driver's air bag did deploy, the driver's body caused the air bag to expand towards the instrument panel, bending the upper portion of the steering wheel's rim (**Figure 16**). The driver was then thrust backwards and a little right by

Figure 16: Case vehicle's driver seating area showing deformation to upper portion of steering wheel rim (case photo #39)
