REDESIGNED AIR BAG REPORT

CASE NUMBER - IN97-066

VEHICLE - 1998 PONTIAC GRAND AM SE

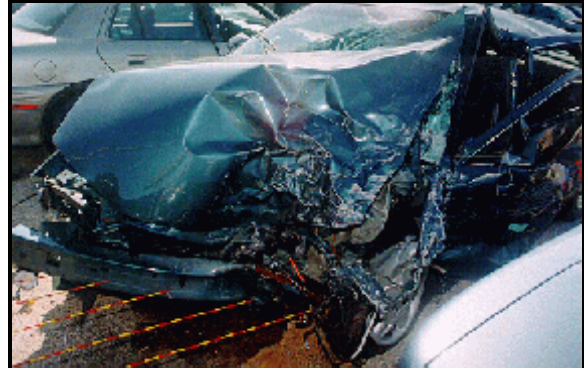
Figure 4: Case vehicle’s overlapping front left and left front damage from deployment impact with vehicle #2 and front left damage from impact with signal pole; Note: contour gauge is present for signal pole impact (case photo #13)

The front left corner and left side of the case vehicle (**Figures 4 and 5**) were impacted by the front of vehicle #2 (**Figures 6 and 7**), causing the case vehicle's driver and front right passenger supplemental restraints (air bags) to deploy. The case vehicle veered off to the southeast (**Figure 8** below) and subsequently impacted a traffic signal light pole (**Figure 9** below) with its front left (**Figure 10** below). The

information, the case vehicle sustained two impacts in the front left corner area, resulting in overlapping (masked) damage. Direct damage along the case vehicle's left side ended 10 centimeters (3.9 inches) in front of the rear axle and was 241 centimeters (94.9 inches) in length. Because of the overlapping damage from the case vehicle's second (signal pole) impact, the length of direct damage along the front of the case vehicle could not be determined. The direct damage from the second impact began 84 centimeters (33.1 inches) leftward of the front right corner and extended to the front left corner where the damage overlapped with the damage from the case vehicle's impact with vehicle #2. Based on our interpretation of the crash, this contractor estimates the CDC for case vehicle's first impact (with vehicle #2) as: **11-FLEE-9 (340)**, reflecting the narrow end engagement and the swiping down the case vehicle's left side. The CDC for case vehicle's second impact (with the signal pole), based on the final crush profile and reflecting the overlapping damage at the front left corner, was determined to be: **12-FYEW-4 (00)** [maximum crush was 106 centimeters (41.7 inches)]. The WinSMASH reconstruction program, ROLDMIS algorithm (i.e., using vehicle #2's crush profile and treating the case vehicle as missing), was used on the case vehicle's highest severity impact (vehicle #2). The Total, Longitudinal, and Lateral Delta V's are, respectively: 35.1 km.p.h. (21.8 m.p.h.), -33.0 km.p.h. (-20.5 m.p.h.) and +12.0 km.p.h. (+7.5 m.p.h.). This is a borderline reconstruction, but the results appear reasonable. Due to the inability to separate the pole impact crush from the vehicle-to-vehicle crush, no Delta Vs were calculated for the case vehicle's second impact. Based on our interpretation of the crash, this contractor estimates that the case vehicle's total Delta V for the pole impact was probably in the range 24 - 29 km.p.h. (15 - 18 m.p.h.). The case vehicle was towed due to damage.

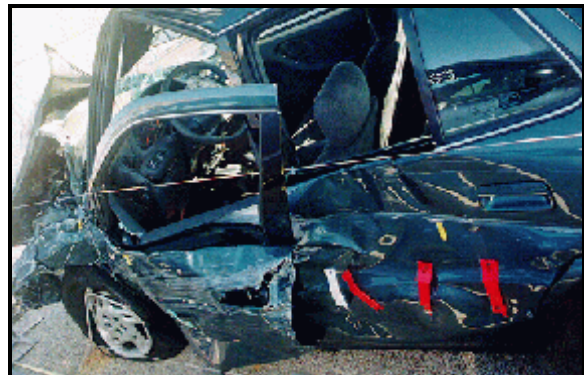
Figure 5: Damage along case vehicle’s left side from impact with vehicle #2 viewed from left back (case photo #16)

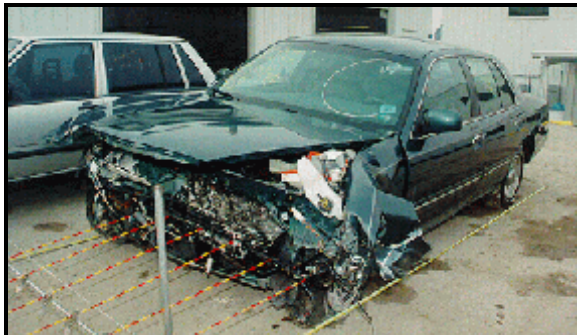
Figure 6: Vehicle #2's frontal damage from impact with case vehicle’s left side viewed from left of front with contour gauge present (case photo #43)

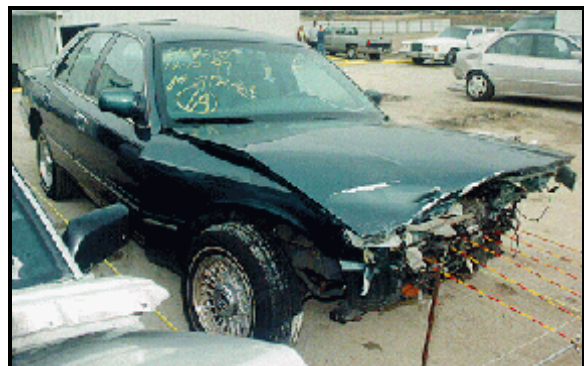
Figure 7: Vehicle #2's frontal damage from impact with case vehicle’s left side viewed from right of front with contour gauge present (case photo #49)

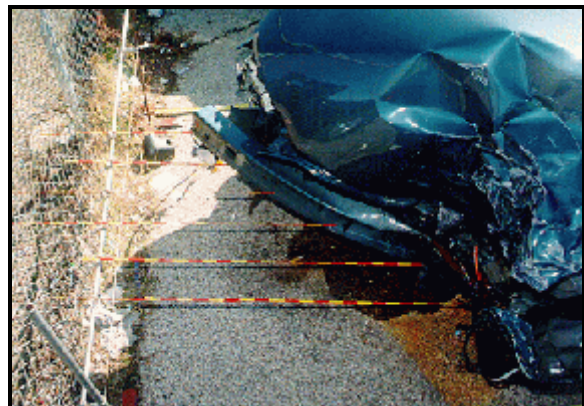
Figure 10: Overhead reference line view from left of case vehicle's front damage from signal pole impact with contour gauge present (case photo #14)

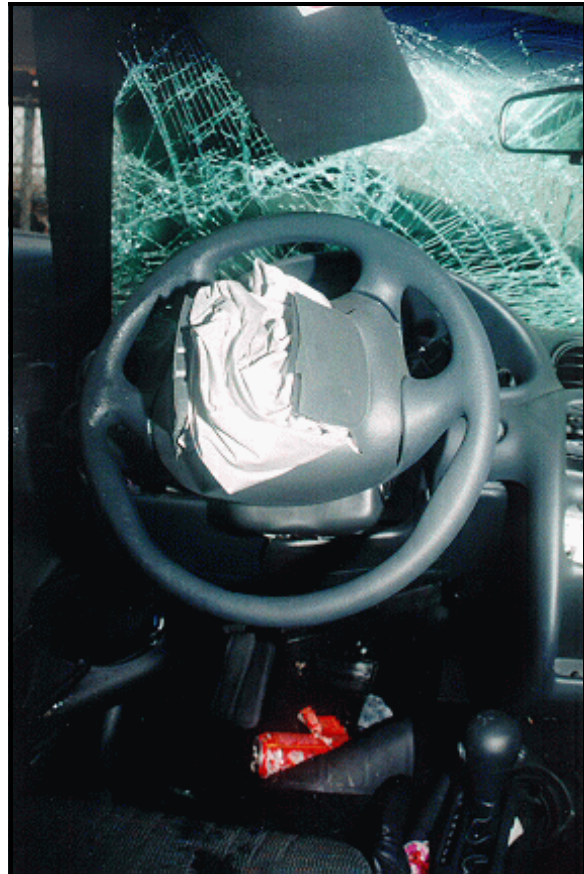
Figure 11: Case vehicle's driver seating area showing steering wheel-mounted driver air bag module with deployed air bag and "I" configured cover flaps; Note: steering wheel is inverted (case photo #40)

module cover consisted of symmetrical ‘T’-configuration cover flaps (**Figure 11**) made of thick vinyl with overall dimensions of 9 centimeters (3.5 inches) at both the right and left horizontal seams and 10 centimeters (3.9 inches) vertically. An inspection of the air bag module's cover flaps and air bag revealed that the cover flaps opened at the designated tear points, and there was no evidence of damage during the deployment to the air bag or the cover flaps. The driver's air bag was designed without any tethers and had two vent ports, each 3 centimeters (1.2 inches) in diameter and located at the 9 and 3 o'clock positions. The deployed driver air bag was round with a diameter of 52 centimeters (20.5 inches). There was a small skin transfer to the upper portion of the air bag between the 12 and 1 o'clock areas (**Figure 12** above).

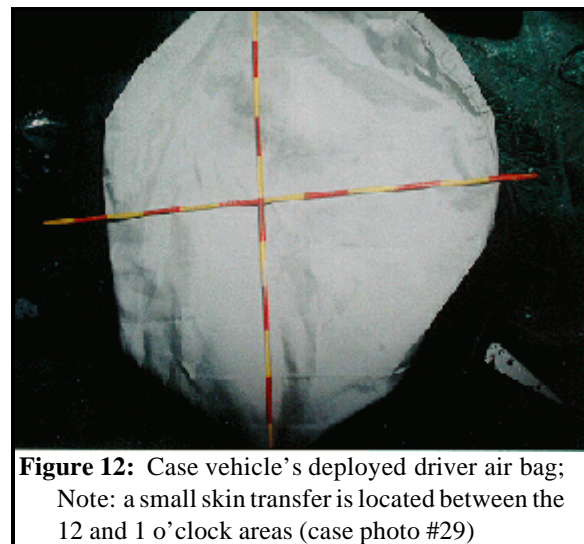
Figure 12: Case vehicle's deployed driver air bag; Note: a small skin transfer is located between the 12 and 1 o'clock areas (case photo #29)

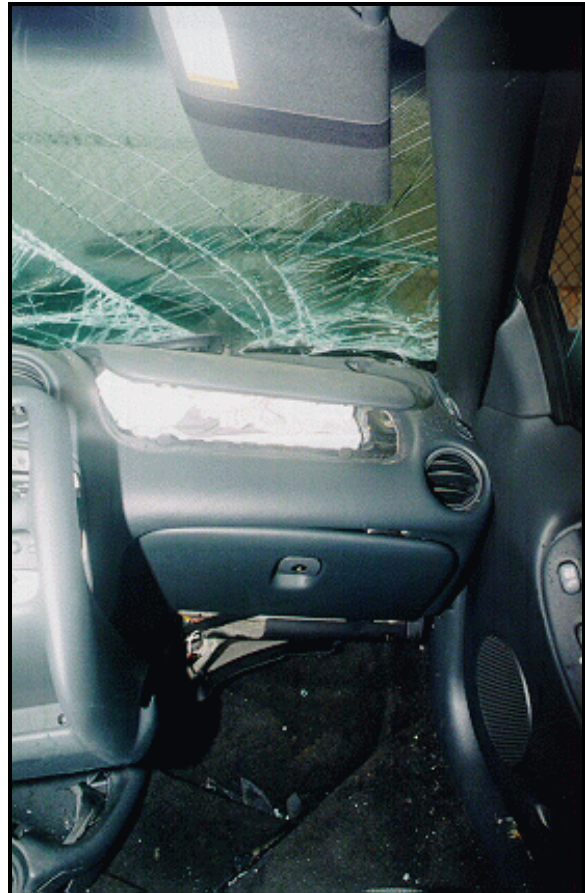
The front right passenger's air bag was primarily located in the middle of the instrument panel. There was a single, asymmetrical (i.e., essentially a leftward shifted parallelogram), modular cover flap (**Figure 13**). The cover flap was made of a thick vinyl over a thick cardboard type frame. The flap's dimensions were: 35 centimeters (13.8 inches) at both the forward and rearward (i.e., toward the windshield) horizontal seams, and 26 centimeters (10.2 inches) along both the right and left vertical seams. The leftward shift was 9 centimeters (3.5 inches). The profile of the case vehicle's instrument panel resulted in a 7 centimeter (2.8 inch) setback of the leading edge of the cover flap relative to the protruding right instrument panel. An inspection of the front right air bag module's cover flaps and air bag revealed that the cover flaps opened at the designated tear points, and there was no evidence of damage during the deployment to the air bag or the cover flaps. The front right passenger's air bag was designed with two tethers, each tether was 5 centimeters (2.0 inches) wide. The front right air bag had no vent ports. The deployed front right air bag was rectangular with a height of approximately 44 centimeters (17.3 inches) and a width of approximately 50 centimeters (19.7 inches). There was a skin transfer to the top of the front right portion (approximately 1:30 o'clock position)

Figure 13: Case vehicle's mid-instrument panel-mounted front right passenger air bag showing deployed air bag and cover flap; Note: no obvious contact evidence is present (case photo #42)

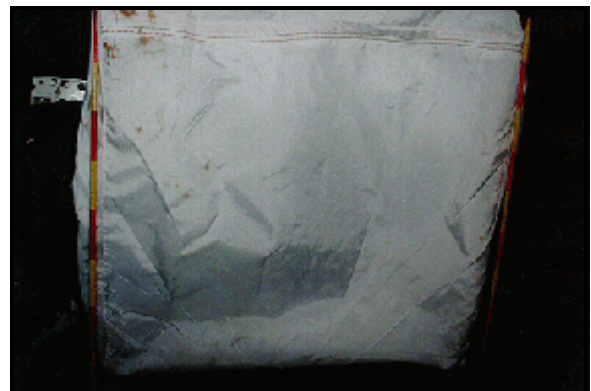
Figure 14: Case vehicle's deployed front right air bag; Note: blood on upper left quadrant is from driver's head lesions as he lay against air bag at final rest (case photo #50)

and a cloth transfer to the bottom of the front portion (approximately 6 o'clock position). There were blood stains (**Figure 14**) to the left side of the front portion; although, this contractor believes these are from the case vehicle's driver, while his head was slumped over at final rest.

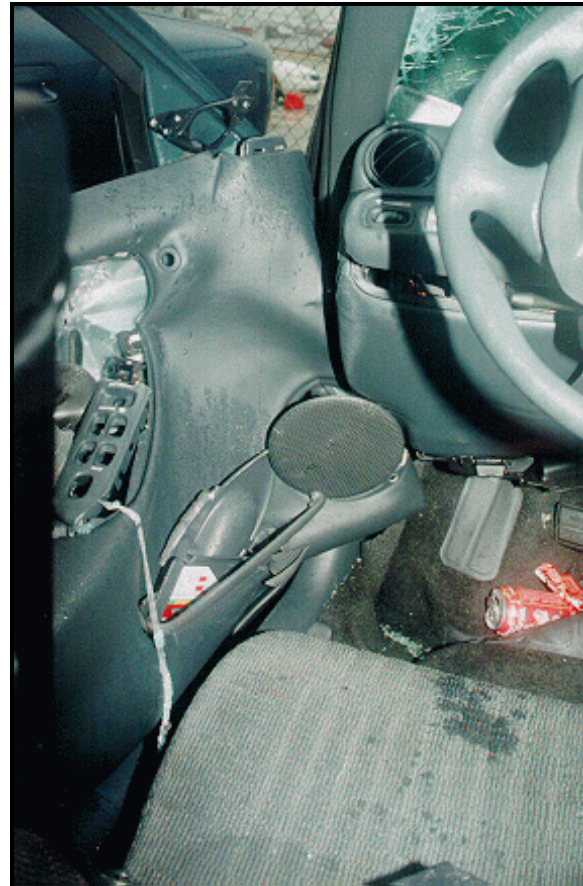
The interior inspection of the case vehicle revealed substantial amounts of intrusion to the driver's seating area (**Figure 15**) and the front center area of the vehicle. Specifically, the toe pan intruded longitudinally 35 centimeters (13.8 inches) into the driver's area while only 24 centimeters (9.4 inches) in the front center area. The left instrument panel intruded 26 centimeters (10.2 inches) longitudinally into the driver's area but only 22 centimeters (8.7 inches) into the front center area, and the windshield intruded 26 centimeters (10.2 inches) into both the driver's and front center areas of the case vehicle. Other components that intruded into the driver's seating area included: the steering wheel, left "A"-pillar, the left side panel forward of the "A"-pillar, the left front door, and the left "B"-pillar. The right instrument panel was also intruded, longitudinally, but the measured magnitude of the intrusion was only minor [4 centimeters (1.6 inches)].

The intrusions sustained by the case vehicle resulted from a combination of the two impacts at its front left area. In this contractor's opinion, the intrusion to the front left interior components (e.g., left "A"-pillar, left instrument panel, toe pan, and steering wheel) and left side interior components (e.g., left front door and left door panel forward of the left "A"-pillar) were primarily influenced by the case vehicle's impact with vehicle #2. On the other hand, the entire instrument panel, windshield, and toe pan were also affected by the case vehicle's front left impact with the signal pole. The steering column had been pushed upwards (**Figure 16**), most likely from the penetration caused by the case vehicle's narrow frontal impact with vehicle #2, but also possibly from loading by the driver during the case vehicle's impact with the signal pole. Other evidence of interior contact by the case vehicle's occupants includes the driver's knee bolster (**Figure 17** below) being deformed by the driver's right knee.

Figure 15: Vertical view of intrusion from driver's door, toe pan, left "A"-pillar, left side panel forward of the "A"-pillar, and left instrument panel into case vehicle's driver seating area; Note: intrusion primarily resulting from impact with vehicle #2 (case photo #24)

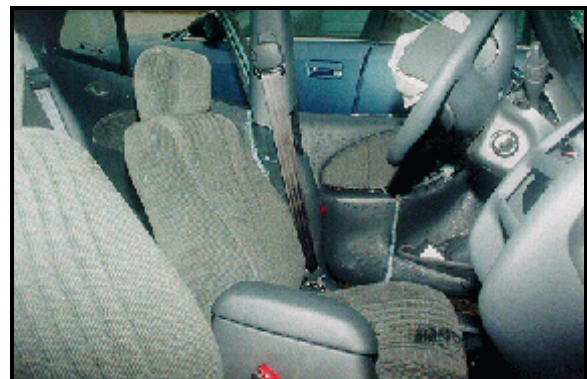
Figure 16: Case vehicle's front seating area showing safety restraints, intruding instrument panel, and steering column with upward shift (case photo #51)

The case vehicle's driver steered to the right and shifted the vehicle into neutral, attempting to avoid the crash. As a result of these attempted avoidance maneuvers and the nonuse of his available safety belts, he moved slightly to his left just prior to impact. The case vehicle's impact with vehicle #2 not only deployed the driver air bag, but enable the driver to move slightly farther to his left toward the 340 degree Direction of Principal Force and to contact his intruding door panel (**Figure 15** above) and the left side of the deployed driver air bag. The driver's impact with the door panel caused him to be redirected back to the right, further loading the deployed air bag, but also the steering assembly. The case vehicle's driver most likely rebounded backwards toward his seat back as the case vehicle separated from vehicle #2. The case vehicle's subsequent front left impact with the traffic signal light pole enabled the driver to move forward once again toward the 360 degree Direction of Principal Force and load the steering column and instrument panel as the case vehicle decelerated (**Figure 17**). During the pole impact, the driver's right knee went into the knee bolster deforming it and causing the driver's knee injury. As the case vehicle reached maximum engagement with the pole, the case vehicle's driver moved to the right as the vehicle rotated slightly counterclockwise around the pole. At final rest, according to the driver's interview, the driver was unconscious and leaning to the right with his upper torso laying over the center console and his face laying over the collapsed front right passenger air bag (**Figure 14** above). The case vehicle's very narrow frontal impact with vehicle #2 and subsequent penetration along the left side, rather than the driver's impact with the steering wheel during the signal pole impact, most likely caused the steering column's shear capsules to separate enabling the steering wheel to move vertically as it was found during the vehicle inspection (**Figure 16** above).

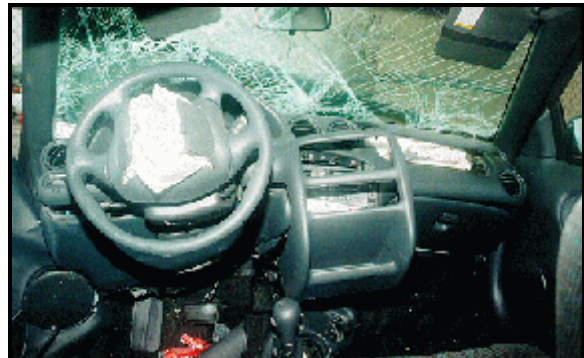
Figure 17: Case vehicle's driver seating area showing deformed instrument panel and contacts to driver's knee bolster and steering wheel (case photo #28)
