**REDESIGNED AIR BAG SPECIAL STUDY (RABSS)
SCI TECHNICAL SUMMARY REPORT**

NASS CDS CASE NO. 1998-02-095C

RABSS VEHICLE - 1998 CHEVROLET MALIBU LS

CRASH DATE - JULY, 1998

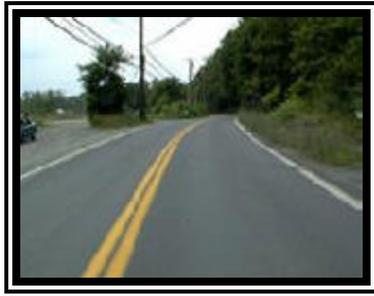
This two-vehicle crash occurred during the early morning hours of July, 1998. At the time of the crash, it was dark (street lighted) with no adverse conditions as the roads were dry. The crash occurred on a slight hillcrest in the eastbound lane of an east/west two lane rural asphalt roadway which curves to the left for eastbound traffic (see **Figure 9 - page 8**). The speed limit at the crash scene was 89 km/h (55 mph). The Chevrolet Malibu was westbound and negotiating a right curve (**Figure 1**). The GMC van was eastbound entering a left curve (**Figure 2**).

Figure 1. Westbound approach for the 1998 Chevrolet Malibu LS.

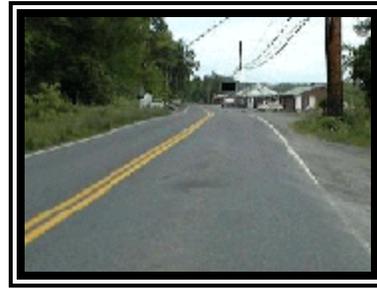
Figure 2. Eastbound approach for the 1986 GMC G-Series van.

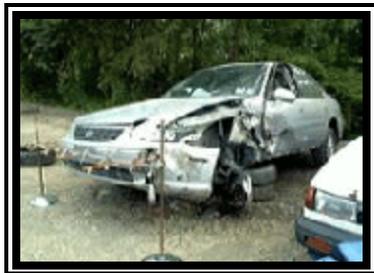
The direct contact damage to the Chevrolet Malibu began at the front left bumper corner and extended inboard 15 cm (6 in). The damage profile measured across the frontal plane exhibited no residual longitudinal displacement at any of the six crush measurements. The contact damage extended longitudinally down the side plane with the left fender deformed rearward to the A-pillar and minimal lateral displacement to the left front door. The left front tire deflated and the wheel/tire rotated counterclockwise 45 degrees from engagement against the left rear wheel of the GMC van during the impact sequence. This damage pattern jammed the left front door and shattered the side window glazing (**Figure 3**). The direct contact damage to the GMC van began 72 cm (28 in) forward of the left front axle and extended 464 cm (183 in) rearward (**Figure 4**). Moderate left rear wheel damage was noted to the van associated to the left front wheel damage of the Chevrolet Malibu.

Figure 3. Narrow end engagement damage to the Chevrolet Malibu.

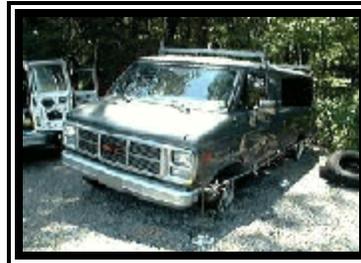
Figure 4. Sideswipe damage to the left side of the GMC van.

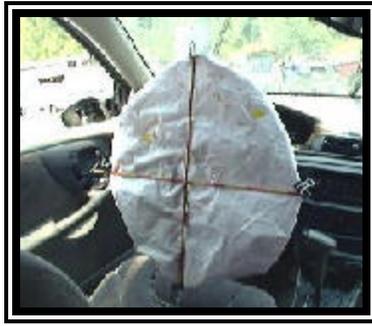
Interior damage to the Chevrolet Malibu identified through the NASS vehicle inspection was minimal and was attributed to occupant contact. A scuff mark was noted on the steering wheel rim along with blood spattering on the upper portion of the driver air bag and door panel (above the armrest). This damage was attributed to the driver's left forearm injury. No remarkable contacts were found on the passenger side air bag. Additional contacts included scuff marks on the driver seat back from the rear occupants and minor fabric transfers to the front left and rear left shoulder belts. No intrusion of interior components were found to the driver seating area. No deformation was noted to the knee bolsters (padded type) or steering wheel rim (tilt column set to the full up position).

Figure 5. Chevrolet Malibu redesigned driver air bag.

The 1998 Chevrolet Malibu LS was equipped with redesigned frontal air bags for the driver and front right passenger positions. The air bags deployed as a result of inertial deceleration from the wheel engagement between the two vehicles just prior to impact spin out, evidenced by the damage pattern(s) to the vehicles and physical evidence found at the scene. The driver air bag was housed in the center of the steering wheel with a vertically oriented flap tear seam (I-configuration). The flaps were symmetrical and measured 7 cm (3 in) in width and 14 cm (6 in) in height. There was no contact evidence to the exterior surface of the module cover flaps but light blood spattering was identified on the upper portion of the air bag. The driver's forearm injury was a result of contact by the expanding air bag during deployment. The NASS researcher measured the diameter of the driver air bag at 60 cm (24 in) in its deflated state (**Figure 5**). The bag was tethered by two internal straps and vented by two ports located at the 11 o'clock and 1 o'clock sectors on the rear aspect of the air bag.

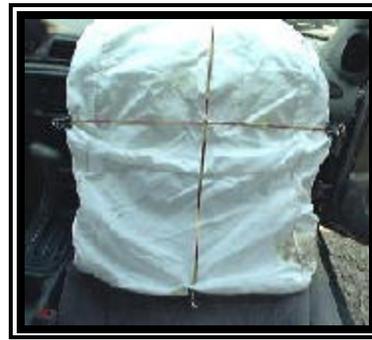
Figure 6. Chevrolet Malibu redesigned passenger air bag.

The front right passenger air bag deployed from a top mount module in the right instrument panel with a single cover flap design hinged at the forward aspect. The cover flap opened in an upward direction toward the windshield. The cover flap was rectangular in shape and measured 33 cm (13 in) in width and 15 cm (6 in) in height. The NASS researcher measured the passenger air bag at 60 cm (24 in) in width and 72 cm (28 in) in height in its deflated state (**Figure 6**). There was no contact evidence noted to the module cover flap or front right air bag.

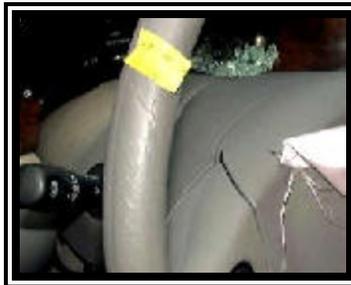
The driver was properly restrained by the 3-point manual lap and shoulder belt system. Belt usage was confirmed by loading marks as he initiated a forward trajectory in response to the 12 o'clock impact force. As the air bag deployed, the expanding air bag contacted the anterior aspect of his left forearm which resulted in abrasions and a minor laceration. This was evidenced by the scuff mark found on the steering wheel rim in conjunction with the location of the blood spattering on the upper portion of the air bag and door panel (**Figure 7**). The driver was transported to a local hospital for treatment and released.

Figure 7. Scuff mark to the steering wheel rim.

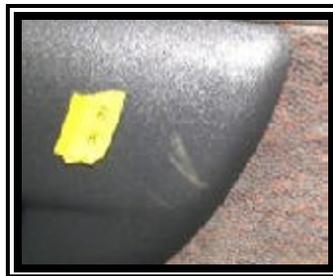
The 16 year old male passenger was seated in the front right position of the Chevrolet Malibu. He was asleep and leaning to the right against the front right door panel, evidenced by the scuff marks on the door panel just below the armrest (**Figure 8**). The seat back was slightly reclined and the seat track was adjusted to the full rearward position. He was properly restrained by the 3-point manual lap and shoulder belt system.

Figure 8. Scuff mark to the front right interior door panel

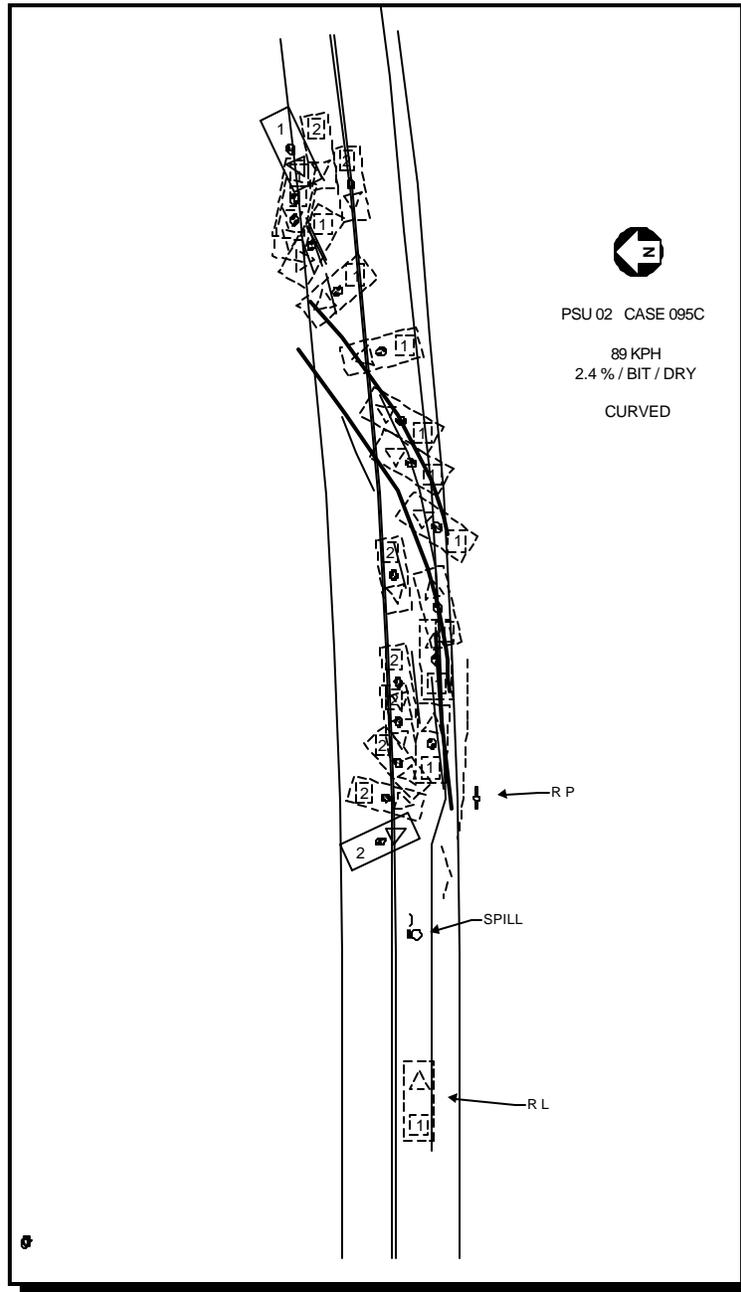
Figure 9. NASS Scene Diagram

As the Chevrolet crossed the centerline of the two lane roadway, the front left corner area of the Chevrolet Malibu struck the left side of the GMC van. The impact induced deceleration was sufficient to deploy the Malibu's redesigned frontal air bag system. The crash, however, could not be reconstructed by WinSMASH due to the corner engagement against the side of the van (out of scope). The Collision Deformation Classification (CDC) for this impact to the Chevrolet Malibu was 12-FLEE-7 (despite above beltline direct damage to the side mirror, vertical code "E" chosen so as not to overstate damage pattern) and 12-LDES-1 for the GMC van. During the impact sequence, engagement occurred between the left front wheel of the Chevrolet Malibu and the left rear wheel of the GMC van which initiated a counterclockwise rotation of both vehicles as they began their respective post-impact trajectories to final rest. The Chevrolet Malibu came to rest 10 meters (33 ft) west of the point of impact (in the roadway) facing southeast. The GMC van came to rest 38 meters (125 ft) from the point of impact partially off the north road edge facing southwest.
