**REDESIGNED AIR BAG SPECIAL STUDY (RABSS)  
SCI TECHNICAL SUMMARY REPORT**

**NASS RABSS CASE NO. 1998-06-803E**

**RABSS VEHICLE - 1998 FORD WINDSTAR**

**CRASH DATE - OCTOBER, 1998**

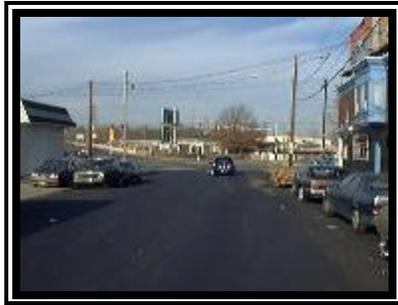
The 54 year old male driver of the 1988 Oldsmobile Delta 88 was operating the vehicle northbound (**Figure 1**) when he failed to observe the red traffic signal or eastbound Ford as he proceeded straight through the 6-leg intersection. The 50 year old male driver of the 1998 Ford Windstar was operating the vehicle eastbound (**Figure 2**) at a (driver reported) speed of 48 km/h (30 mph) when he entered the intersection and observed the northbound Oldsmobile cross his path of travel. The Ford driver reported no avoidance maneuvers in anticipation of the impending crash.

**Figure 1. Northbound approach for the 1988 Oldsmobile Delta 88 Royale.**

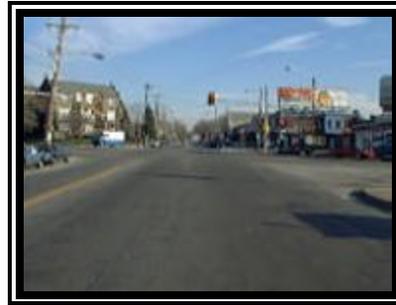
**Figure 2. Eastbound approach for the 1998 Ford Windstar.**

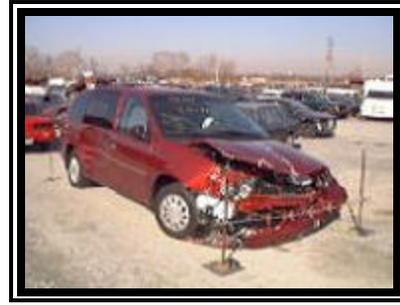
The 1998 Ford Windstar sustained moderate frontal damage as a result of the initial impact with the Oldsmobile Delta 88 (**Figure 3**). The direct contact damage began at the front right bumper corner and extended 120.0 cm (47.2 in) inboard. The impact deformed the full frontal width resulting in a combined direct and induced damage length (Field L) of 158.0 cm (62.2 in). Six crush measurements were documented at the level of the reinforcement bar (*partial bumper fascia separation*): C1= 4.0 cm (1.6 in), C2= 12.0 cm (4.7 in), C3= 18.0 cm (7.1 in), C4= 22.0 cm (8.7 in), C5= 24.0 cm (9.4 in), C6= 25.0 cm (9.8 in). The (*SCI revised*) Collision Deformation Classification (CDC) for this impact to the Ford was 81-FDEW-2 with a principal direction of force of (+)30 degrees (principal direction of force incremented to reflect shifting of end structure to the left). The grille and headlight assemblies fractured and separated from the vehicle during the collision sequence. The fenders were displaced rearward and to the left which restricted the right front wheel/tire (not deflated). The hood was deformed up and rearward from engagement against the side surface of the Oldsmobile. Reduction in the left side wheelbase measured 6.0 cm (2.4 in). The right side wheelbase was elongated 3.0 cm (1.2 in). All glazing remained undamaged.

**Figure 3. Front and right side surface damage to the 1998 Ford Windstar.**

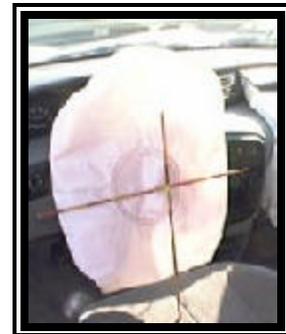
The 1998 Ford Windstar was equipped with redesigned frontal air bags for the driver and front right passenger positions. The air bags had deployed as a result of the crash. The driver air bag was housed in the center of the steering wheel with a horizontally oriented flap tear seam (H-configuration). The flaps were asymmetrical in shape as the upper flap measured 19.0 cm (7.5 in) in width and 12.0 cm (4.7 in) in height while the lower flap measured 19.0 cm (7.5 in) in width and 6.0 cm (2.4 in) in height. Although no contact evidence was identified on the exterior surface of the module cover flaps, a scuff mark was documented at the upper right quadrant of the air bag. The NASS researcher measured the diameter of the driver air bag at 48.0 cm (18.9 in) in its deflated state (**Figure 5**). The bag was tethered by two internal straps and vented by two ports located at the 11 o'clock and 1 o'clock (centered) sectors on the rear aspect of the air bag.

**Figure 5. 1998 Ford Windstar redesigned driver air bag.**

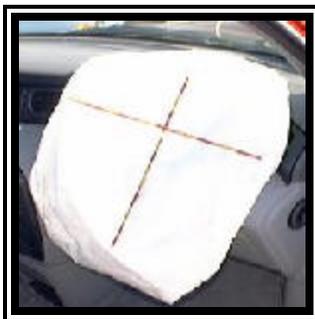
**Figure 6. 1998 Ford Windstar redesigned passenger air bag.**

The front right passenger air bag deployed from the right mid-instrument panel area with a single cover flap design hinged at the top aspect (**Figure 6**). No contact evidence was identified on the air bag or exterior surface of the module cover flap. The cover flap was rectangular in shape and measured 33.0 cm (13.0 in) in width and 13.0 cm (5.1 in) in height. The NASS researcher measured the passenger air bag at 44.0 cm (17.3 in) in width and 60.0 cm (23.6 in) in height in its deflated state. No internal tether straps were present. The bag was vented by one port located at the 10 o'clock sector on the side aspect of the air bag. No cutoff switch was found for the front right air bag.

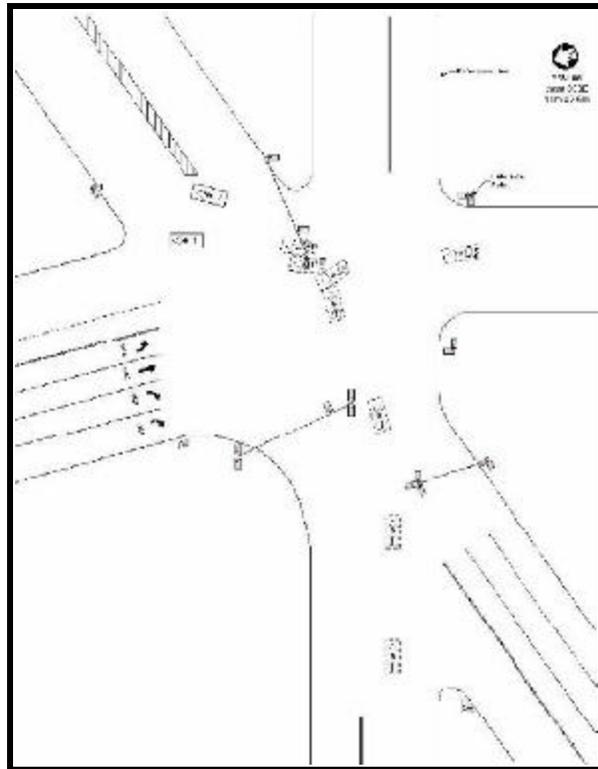
Figure 7. NASS Scene Diagram.

This two vehicle crash occurred during the early morning hours of October, 1998. At the time of the crash, it was daylight with no adverse conditions as the roads were dry. The crash occurred in the northbound lane of a straight and level 6-leg asphalt intersection (**see Figure 7 - page 5**). Traffic flow through the 2-lane urban intersection was controlled by an overhead signal system in green phase for eastbound traffic. The posted speed limit at the crash site was 40 km/h (25 mph).
