**REDESIGNED AIR BAG SPECIAL STUDY (RABSS)
SCI TECHNICAL SUMMARY REPORT**

NASS RABSS CASE NO. 1998-08-806F

RABSS VEHICLE - 1999 FORD TAURUS SE

CRASH DATE - NOVEMBER, 1998

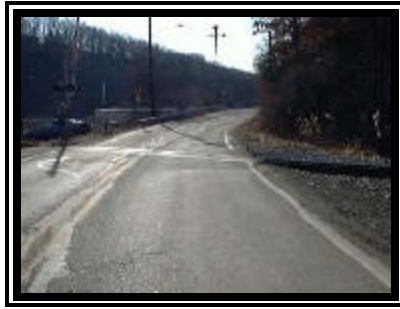
The 40 year old male driver of the 1999 Ford Taurus SE was operating the vehicle westbound (**Figure 1**) and negotiating a right curve when he reportedly looked down to read some directions and allowed the vehicle to cross the centerline into the eastbound lane. The 64 year old male driver of the 1993 Buick Century was operating the vehicle eastbound (**Figure 2**) and negotiating a left curve when he observed the westbound Ford enter his lane of travel. No brake marks were documented at the scene indicative of driver avoidance maneuvers.

Figure 1. Westbound approach for the 1999 Ford Taurus SE.

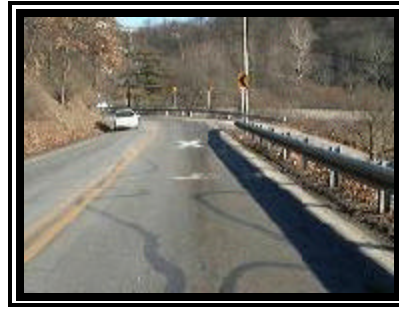
Figure 2. Eastbound approach for the 1993 Buick Century.

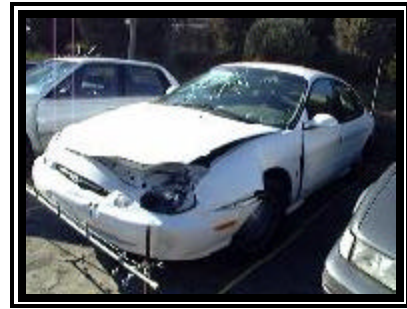
The 1999 Ford Taurus SE sustained moderate frontal damage as a result of the impact with the Buick Century (**Figure 3**). The (*SCI revised*) direct contact damage began at the front left bumper corner and extended 74.0 cm (29.1 in) inboard. The impact deformed the full frontal width resulting in a combined direct and induced damage length (Field L) of 148.0 cm (58.3 in). Six crush measurements were documented at the

level of the bumper: C1= 18.0 cm (7.1 in), C2= 8.0 cm (3.1 in), C3= 2.0 (0.8 in), C4= 1.0 cm (0.4 in), C5=0 cm, C6= 0 cm. The Collision Deformation Classification (CDC) for this impact to the Ford was 12-FYEW-1 with a principal direction of force of 0 degrees. The hood was displaced slightly up and rearward from the impact force. The left fender was deformed rearward which restricted the left front wheel/tire (not deflated). Reduction in the right side wheelbase measured 3.0 cm (1.2 in). The windshield sustained no damage from exterior impact forces. All tempered glazing remained undamaged.

Figure 3. Front left damage to the 1999 Ford Taurus SE.

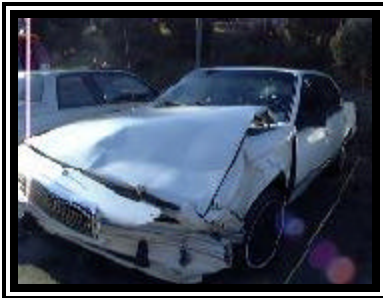
Figure 4. Front left damage to the 1993 Buick Century Special.

The 1993 Buick Century Special 4-door sedan sustained moderate frontal damage as a result of the impact with the Ford Taurus (**Figure 4**). The direct contact damage began at the front left bumper corner and extended 73.0 cm (28.7 in) inboard. The impact deformed the full frontal width resulting in a combined direct and induced damage length (Field L) of 146.0 cm (57.5 in). The (*SCI revised*) CDC for this impact to the Buick was 12-FYEW-2 with a principal direction of force of (-)10 degrees. The hood was deformed up and rearward from the impact force. The left fender was deformed rearward which restricted the left front wheel/tire (not deflated). No reduction in the vehicle's wheelbase was found.

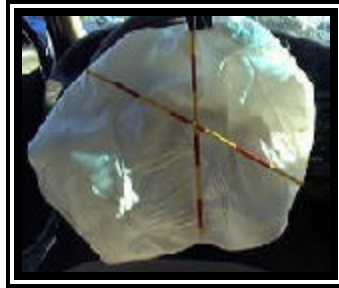
The 1999 Ford Taurus SE was equipped with redesigned frontal air bags for the driver and front right passenger positions. The air bags had deployed as a result of the crash. The driver air bag was housed in the center of the steering wheel with a horizontally oriented flap tear seam (H-configuration). The flaps were asymmetrical in shape as the upper flap measured 16.0 cm (6.3 in) in width and 6.0 cm (2.4 in) in height while the lower flap measured 16.0 cm (6.3 in) in width and 5.0 cm (2.0 in) in height along the flap tear seam. Although no contact evidence was identified on the exterior surface of the module cover flaps, blood spattering was noted across the face of the air bag and rear upper portion. The NASS researcher measured the diameter of the driver air bag at 50.0 cm (19.7 in) in its deflated state (**Figure 5**). The bag was tethered by two internal straps and vented by two ports located at the 11 o'clock and 1 o'clock sectors on the rear aspect of the air bag.

Figure 5. 1999 Ford Taurus SE redesigned driver air bag.

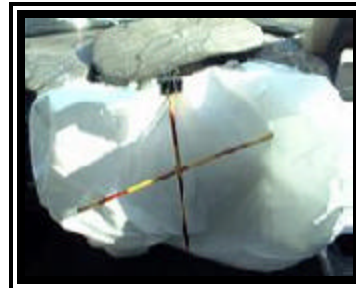
The front right passenger air bag deployed from the right top instrument panel area with a single cover flap design hinged at the forward aspect (*right mid-windshield area fractured by the module cover flap*). No contact evidence was identified on the air bag or exterior surface of the module cover flap. The oval shaped cover flap measured 42.0 cm (16.5 in) in width along the lower edge, 27.0 cm (10.6 in) along the upper edge and 30.0 cm (11.8 in) in height along the left edge and 22.0 cm (8.7 in) along the right edge. The NASS researcher measured the passenger air bag at 45.0 cm (17.7 in) in width and 50.0 cm (19.7 in) in height in its deflated state (**Figure 6**). No internal tether straps were present. The bag was vented by two ports located at the 9 o'clock and 3 o'clock sectors on the side aspect of the air bag. No cutoff switch was found for the front right air bag.

Figure 6. 1999 Ford Taurus SE redesigned passenger air bag.

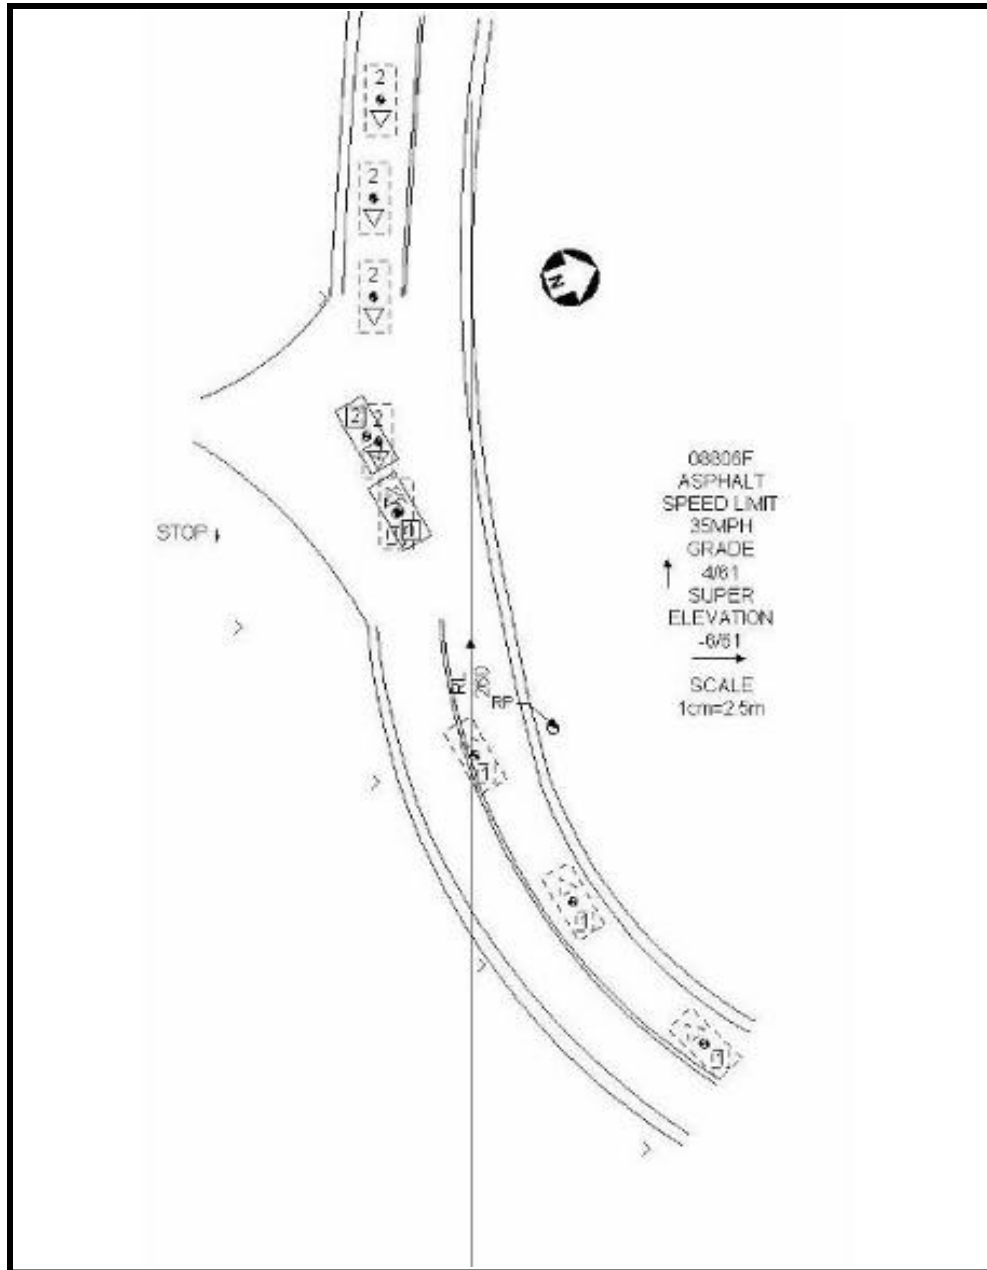
Figure 7. NASS Scene Diagram.

This two vehicle crash occurred during the evening hours of November, 1998. At the time of the crash, it was dark (street not lighted) with rainy conditions as the roads were wet. The crash occurred in the eastbound lane of a two lane east/west asphalt roadway (**see Figure 7 - page 5**) which curved right (with a positive grade) for westbound traffic. Curve warning signs were present at the scene which had a posted speed limit of 56 km/h (35 mph).
