**REDESIGNED AIR BAG SPECIAL STUDY (RABSS)
SCI TECHNICAL SUMMARY REPORT**

NASS RABSS CASE NO. 1998-09-802C

RABSS VEHICLE - 1998 HONDA CIVIC EX

LOCATION - STATE OF MARYLAND

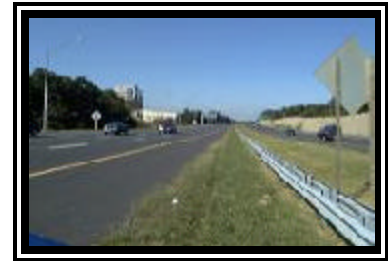
As the Honda Civic traveled northbound in the #2 outboard lane of the multi-lane divided highway, the front right area struck the rear left area of the 1985 International tractor-trailer (shipping container) resulting in moderate damage. The impact induced deceleration was sufficient to deploy the Honda's redesigned frontal air bag system. Although the impact was classified as out of scope (heavy trucks beyond the scope of the program), the damage algorithm of the WinSMASH program computed a (barrier equivalent) velocity change of 29.2 km/h (18.1 mph). The specific longitudinal component was -29.2 km/h (-18.1 mph). The Collision Deformation Classification (CDC) for the initial impact to the Honda Civic was 12-FRAA-7. At this point, the Honda underrode the trailer as engagement continued into the greenhouse area with subsequent penetration through the windshield and into the passenger compartment. The vehicle rotated clockwise and traveled into the center median strip where it impacted a guardrail resulting in superficial rear damage. The Collision Deformation Classification (CDC) for the secondary impact to the Honda was 05-BREE-3. The Honda came to rest against the guardrail facing southeast (**Figure 1**).

Figure 1. Look back (south) from vehicle final rest showing overview of crash site.

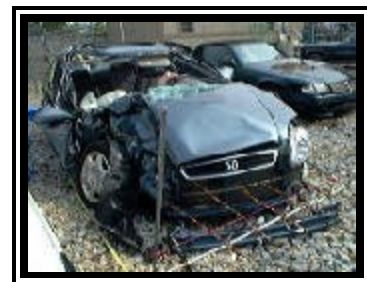
Figure 2. Frontal damage to the 1998 Honda civic EX.

The 1998 Honda Civic EX sustained moderate frontal damage as a result of the impact with the tractor-trailer (**Figure 2**). The direct contact damage began at the front right bumper corner and extended 40.0 cm (15.7 in) inboard. The impact deformed the full frontal width resulting in a combined direct and induced damage length (Field L) of 110.0 cm (43.3 in). Six crush measurements were documented at the level of the lower radiator support (the bumper fascia and reinforcement bar separated from the mounting assembly): C1 = 2.0 cm (0.8 in), C2 = 2.0 cm (0.8 in), C3 = 13.0 cm (5.1 in), C4 = 23.0 cm (9.1 in), C5 = 29.0 cm (11.4 in), C6 = 38.0 cm (15.0 in). Damage was noted to the right front wheel/tire which was restricted and deflated from both lateral and rearward displacement of the right fender. The right windshield header, A-pillar and roof area were deformed from the trailer underride (**Figures 3 & 4**). The windshield was fractured and holed from the trailer penetration into the passenger compartment area. Extrication damage was also noted at the outer seams of the windshield which was removed post-crash. Induced buckling restricted the right front door opening and shattered the side glazing. Superficial damage was noted to the rear right bumper corner and quarter panel from the guardrail impact.

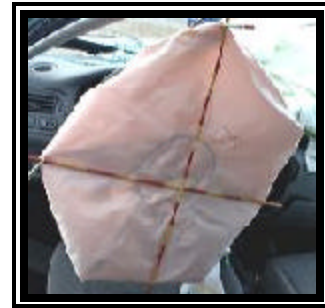
Figure 5. 1998 Honda Civic EX redesigned driver air bag.

The 1998 Honda Civic EX was equipped with redesigned frontal air bags for the driver and front right passenger positions. The air bags deployed as a result of the crash. The driver air bag was housed in the center of the steering wheel with a horizontally oriented flap tear seam (H-configuration). The upper flap measured 14.5 cm (5.7 in) in width and 6.5 cm (2.6 in) in height while the lower flap measured 14.0 cm (5.5 in) in width and 5.0 cm (2.0 in) in height. There was no contact evidence on the exterior surface of the module cover flaps, but blood spattering was identified at the (right) upper and lower quadrants of the air bag associated with the driver's forehead injury. The NASS researcher measured the diameter of the driver air bag at 66.0 cm (26.0 in) in its deflated state (**Figure 6**). The bag was tethered by two internal straps and vented by two ports located at the 11 o'clock and 1 o'clock sectors on the rear aspect of the air bag.

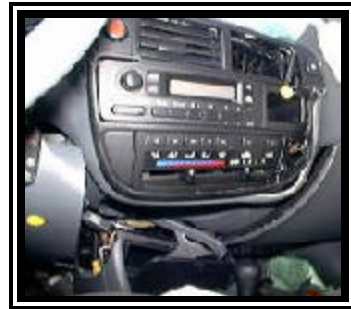
Interior damage to the Honda Civic identified through the NASS vehicle inspection was moderate and was attributed to occupant contact. No transfers or loading marks were noted to the available 3-point manual lap and shoulder belt system. No wear marks to the latch plate of the manual restraint were noted which would be an indication of frequent use. No contacts were identified on the exterior surface of the driver air bag module cover flaps, but blood transfers were documented at the (right) upper and lower quadrants of the redesigned driver air bag. The lower portion of the steering wheel rim was deformed forward 2.0 cm (0.8 in) with the tilt column adjusted between the full up and center position. The center instrument panel (**Figure 5**) and left knee bolster were fractured and scuffed. The rear view mirror was fractured and separated from the windshield. No contacts were identified to the exterior surface of the front right air bag module cover flaps, but blood spattering was noted to upper left quadrant of the redesigned passenger air bag. Intrusions into the driver space included 4.0 cm (1.6 in) of longitudinal toepan intrusion and 3.0 cm (1.2 in) of longitudinal instrument panel intrusion. Intrusions into the front right seating area included 14.0 cm (5.5 in) of toepan intrusion, 21.0 cm (8.3 in) of instrument panel intrusion and an (approximated) exterior object intrusion (trailer) of 30.0 cm (11.8 in).

Figure 6. Damage to the center instrument panel.

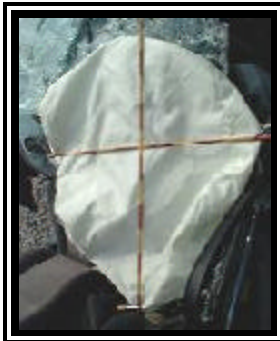
Figure 7. 1998 Honda Civic EX redesigned passenger air bag.

The front right passenger air bag deployed from a top mount module in the right instrument panel with a horizontally oriented flap tear seam (H-configuration). The cover flaps opened in an upward direction toward the windshield. Flap contact to the right windshield was unknown given the extrication damage to the windshield. The cover flaps were symmetrical and rectangular in shape which measured 23.0 cm (9.1 in) in width and 5.0 cm (2.0 in) in height. There was no contact evidence noted to the exterior surface of the module cover flaps, but blood spattering was identified to the left upper quadrant of the air bag associated with the driver's right forearm/hand injury. The NASS researcher measured the passenger air bag at 49.0 cm (19.3 in) in width and 54.0 cm (21.3 in) in height in its deflated state (**Figure 7**). No internal tether straps were present. The bag was vented by two ports located at the 3 o'clock and 9 o'clock sectors on the side

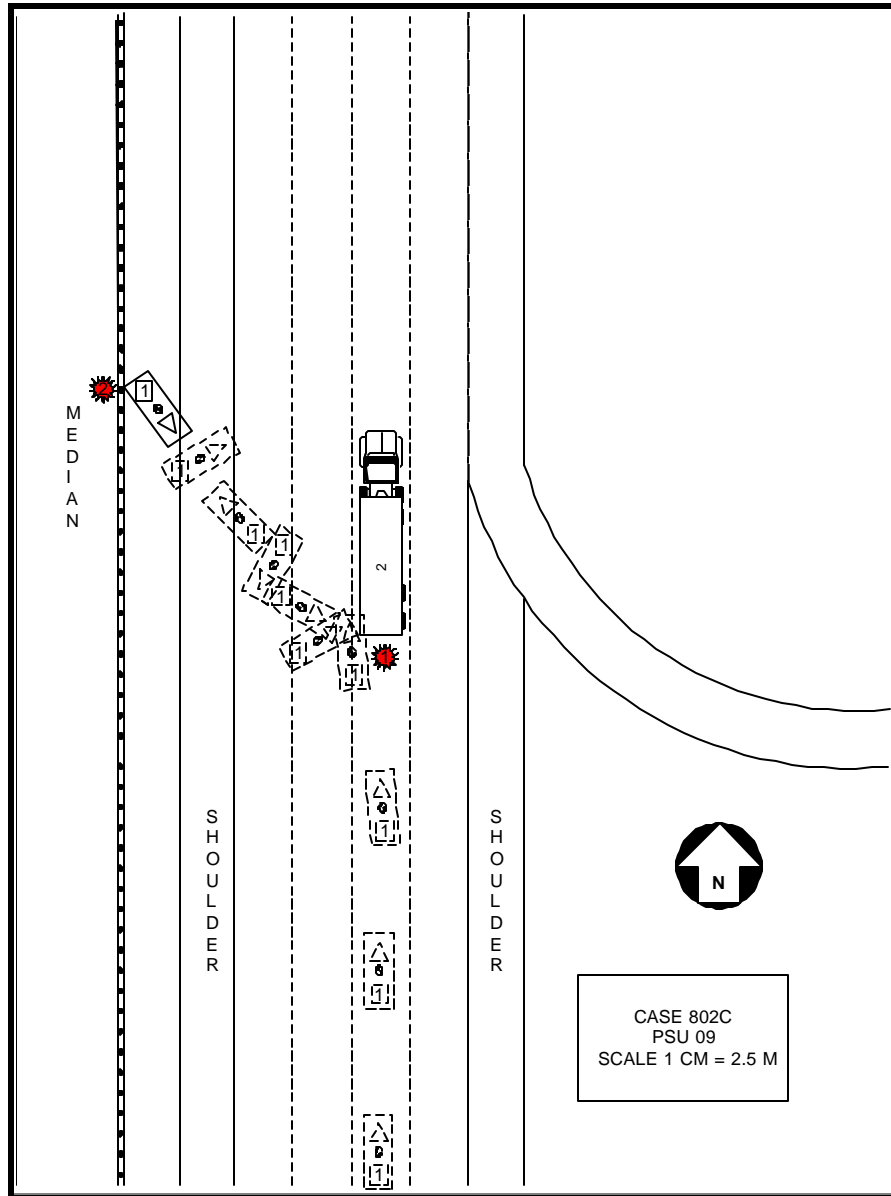
Figure 9. NASS Scene Diagram

This two vehicle crash occurred during the morning hours of August, 1998. At the time of the crash, it was daylight with no adverse conditions as the roads were dry. The crash occurred in the northbound lanes of a multi-lane north/south (asphalt) highway (see **Figure 9 - page 6**) which is divided by a median strip and guardrail. The speed limit at the crash scene was 89 km/h (55 mph).
