**REDESIGNED AIR BAG SPECIAL STUDY (RABSS)  
SCI TECHNICAL SUMMARY REPORT**

**NASS CDS CASE NO. 1998-11-208F**

**RABSS VEHICLE - 1998 FORD F-150 PICKUP TRUCK**

**CRASH DATE - NOVEMBER, 1998**

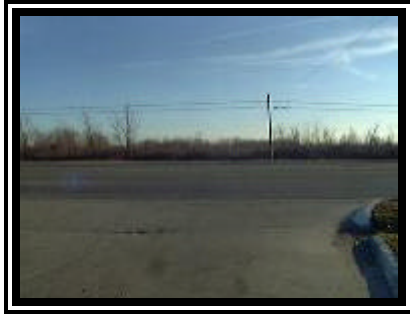
The 73 year old male driver of the 1998 Ford F-150 pickup truck was stationary and faced south in preparation of a left turn (east) out of a private driveway (**Figure 1**). He reportedly looked both ways and became disoriented by the sun's glare as he proceeded east onto the urban roadway at a (driver reported) speed of 16 km/h (10 mph). The 23 year old female driver of the 1993 Ford Festiva was operating the vehicle westbound in the outboard lane (**Figure 2**) of the five lane urban roadway at a (driver reported) speed of 72 km/h (45 mph) when she observed the Ford pickup cross her path of travel. Upon recognition of the impending harmful event, she steered left/ braked in avoidance and partially entered the inboard (westbound) lane prior to the collision. The front right seating position of the Ford Festiva was occupied by a 22 year old male.

Figure 1. Southbound approach for the 1998 Ford F-150 pickup truck.

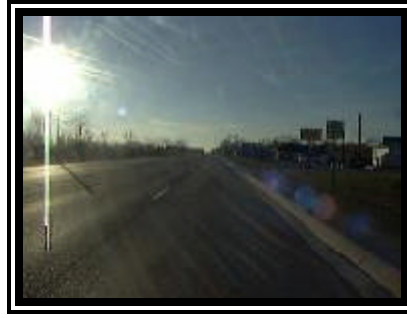
Figure 2. Westbound approach for the 1993 Ford Festiva.

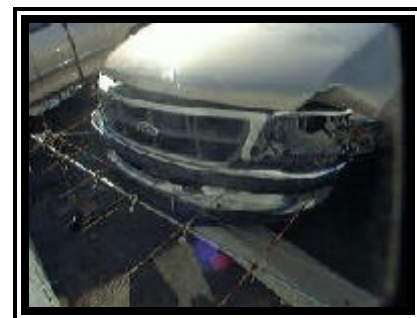
The 1998 Ford F-150 pickup truck sustained minor frontal damage as a result of the impact with the Ford Festiva (**Figure 3**). The direct contact damage began at the front left bumper corner and extended 70.0 cm (27.6 in) inboard. The impact deformed the full frontal width resulting in a combined direct and induced damage length (Field L) of 168.0 cm (66.1 in). A

Figure 3. Frontal damage to the 1998 Ford F-150 pickup truck.

maximum crush value of 6.0 cm (2.4 in) was identified at the C2 position. The Collision Deformation Classification (CDC) for this impact to the Ford was 11-FYEW-1 with a principal direction of force of (-)30 degrees. The left headlight assembly fractured with the hood deformed slightly rearward from engagement against the side surface of the Festiva. All glazing remained intact.

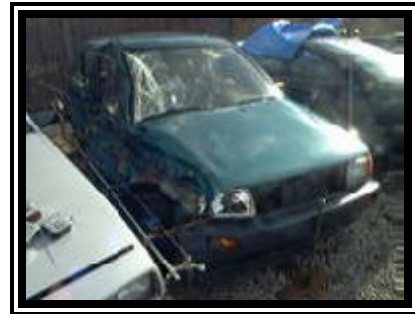
The 1993 Ford Festiva 2-door hatchback sustained moderate right side surface damage as a result of the impact with the Ford pickup (**Figure 4**). The direct contact damage began at the front right bumper corner and extended 299.0 cm (117.7 in) rearward. A maximum crush value of 23.0 cm (9.1 in) was documented along the right door. The CDC for this impact to the Festiva was 02-RDAW-2 with a principal direction of force of (+)70 degrees. Direct contact damage was noted to the right A-pillar which was displaced rearward with associated induced contact damage noted to the roof area at the B-pillar. The right fender was deformed laterally to the left which restricted the left front wheel/tire (not deflated). The windshield fractured as the right front window tempered glazing disintegrated from the impact force.

**Figure 4. Right side surface damage to the 1993 Ford Festiva.**

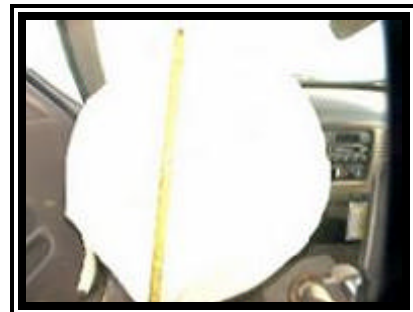
The 1998 Ford F-150 pickup truck was equipped with redesigned frontal air bags for the driver and front right passenger positions. The air bags had deployed as a result of the crash. The driver air bag was housed in the center of the steering wheel with a horizontally oriented flap tear seam (H-configuration). The flaps were asymmetrical and rectangular in shape. Although no contact evidence was identified on the exterior surface of the module cover flaps, a scuff mark was documented to the right mid-portion of the air bag face. The NASS researcher measured the diameter of the driver air bag at 60.0 cm (23.6 in) in its deflated state (**Figure 5**). The bag was tethered by two internal straps and vented by two ports located at the 11 o'clock and 1 o'clock sectors on the rear aspect of the air bag.

**Figure 5. 1998 Ford F-150 redesigned driver air bag.**

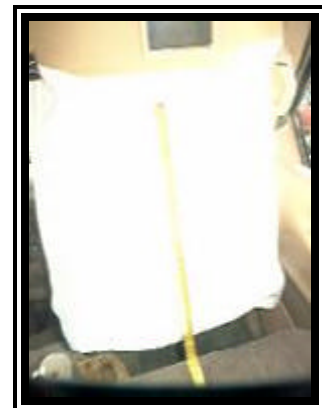
The front right passenger air bag deployed from the right mid-instrument panel area with a single cover flap design hinged at the top aspect. No contact evidence was identified on the air bag or exterior surface of the rectangular module cover flap. The NASS researcher measured the passenger air bag at 50.0 cm (20.0 in) in width and 60.0 cm (23.6 in) in height in its deflated state. No vent ports or internal tether straps (**Figure 6**) were present. A cutoff switch was found at the center mid-instrument panel area and was set to the “on” position.

**Figure 6. 1998 Ford F-150 redesigned passenger air bag.**
