**TRANSPORTATION SCIENCES
CRASH RESEARCH SECTION**

**REDESIGNED AIR BAG SPECIAL STUDY (RABSS)
SCI TECHNICAL SUMMARY REPORT**

NASS CDS CASE NO. 1998-12-229E

**RABSS VEHICLES - 1998 CADILLAC DEVILLE
1998 BUICK CENTURY CUSTOM**

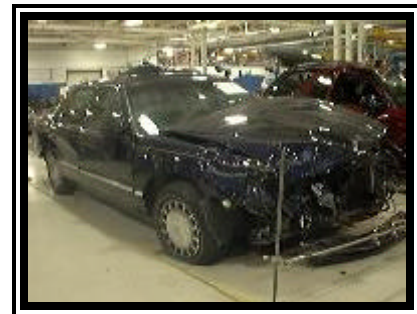
The 1998 Cadillac Deville sustained moderate frontal damage as a result of the impact with the Buick Century (**Figure 3**). The direct contact damage encompassed the full frontal width resulting in a combined direct and induced damage length (Field L) of 100.0 cm (39.4 in). Six crush measurements were documented at the level of the reinforcement bar (*bumper fascia separation*): C1= 9.0 cm (3.5 in), C2= 28.0 cm (11.0 in), C3= 39.0 cm (15.4 in), C4= 44.0 cm (17.3 in), C5= 37.0 cm (14.6 in), C6= 1.0 cm (0.4 in).

Figure 3. Frontal damage to the 1998 Cadillac Deville.

The (*SCI revised*) Collision Deformation Classification (CDC) for this impact to the Cadillac was 81-FDEW-2 with a principal direction of force of (+)40 degrees (principal direction of force incremented to reflect shifting of end structure to the left). The grille and headlight assemblies fractured and separated from the vehicle during the collision sequence. The fenders were displaced rearward and to the left which restricted the left front wheel/tire (not deflated). The hood was deformed slightly up and rearward from engagement against the side surface of the Buick. The windshield was fractured by the interior front right passenger air bag module cover flap (only).

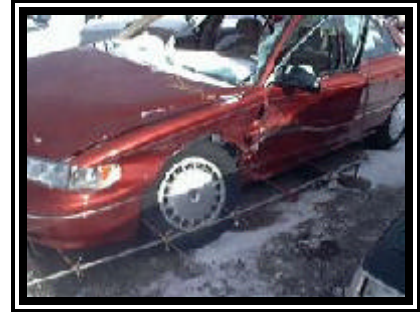
The 1998 Buick Century Custom 4-door sedan sustained moderate left front side surface damage as a result of the impact with the Cadillac Deville (**Figure 4**). The direct contact damage began 32.0 cm (12.6 in) aft of the front left bumper corner and extended 151.0 cm (59.4 in) rearward. The combined direct and induced damage length (Field L) began at the front left bumper corner and extended 242.0 cm (95.3 in) rearward. Six crush measurements were documented at the level of the mid-door: C1= 5.0 cm (2.0 in), C2= 8.0 cm (3.1 in), C3= 18.0 cm (7.1 in), C4= 7.0 cm (2.8 in), C5= 0 cm, C6= 0 cm. The (*SCI revised*) CDC for this initial impact to the Buick was 10-LYEW-2 with a principal direction of force of (-)50 degrees. The left fender was deformed laterally to the right which restricted the left front wheel/tire (not deflated). Outward bowing of the left front door upper window frame was noted (door jammed).

Figure 4. Left front side surface damage to the 1998 Buick Century Custom.

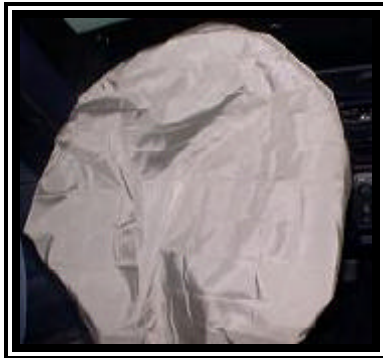
evidence was identified on the air bag or exterior surface of the module cover flaps. The NASS researcher measured the diameter of the driver air bag at 64.0 cm (25.2 in) in its deflated state (**Figure 5**). No internal tether straps were present. The bag was vented by two ports located at the 9 o'clock and 3 o'clock sectors on the rear aspect of the air bag.

Figure 5. 1998 Cadillac Deville redesigned driver air bag.

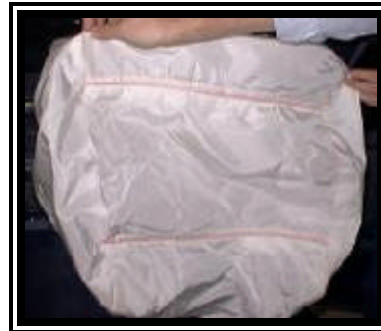
The front right passenger air bag deployed from the right mid-instrument panel area with a module design recessed into the instrument panel. This configuration did not utilize a conventional flap as the instrument panel separated to allow the bag to expand. The right mid-windshield area was fractured by the module cover flap. No contact evidence was identified on the air bag or exterior surface of the module cover flap. The NASS researcher measured the passenger air bag at 65.0 cm (25.6 in) in width and 60.0 cm (23.6 in) in height in its deflated state (**Figure 6**). The bag was tethered by two internal straps and vented by two ports located at the 10 o'clock and 2 o'clock sectors on the side aspect of the air bag. No cutoff switch was found for the front right air bag.

Figure 6. 1998 Cadillac Deville redesigned passenger air bag.

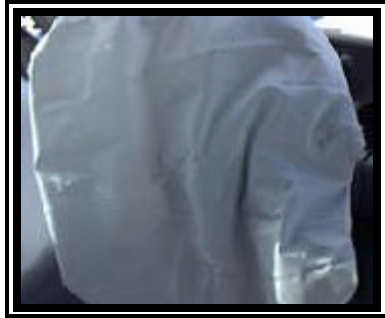
The 1998 Buick Century Custom was equipped with redesigned frontal air bags for the driver and right passenger positions. The air bags had deployed as a result of the impact with the Cadillac. The driver air bag was housed in the center of the steering wheel with a vertically oriented flap tear seam (I-configuration). The flaps were symmetrical in shape and measured 10.0 cm (3.9 in) in width and 9.0 cm (3.5 in) in height. Although no contact evidence was identified on the exterior surface of the module cover flaps, skin oil and dirt was documented on the upper center portion of the air bag face along with blood spattering to the left portion on the rear aspect of the air bag. The NASS researcher measured the diameter of the driver air bag at 65.0 cm (25.6 in) in its deflated state (**Figure 7**). The bag was tethered by two internal straps and vented by two ports located at the 9 o'clock and 3 o'clock sectors on the rear aspect of the air bag.

Figure 7. 1998 Buick Century Custom redesigned driver air bag.

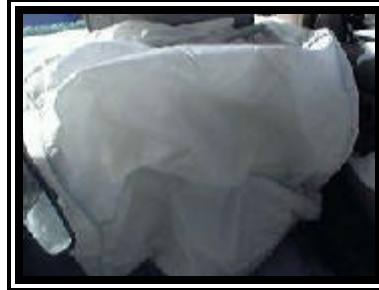
cm (15.0 in) in width and 21.0 cm (8.3 in) in height. Although no contact evidence was identified on the exterior surface of the module cover flap, blood spattering was noted at the upper right quadrant of the air bag face. The NASS researcher measured the passenger air bag at 63.0 cm (24.8 in) in width and 70.0 cm (27.6 in) in height in its deflated state (**Figure 8**). No vent ports were present. The bag was tethered by two internal straps. No cutoff switch was found for the front right air bag.

Figure 8. 1998 Buick Century Custom redesigned passenger air bag.
