**REDESIGNED AIR BAG SPECIAL STUDY (RABSS)
SCI TECHNICAL SUMMARY REPORT**

NASS RABSS CASE NO. 1998-12-803E

RABSS VEHICLE - 1998 CHEVROLET CAVALIER

CRASH DATE - SEPTEMBER, 1998

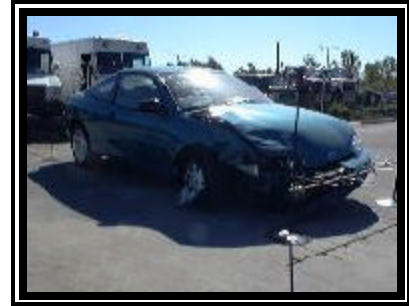
The 1998 Chevrolet Cavalier 2-door coupe sustained moderate frontal damage as a result of the impact with the Eagle Premier (**Figure 3**). The (*SCI revised*) direct contact damage began at the front right bumper

corner and extended 80.0 cm (31.5 in) inboard. The impact deformed the full frontal width resulting in a combined direct and induced damage length (Field L) of 123.0 cm (48.4 in). Six crush measurements were documented at the level of the reinforcement bar (*partial bumper fascia separation*): C1= 0 cm, C2= 0 cm, C3= 0 cm, C4= 2.0 cm (0.8 in), C5= 5.0 cm (2.0 in), C6= 6.0 cm (2.4 in). The Collision Deformation Classification (CDC) for this impact to the Chevrolet was 12-FZEW-1 with a principal direction of force of (-)10 degrees. The right fender was displaced rearward which restricted/deflated the right front wheel/tire. The hood was deformed up and rearward from engagement against the side surface of the Eagle. Reduction in the right side wheelbase measured 13.0 cm (5.1 in). The windshield was fractured from (exterior) impact forces and the (interior) front right air bag module cover flap. All tempered glazing remained undamaged.

Figure 3. Front right damage to the 1998 Chevrolet Cavalier.

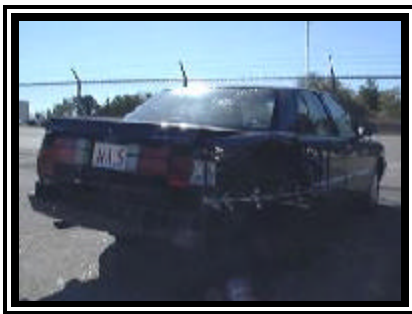
Figure 4. Right rear side surface damage to the 1991 Eagle Premier LX.

The 1991 Eagle Premier LX 4-door sedan sustained moderate right rear side surface damage as a result of the impact with the Chevrolet Cavalier (**Figure 4**). The direct contact damage began at the rear right bumper corner and extended 159.0 cm (62.6 in) forward. The (*SCI revised*) CDC for this impact to the Eagle was 02-RZEW-2 with a principal direction of force of (+)70 degrees. The right rear wheel/tire separated from the axle during the collision sequence. This allowed penetration of the Chevrolet into the vehicle's undercarriage resulting in a rupture of the plastic gas tank. All glazing remained undamaged.

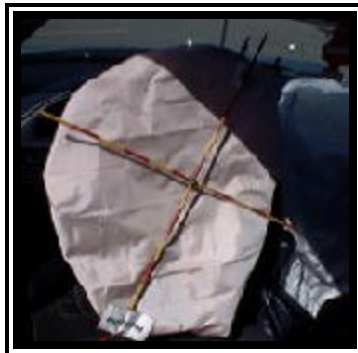
The 1998 Chevrolet Cavalier was equipped with redesigned frontal air bags for the driver and front right passenger positions. The air bags had deployed as a result of the crash. The driver air bag was housed in the center of the steering wheel with a vertically oriented flap tear seam (I-configuration). The flaps were symmetrical in shape and measured 11.0 cm (4.3 in) in width and 10.0 cm (3.9 in) in height. Although no contact evidence was identified on the exterior surface of the module cover flaps, a lipstick transfer was documented to the lower right quadrant of the air bag. The NASS researcher measured the diameter of the driver air bag at 60.0 cm (23.6 in) in its deflated state (**Figure 5**). No internal tether straps were present. The bag was vented by two ports located at the 9 o'clock and 3 o'clock sectors on the rear aspect of the air bag.

Figure 5. 1998 Chevrolet Cavalier redesigned driver air bag.

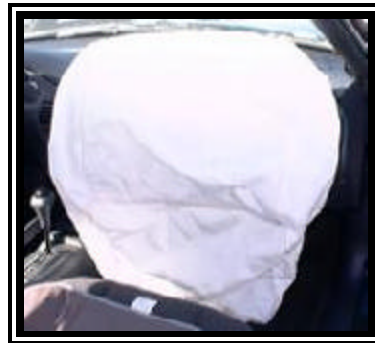
The front right passenger air bag deployed from the right top instrument panel area with a single cover flap design hinged at the forward aspect (*right mid-windshield area fractured by the module cover flap*). No contact evidence was identified on the air bag or exterior surface of the module cover flap. The cover flap was rectangular in shape and measured 32.0 cm (12.6 in) in width and 25.0 cm (9.8 in) in height. The NASS researcher measured the passenger air bag at 50.0 cm (19.7 in) in width and 80.0 cm (31.5 in) in height in its deflated state (**Figure 6**). No vent ports or internal tether straps were present. No cutoff switch was found for the front right air bag.

Figure 6. 1998 Chevrolet Cavalier redesigned passenger air bag.
