**REDESIGNED AIR BAG SPECIAL STUDY (RABSS)
SCI TECHNICAL SUMMARY REPORT**

NASS RABSS CASE NO. 1998-12-804E

RABSS VEHICLE - 1998 BUICK LeSABRE CUSTOM

CRASH DATE - SEPTEMBER, 1998

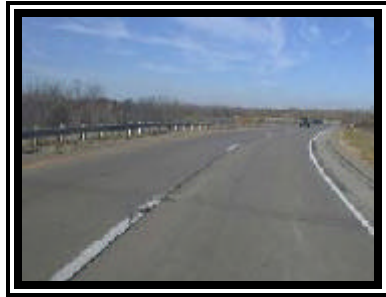
The 45 year old female driver of the 1998 Buick LeSabre was operating the vehicle westbound on the highway entrance ramp (**Figure 1**) and negotiating a right curve in fog conditions. She apparently had fallen asleep following an all night study session for school and allowed the vehicle to continue in a forward tracking motion. The Buick subsequently departed the left (south) pavement edge. The driver

Figure 1. Westbound approach for the 1998 Buick LeSabre Custom.

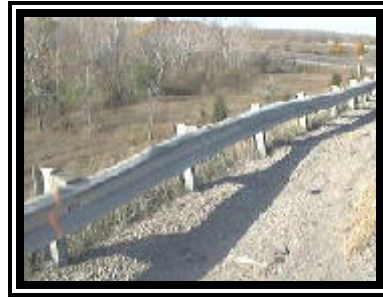
Figure 2. Struck guardrail.

As the Buick LeSabre exited the south pavement edge of the two lane highway entrance ramp, the front left area struck a W-beam guardrail (**Figure 2**) resulting in minor damage. The impact induced deceleration was sufficient to deploy the Buick's redesigned frontal air bag system. Although the guardrail was classified as a yielding object (out of scope), the damage algorithm of the WinSMASH program computed a (barrier equivalent) velocity change of 15.7 km/h (9.8 mph). The specific longitudinal component was -15.4 km/h (-9.6 mph). The Collision Deformation Classification (CDC) for this impact to the Buick LeSabre was 12-FDEW-1. Contact damage continued down the left side surface as the vehicle initiated a counterclockwise rotation which subsequently engaged the entire front end width. At this point, the right rear area impacted the guardrail a second time resulting in minor damage. The CDC for this impact to the Buick was 03-RBEE-1. The Buick came to rest on the south shoulder facing northeast.

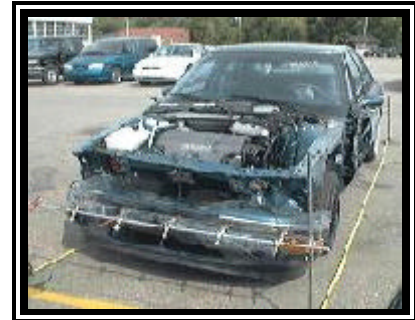
The 1998 Buick LeSabre Custom sustained minor frontal damage as a result of the impact with the guardrail (**Figure 3**). The direct contact damage encompassed the entire front end width resulting in a combined direct and induced damage length (Field L) of 145.0 cm (57.1 in). Six crush measurements were documented at the level of the bumper: C1= 9.0 cm (3.5 in), C2= 7.0 cm (2.8 in), C3= 7.0 cm (2.8 in), C4= 9.0 cm (3.5 in), C5= 7.0 cm (2.8 in), C6= 7.0 cm (2.8 in). Damage was documented along the left side surface of the Buick from sustained contact with the guardrail prior to spinout. Damage was also noted to the right rear area attributed to the second guardrail impact. The windshield was undamaged.

Figure 3. Frontal damage to the 1998 Buick LeSabre Custom.

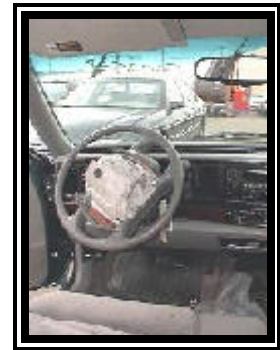
Interior damage to the Buick LeSabre identified through the NASS vehicle inspection was minimal and was attributed to occupant contact (**Figure 4**). A scuff mark was documented to the left sunvisor. The center armrest was slightly displaced to the right with the cup holder deformed. The ashtray was out of place. No deformation was identified to the knee bolster (padded type) or steering wheel hub/rim. No intrusions were found in the vehicle.

Figure 4. Interior view.

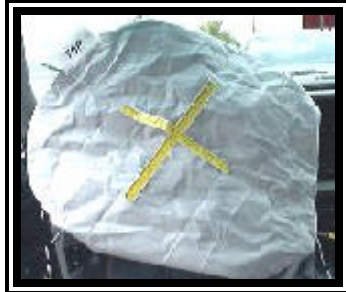
The 1998 Buick LeSabre Custom was equipped with redesigned frontal air bags for the driver and front right passenger positions. The air bags had deployed as a result of the crash. Air bag warning labels were affixed to each sun visor. The driver air bag was housed in the center of the steering wheel with a vertically oriented flap tear seam (I-configuration). The flaps were symmetrical in shape and measured 13.0 cm (5.1 in) in width and 9.0 cm (3.5 in) in height. Although no contact evidence was identified on the exterior surface of the module cover flaps, oil/dirt transfers were documented along the front lower and rear upper sections of the air bag. The NASS researcher measured the diameter of the driver air bag at 66.0 cm (26.0 in) in its deflated state (**Figure 5**). No internal tether straps were present. The bag was vented by two ports located at the 3 o'clock and 9 o'clock sectors on the rear aspect of the air bag.

Figure 5. 1998 Buick LeSabre redesigned driver air bag.

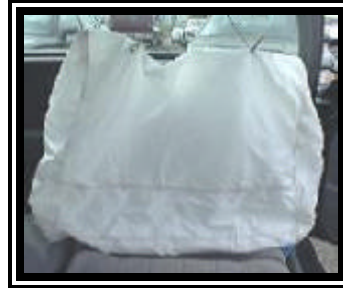
The front right passenger air bag deployed from the right mid-instrument panel area with a single cover flap design hinged at the top aspect. There was no contact evidence identified on the air bag or exterior surface of the module cover flap. The cover flap was rectangular in shape and measured 32.0 cm (12.6 in) in width and 13.0 cm (5.1 in) in height. The NASS researcher measured the passenger air bag at

55.0 cm (21.7 in) in width and 70.0 cm (27.6 in) in height in its deflated state (**Figure 6**). No internal tether straps were present. The bag was vented by two ports located at the 3 o'clock and 9 o'clock sectors on the side aspect of the air bag. No cutoff switch was reported for the front right redesigned passenger air bag.

Figure 6. 1998 Buick LeSabre redesigned passenger air bag.

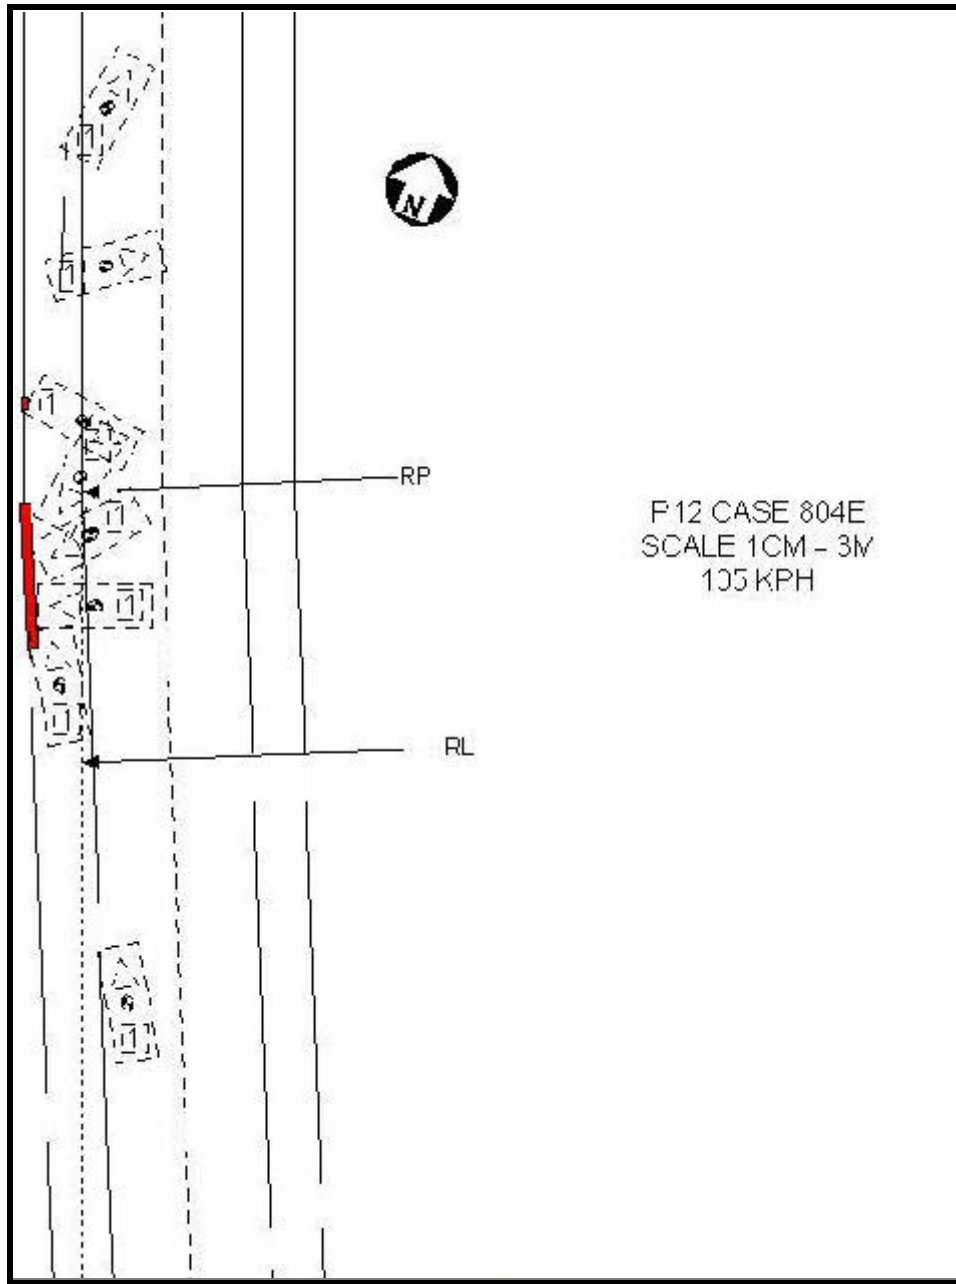
Figure 7. NASS Scene Diagram.

This single vehicle crash occurred during the morning hours of September, 1998. At the time of the crash, it was dawn with fog conditions as the roads were dry. The crash occurred off the south pavement edge of a (level) asphalt two lane highway on-ramp (**see Figure 7 - page 5**) which curved right for westbound traffic. The roadside environment included paved shoulders and a W-beam guardrail located approximately 3.0 meters (9.8 feet) off the south pavement edge. No traffic control was present at the scene which had a posted speed limit of 105 km/h (65 mph).
