**REDESIGNED AIR BAG SPECIAL STUDY (RABSS)
SCI TECHNICAL SUMMARY REPORT**

NASS CDS CASE NO. 1998-13-161E

RABSS VEHICLE - 1998 CHEVROLET S-10 PICKUP TRUCK

CRASH DATE - AUGUST, 1998

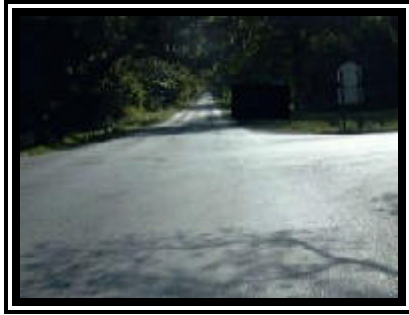
The 21 year old female driver of the 1990 Jeep Cherokee was operating the vehicle eastbound on approach to the 4-leg intersection (**Figure 1**) when she stopped at the stop sign and proceeded straight at a (driver reported) speed of 16 km/h (10 mph). The Jeep driver reported to police that she thought she was at a 4-way stop and had the right-of-way through the intersection. The front right seating position of the Jeep was occupied by a 23 year old male with the rear left and right seating positions

Figure 1. Eastbound approach for the 1990 Jeep Cherokee.

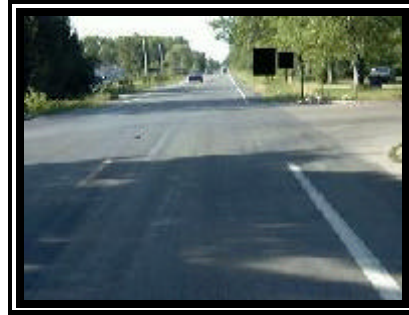
occupied by a 20 year old female and 22 year old male, respectively. The 25 year old male driver of the 1998 Chevrolet S-10 pickup was operating the vehicle southbound (**Figure 2**) at a (driver reported) speed of 80 km/h (50 mph) when he entered the intersection and observed the eastbound Jeep cross his path of travel. Upon recognition of the impending harmful event, the driver braked in avoidance remaining in the southbound lane prior to the collision. The front right seating position of the Chevrolet was occupied by a 25 year old male.

Figure 2. Southbound approach for the 1998 Chevrolet S-10 pickup truck.

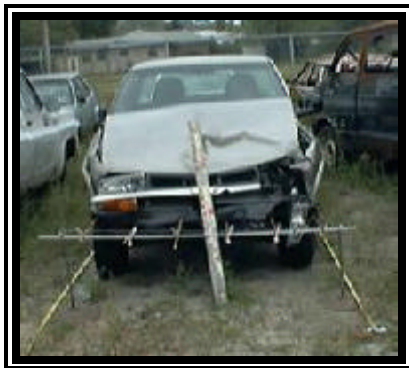
The 1998 Chevrolet S-10 pickup sustained moderate frontal damage as a result of the impact with the Jeep Cherokee (**Figures 3&4**). The direct contact damage encompassed the full frontal width resulting in a combined direct and induced damage length (Field L) of 148.0 cm (58.3 in). Six crush measurements were documented at the level of the bumper: C1= 37.0 cm (14.6 in), C2= 25.0 cm (9.8 in), C3= 25.0 cm (9.8 in), C4= 24.0 cm (9.4 in), C5= 22.0 cm (8.7 in), C6= 30.0 cm (11.8 in). The Collision Deformation Classification (CDC) for this impact to the Ford was 01-FDEW-2 with a principal direction of force of (+)30 degrees. The grille and left headlight assembly fractured and separated from the vehicle during the collision sequence. The hood was deformed up and rearward from engagement against the side surface of the Jeep. Both fenders were displaced rearward which restricted the front wheels/tires (not deflated). Reduction in the left side wheelbase measured 5.0 cm (2.0 in) while reduction in the right side wheelbase measured 2.0 cm (0.8 in). The windshield was fractured from (exterior) impact forces and (interior) occupant contact.

Figure 3. Frontal damage to the 1998 Chevrolet S-10 pickup truck.

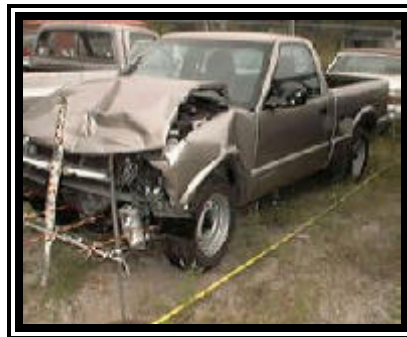
Figure 4. Oblique view of the 1998 Chevrolet pickup.

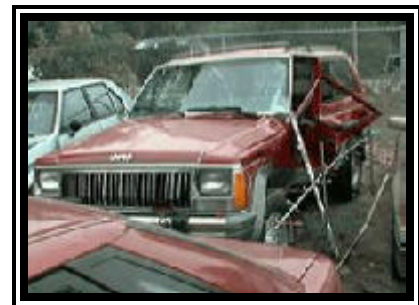
The 1990 Jeep Cherokee 2-door sport utility vehicle sustained moderate left side surface damage as a result of the impact with the Chevrolet pickup (**Figure 5**). The direct contact damage began 22.0 cm (8.7 in) aft of the left front axle and extended 155.0 cm (61.0 in) rearward. A maximum crush value of 44.0 cm (17.3 in) was documented just forward of the B-pillar. The (*SCI revised*) CDC for this impact to the Jeep was 10-LYEW-4 with a principal direction of force of (-)60 degrees. The windshield was fractured by exterior impact forces (only) as the left front window glazing was disintegrated by driver contact. Post-crash extrication damage was noted to the left door along with outward bowing of the upper window frame.

Figure 5. Left side surface damage to the 1990 Jeep Cherokee.

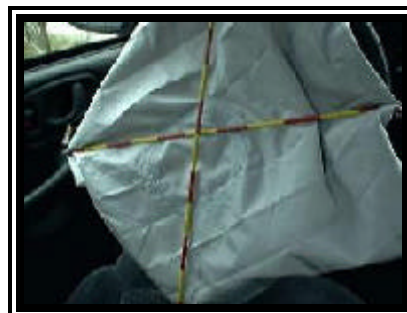
The 1998 Chevrolet S-10 was equipped with redesigned frontal air bags for the driver and front right passenger positions. The driver side air bag had deployed as a result of the crash. The driver air bag was housed in the center of the steering wheel with a vertically oriented flap tear seam (I-configuration). The flaps were symmetrical in shape and measured 11.0 cm (4.3 in) in width and 10.0 cm (3.9 in) in height. No contact evidence was identified on the air bag or exterior surface of the module cover flaps. The NASS researcher measured the diameter of the driver air bag at 63.0 cm (24.8 in) in its deflated state (**Figure 6**). The bag was tethered by four internal straps and vented by two ports located at the 11 o'clock and 1 o'clock sectors on the rear aspect of the air bag.

Figure 6. 1998 Chevrolet S-10 redesigned driver air bag.

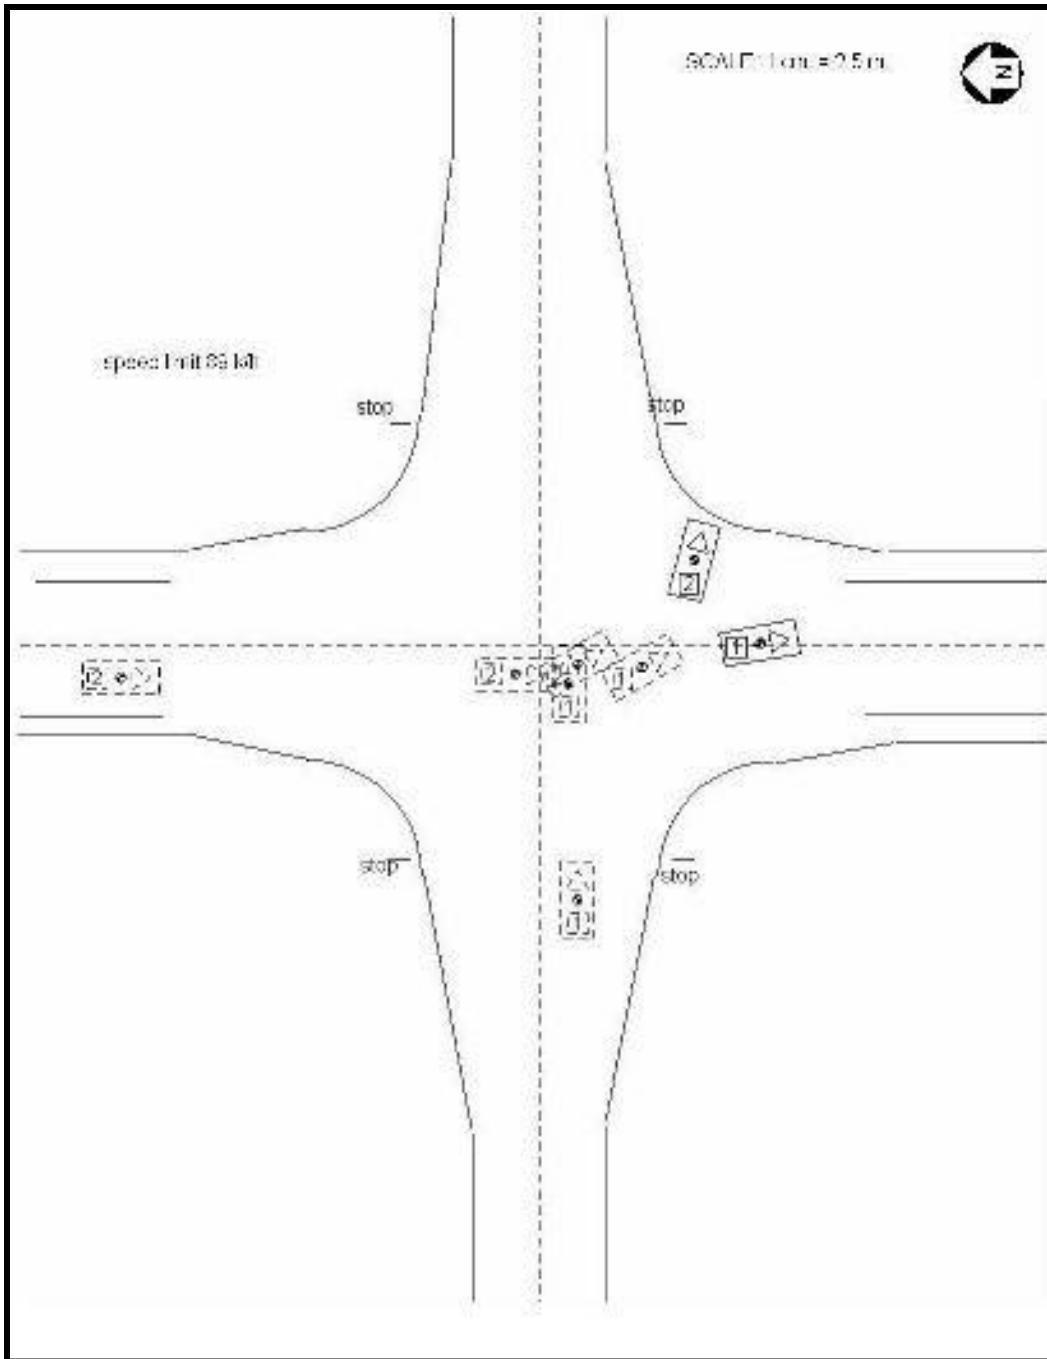
Figure 7. NASS Scene Diagram.

This two vehicle crash occurred during the evening hours of August, 1998. At the time of the crash, it was dark (street not lighted) with no adverse conditions as the roads were dry. The crash occurred in a straight and level 4-leg asphalt intersection (**see Figure 7 - page 6**). Traffic flow through the intersection was controlled by stop signs for east/westbound traffic. The posted speed limit at the crash site was 89 km/h (55 mph).
