**REDESIGNED AIR BAG SPECIAL STUDY (RABSS)
SCI TECHNICAL SUMMARY REPORT**

NASS CDS CASE NO. 1998-13-209E

RABSS VEHICLE - 1998 CHEVROLET CAVALIER LS

CRASH DATE - OCTOBER, 1998

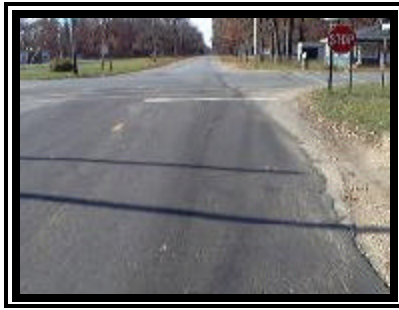
The 44 year old male driver of the 1998 Chevrolet Cavalier was operating the vehicle westbound (**Figure 1**) at a (driver reported) speed of 56 km/h (35 mph) when he failed to observe the stop sign or northbound Ford tractor as he proceeded straight through the 4-leg intersection. The Chevrolet driver reported to police that he was "daydreaming" and did not notice the stop sign. The 32 year old male driver of the Ford LN8000 was operating the vehicle northbound (**Figure 2**) and proceeding straight. The NASS researcher reported no brake marks at the scene indicative of driver avoidance maneuvers.

Figure 1. Westbound approach for the 1998 Chevrolet Cavalier LS.

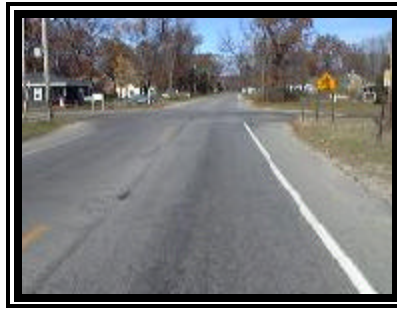
Figure 2. Northbound approach for the 1997 Ford LN8000 tractor truck.

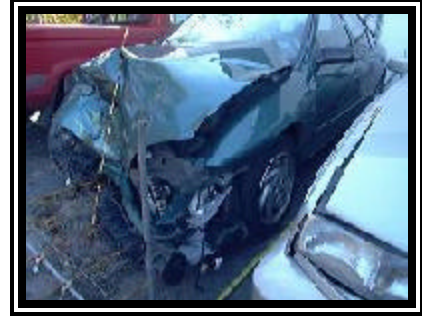
The 1998 Chevrolet Cavalier sustained moderate frontal damage as a result of the impact with the Ford tractor (**Figure 3**). The direct contact encompassed the full frontal width resulting in a combined direct and induced damage length (Field L) of 118.0 cm (46.5 in). Six crush measurements were documented at the level of the lower radiator (*bumper fascia/reinforcement bar separation*): C1= 0 cm, C2= 13.0 cm (5.1 in), C3= 22.0 cm (8.7 in), C4= 33.0 cm (13.0 in), C5= 35.0 cm (13.8 in), C6= 17.0 cm (6.7 in). The Collision Deformation Classification (CDC) for this impact to the Chevrolet was 11-FDEW-2 with a principal direction of force of (-)30 degrees. The right and left fenders were displaced rearward and to the left. The grille and headlight assemblies fractured and separated from the vehicle during the collision sequence. A large wheel/tire imprint was noted to the end structure attributed to the right rear wheel of the Ford truck. The hood was deformed up and rearward from engagement against the side surface of the Ford. There was no reduction in the vehicle's wheelbase. The windshield was fractured from (exterior) impact forces and the (interior) front right air bag module cover flap .

Figure 3. Frontal damage to the 1998 Chevrolet Cavalier LS.

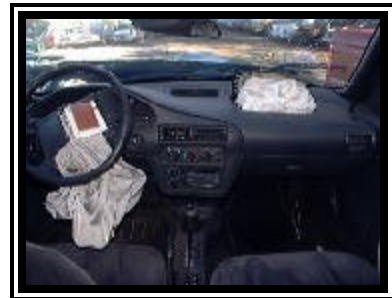
Interior damage to the Chevrolet was minimal and attributed to occupant contact (**Figure 4**). Scuff marks were documented on the left knee bolster (rigid plastic type). No intrusions were found in the vehicle.

Figure 4. Interior view.

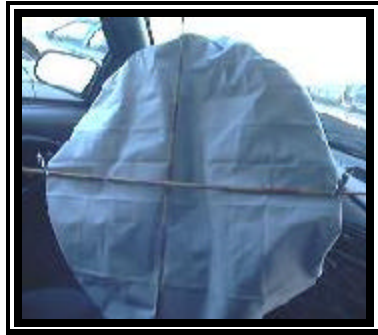
The 1998 Chevrolet Cavalier was equipped with redesigned frontal air bags for the driver and front right passenger positions. The air bags had deployed as a result of the crash. The driver air bag was housed in the center of the steering wheel with a vertically oriented flap tear seam (I-configuration). No contact evidence was identified on the air bag or exterior surface of the module cover flaps. The flaps were symmetrical in shape and measured 10.0 cm (3.9 in) square. Multiple black vinyl transfers were noted to the face of the air bag from expansion within the module. The NASS researcher measured the diameter of the driver air bag at 50.0 cm (19.7 in) in its deflated state (**Figure 5**). No internal straps were present. The bag was vented by two ports located at the 9 o'clock and 3 o'clock (centered) sectors on the rear aspect of the air bag.

Figure 5. 1998 Chevrolet Cavalier LS redesigned driver air bag.

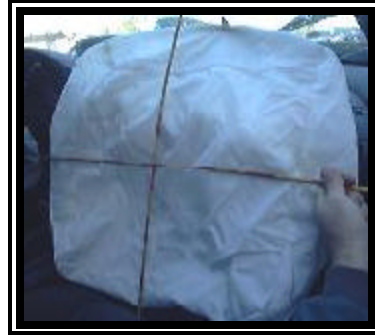
The front right passenger air bag deployed from the right top instrument panel area with a single cover flap design hinged at the forward aspect. No contact evidence was identified on the air bag or exterior surface of the module cover flap. The cover flap was rectangular in shape and measured 32.0 cm (12.6 in) in width and 18.0 cm (7.1 in) in height (*right lower windshield area fractured by the flap*). The NASS

researcher measured the passenger air bag at 50.0 cm (19.7 in) square in its deflated state (**Figure 6**). The bag was tethered by two internal straps with no vent ports present. No cutoff switch was found for the front right air bag.

Figure 6. 1998 Chevrolet Cavalier LS redesigned passenger air bag.

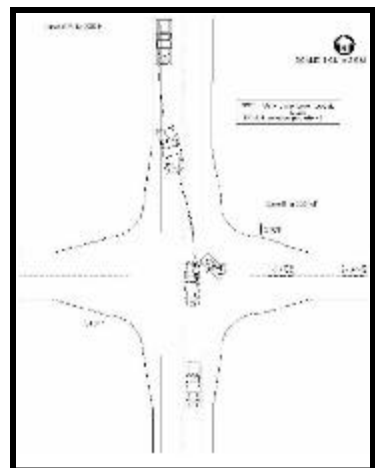
Figure 7. NASS Scene Diagram.

This two vehicle crash occurred during the afternoon hours of October, 1998. At the time of the crash, it was daylight with no adverse conditions as the roads were dry. The crash occurred in the northbound lane of a straight and level 4-leg asphalt intersection (see **Figure 7 - page 4**). The posted speed limit at the crash site was 56 km/h (35 mph) with east/westbound traffic controlled by stop signs.
