SCI/NASS COMBINATION CASE REPORT

CASE NUMBER - NASS-98-41-086C

VEHICLE - 1997 BMW 328i

CRASH DATE - June 1998

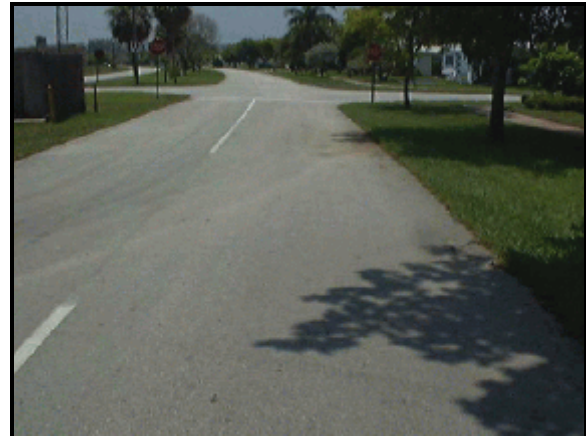
a grass median), and was approaching a four leg intersection intending to pass through the intersection and continue its southbound travel (**Figure 1**). Vehicle #2 was traveling west in the westbound lane of an intersecting, two-lane, undivided roadway, and was approaching the intersection intending to pass through and continue in its westbound travel. The intersection was controlled by stop signs for north-south traffic. The speed limit for both vehicles was 48 km.p.h. (30 m.p.h.). The bituminous road surface was dry and without defects for both vehicles. It was daylight, and there were no adverse atmospheric driving conditions. The case vehicle came to a complete stop and then entered the intersection. The case vehicle's driver did not attempt any avoidance actions while the driver of vehicle #2 braked with full lockup. The crash occurred within the intersection.

Figure 1: Case vehicle's southbound approach

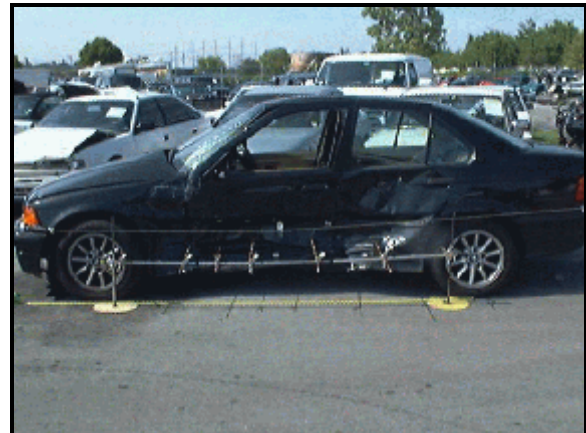
The left side (**Figure 2**) of the case vehicle was impacted by the front of vehicle #2, causing the case vehicle driver's side air bag to deploy. The case vehicle was also equipped with dual frontal air bags and a right front side air bag, none of which deployed. The case vehicle rotated a few degrees clockwise, traveled in a south-southwesterly direction and came to rest off the roadway at the south-west corner of the intersection. Vehicle #2 rotated approximately 45 degrees counterclockwise and came to rest close to the point of impact.

Figure 2: Case vehicle's left side damage

Damage to the case vehicle consisted of direct contact along the left side from slightly forward of the "A"-pillar to the rearward edge of the left rear door, with maximum crush 38 centimeters (15 inches) at the middle of the left front door (**Figure 2** above). The driver's door glazing was disintegrated, and the windshield was cracked along the left "A"-pillar, with no other glazing damage. The wheelbase was shortened by 8 centimeters (3.1 inches) on the left. The CDC for the case vehicle is: **10-LYEW-3**, with principal direction of force 310 (-50) degrees. The WinSMASH reconstruction program, ROLDMIS

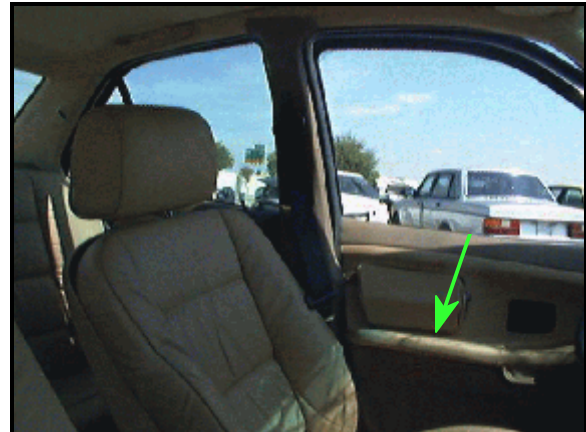
Figure 3: Case vehicle's driver seating area, with deployed side air bag folded away and side module cover flap set in place

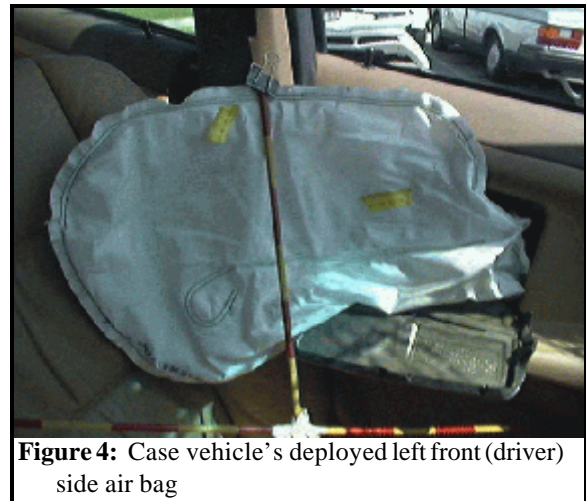
The deployed driver's side air bag was a rounded rectangle, approximately 25 centimeters (9.8 inches) high and 40 centimeters (15.7 inches) wide, with one tether and no vent ports (Figure 4). The module cover flap opened along the perforations, with no evidence of damage to the air bag, the cover flap, or the adjacent structures (Figure 3). There were two small areas of blood stain on the inboard surface of the air bag. The driver sustained several small lacerations due to flying glass (see discussion of injuries, below), and these blood stains do not indicate air bag-induced injuries.

Figure 4: Case vehicle's deployed left front (driver) side air bag

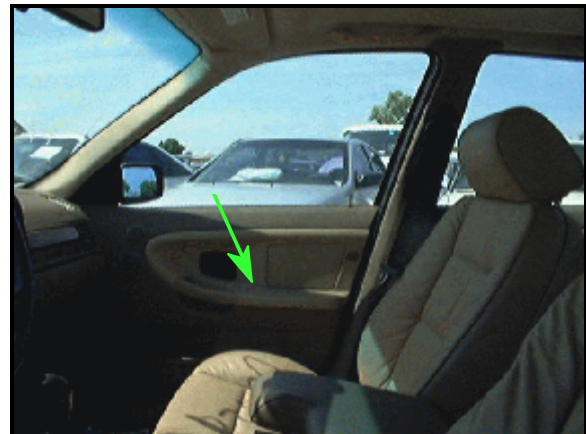
Figure 5: Case vehicle's front right passenger seating area and non-deployed front right side air bag
