**REDESIGNED AIR BAG SPECIAL STUDY (RABSS)  
SCI TECHNICAL SUMMARY REPORT**

**NASS RABSS CASE NO. 1998-43-801G**

**RABSS VEHICLE - 1998 CHEVROLET S-10 PICKUP TRUCK**

**CRASH DATE - JULY, 1998**

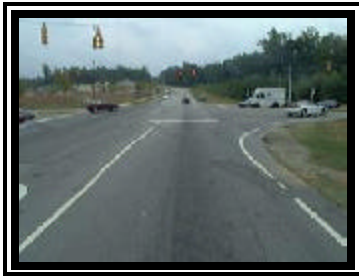
The 16 year old male driver of the 1998 Chevrolet S-10 was operating the vehicle eastbound (**Figure 1**) at a police reported speed of 72 km/h (45 mph) and proceeding straight when he observed the Honda Accord turn left (south) across his lane of travel. Upon recognition of the impending harmful event, the driver braked in avoidance remaining in the eastbound travel lane prior to the collision. The 1996 Honda Accord was driven by a 25 year old male who was operating the vehicle westbound (**Figure 2**) when he failed to detect the Chevrolet as he turned left (south) at a police reported speed of 24 km/h (15 mph).

**Figure 1. Eastbound approach for the 1998 Chevrolet S-10 pickup truck.**

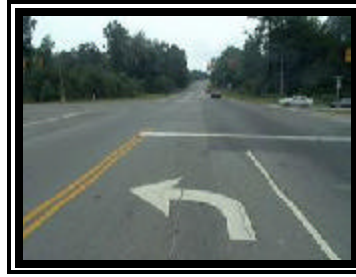
**Figure 2. Westbound approach for the 1996 Honda Accord EX.**

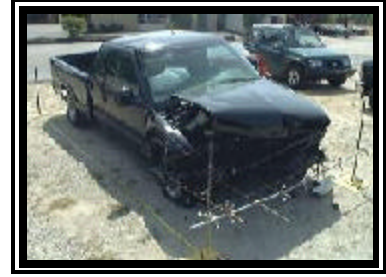
The Chevrolet S-10 sustained moderate frontal damage as a result of the impact with the Honda Accord (**Figure 3**). The direct contact damage encompassed the full frontal width resulting in a combined direct and induced damage length (Field L) of 141.0 cm (55.5 in). Six crush measurements were documented at the level of the bumper: C1= 0 cm, C2= 18.0 cm (7.1 in), C3= 33.0 cm (13.0 in), C4= 48.0 cm (18.9 in), C5= 53.0 cm (20.9 in), C6= 58.0 cm (22.8 in). Damage was noted to the hood which was displaced up and rearward from the impact force. The end structure was displaced approximately 12.0 cm (4.7 in) to the right. Induced buckling was noted to the roof area between the A-pillar and B-pillar. The right fender was displaced rearward which restricted/deflated the wheel/tire and jammed the right door. Bed to cab contact was documented to the right side. No windshield damage was found from exterior forces or the (interior) front right air bag deployment.

**Figure 3. Frontal damage to the 1998 Chevrolet S-10 pickup truck.**

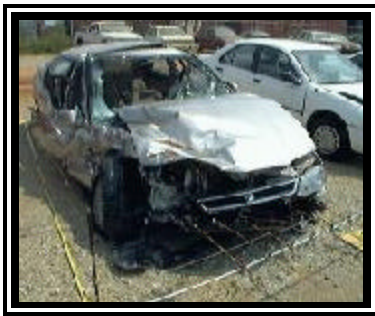
**Figure 4. Frontal damage to the 1996 Honda Accord EX.**

The Honda Accord sustained moderate frontal damage as a result of the impact with the Chevrolet S-10 (**Figure 4**). The direct contact damage began at the front right bumper corner and extended 62.0 cm (24.4 in) inboard. The impact deformed the full frontal width resulting in a combined direct and induced damage length (Field L) of 94.0 cm (37.0 in). The bumper fascia separated from the reinforcement bar. The direct contact damage continued rearward to the A-pillar from sustained contact between the vehicles during spinout. This damage pattern restricted/bowed the right front door and shattered the side glazing. The right fender was displaced laterally which restricted the right front wheel/tire (not deflated). The windshield was fractured and

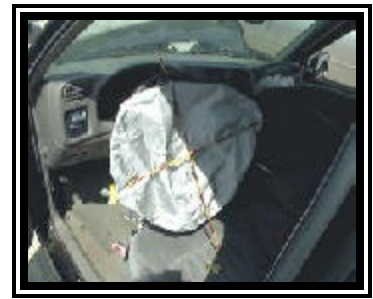
The 1998 Chevrolet S-10 was equipped with redesigned frontal air bags for the driver and front right passenger positions. The air bags had deployed as a result of the crash. The driver air bag was housed in the center of the steering wheel with a vertically oriented flap tear seam (I-configuration). The flaps were symmetrical in shape and measured 12.0 cm (4.7 in) in width and 10.0 cm (3.9 in) in height. No contact evidence was identified on the air bag or exterior surface of the module cover flaps. The NASS researcher measured the diameter of the driver air bag at 60.0 cm (23.6 in) in its deflated state (**Figure 6**). The bag was tethered by two internal straps and vented by two ports located at the 11 o'clock and 1 o'clock sectors on the rear aspect of the air bag.

**Figure 6. 1998 Chevrolet S-10 redesigned driver air bag.**

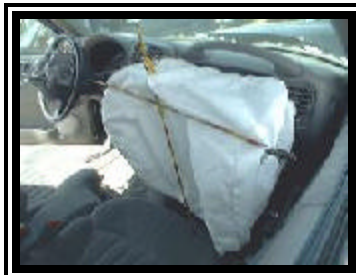
**Figure 7. 1998 Chevrolet S-10 redesigned passenger air bag.**

The front right passenger air bag deployed from a mid-mount module in the right instrument panel with a single cover flap design hinged at the bottom aspect. No contact evidence was identified on the air bag or exterior surface of the module cover flap. The cover flap was rectangular in shape which opened in a downward direction away from the windshield and measured 32.0 cm (12.6 in) in width and 13.0 cm (5.1 in) in height. The NASS researcher measured the passenger air bag at 56.0 cm (22.0 in) in width and 44.0 cm (17.3 in) in height in its deflated state (**Figure**

**7**). No tether straps were present. The bag was vented by two ports located at the 9 o'clock and 3 o'clock sectors on the side aspect of the air bag. A cutoff switch was located on the instrument panel (**Figure 8**) to the right of the steering column.

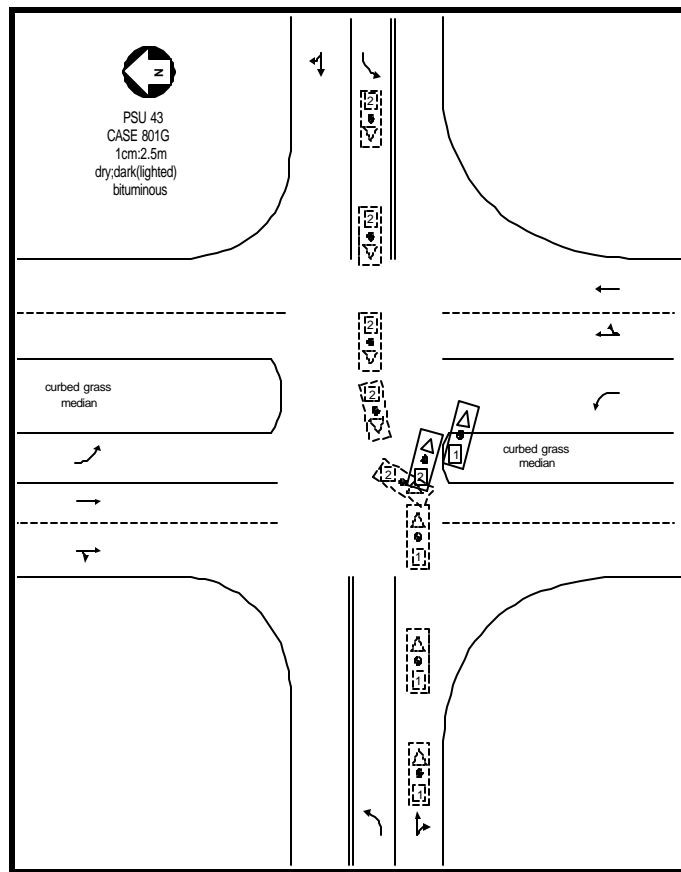
Figure 9. NASS Scene Diagram

This two-vehicle crash occurred during the evening hours of July, 1998. At the time of the crash, it was dark (street lighted) with no adverse conditions as the roads were dry. The crash occurred in the eastbound lane of a 4-leg rural (level/asphalt) intersection which is controlled by overhead tri-lights (see **Figure 9 - page 5**). The speed limit at the crash scene was 72 km/h (45 mph).
