**REDESIGNED AIR BAG SPECIAL STUDY (RABSS)
SCI TECHNICAL SUMMARY REPORT**

NASS RABSS CASE NO. 1998-43-804D

RABSS VEHICLE - 1998 TOYOTA COROLLA

CRASH DATE - AUGUST, 1998

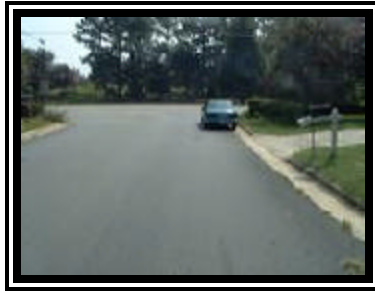
The 80 year old female driver of the 1992 Geo Prizm was operating the vehicle eastbound (**Figure 1**) when she stopped at the stop sign and attempted to turn left (north) at a (police reported) speed of 16 km/h (10 mph). The 45 year old female driver of the 1998 Toyota Corolla was operating the vehicle southbound on an approach to the 3-leg intersection (**Figure 2**) at a (driver reported) speed of 64 km/h (40 mph) when she observed the Geo cross her path of travel. Upon recognition of the impending harmful event, she braked in avoidance remaining in the southbound lane prior to the

Figure 1. Eastbound approach for the 1992 Geo Prizm.

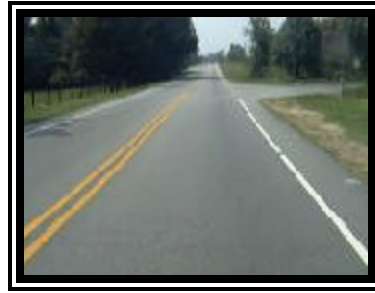
Figure 2. Southbound approach for the 1998 Toyota Corolla.

collision. *Although not documented by the NASS researcher*, this trajectory was evidenced by 13.4 meters (44.0 feet) of pre-impact brake marks identified at the scene by police.

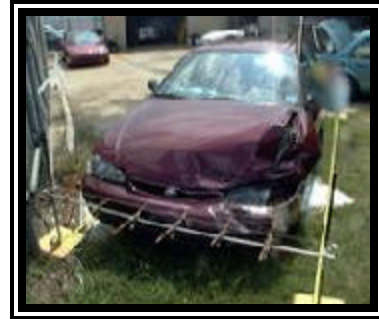
The 1998 Toyota Corolla sustained minor frontal damage as a result of the impact with the Geo Prizm (**Figure 3**). The direct contact damage began at the front left bumper corner and extended 82.0 cm (32.3 in) inboard. The impact deformed the full frontal width resulting in a combined direct and induced damage length (Field L) of 137.0 cm (53.9 in). Six crush measurements were documented at the level of the bumper: C1= 17.0 cm (6.7 in), C2= 17.0 cm (6.7 in), C3= 11.0 cm (4.3 in), C4= 7.0 cm (2.8 in), C5= 2.0 cm (0.8 in), C6= 0. The Collision Deformation Classification (CDC) for this impact to the Toyota Corolla was 12-FYEW-2 with a principal direction of force of 0 degrees. A secondary profile was obtained above the level of the bumper. This profile was not required for this impact configuration, therefore, the crush profile was somewhat overstated. The left fender was displaced rearward which restricted the left front wheel/tire (not deflated). The hood was displaced up and rearward from engagement against the side surface of the Geo. Reduction in the left side wheelbase measured 2.0 cm (0.8 in). The windshield was fractured from the (interior) passenger air bag module cover flaps (only).

Figure 3. Frontal damage to the 1998 Toyota Corolla.

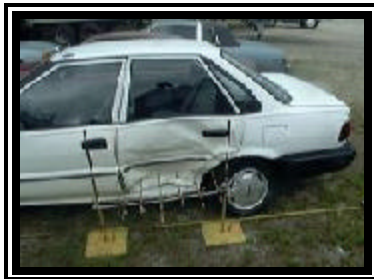
Figure 4. Left side surface damage to the 1992 Geo Prizm.

The 1992 Geo Prizm 4-door sedan sustained minor left side damage as a result of the impact with the Toyota Corolla (**Figure 4**). The direct (*and induced*) contact damage began 30.0 cm (11.8 in) forward of the left rear axle and extended 65.0 cm (25.6 in) forward. The CDC for this impact to the Geo Prizm was 09-LPEW-2 with a principal direction of force of (-)80 degrees. The damage was concentrated mainly at the left rear door area with no above beltline damage noted. All glazing remained intact.

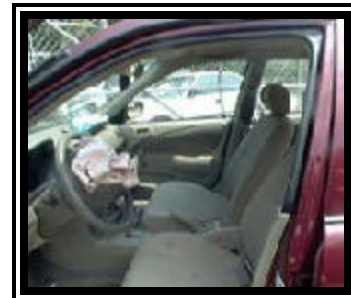
There was no damage to the interior surfaces of the Toyota Corolla from intrusions or occupant contact (**Figure 5**).

Figure 5. Interior view of the 1998 Toyota Corolla.

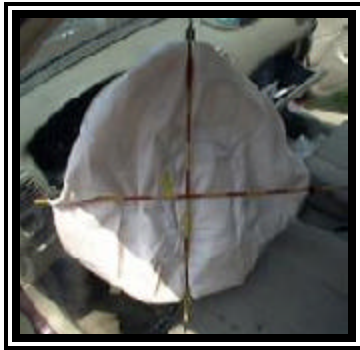
The 1998 Toyota Corolla was equipped with redesigned frontal air bags for the driver and front right passenger positions. The air bags had deployed as a result of the crash. The driver air bag was housed in the center of the steering wheel with a horizontally oriented flap tear seam (H-configuration). The flaps were asymmetrical in shape as the upper flap measured 16.0 cm (6.3 in) in width and 7.0 cm (2.8 in) in height while the lower flap measured 16.0 cm (6.3 in) in width

and 10.0 cm (3.9 in) in height. Although no contact evidence was identified on the exterior surface of the module cover flaps, skin tissue was documented on the lower right quadrant of the air bag along with dirt to the upper right quadrant. The NASS researcher measured the diameter of the driver air bag at 62.0 cm (24.4 in) in its deflated state (**Figure 6**). The bag was tethered by two internal straps and vented by two ports located at the 11 o'clock and 1 o'clock sectors on the rear aspect of the air bag.

Figure 6. 1998 Toyota Corolla redesigned driver air bag.

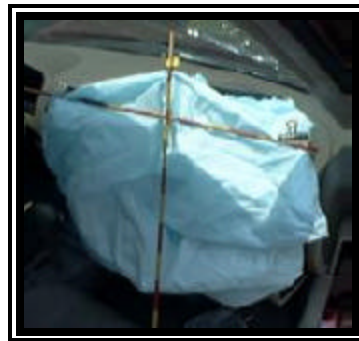
The front right passenger air bag deployed from the right top instrument panel area with a horizontally oriented flap tear seam (H-configuration). No contact evidence was identified on the air bag or exterior surface of the module cover flaps. The cover flaps were nearly symmetrical in shape as the forward flap measured 23.0 cm (9.1 in) in width and 4.0 cm (1.6 in) in height while the aft flap measured 23.0 cm (9.1 in) in width and 6.0 cm (2.4 in) in height. The NASS researcher measured the passenger air bag at 70.0 cm (27.6 in) square in its deflated state (**Figure 7**). No internal tether straps were present. The bag was vented by two ports located at the 10 o'clock and 2 o'clock sectors on the side aspect of the air bag. No cutoff switch was found for the front right air bag.

Figure 7. 1998 Toyota Corolla redesigned passenger air bag.

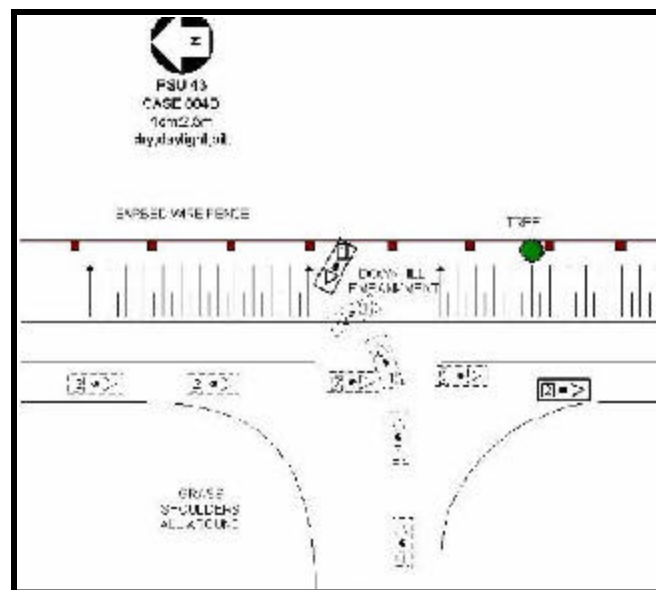
Figure 8. NASS Scene Diagram.

This two vehicle crash occurred during the afternoon hours of August, 1998. At the time of the crash, it was daylight with no adverse conditions as the roads were dry. The crash occurred in the southbound lane of a straight/level 3-leg (asphalt) intersection (**see Figure 8 - page 5**) which was bordered by narrow paved shoulders and a barbed wire fence located approximately 10.0 meters (32.8 feet) east of the crash site. Eastbound traffic was controlled by a stop sign with a posted speed limit of 72 km/h (45 mph).
