**REDESIGNED AIR BAG SPECIAL STUDY (RABSS)
SCI TECHNICAL SUMMARY REPORT**

NASS CDS CASE NO. 1998-45-088J

RABSS VEHICLE - 1998 NISSAN PATHFINDER SPORT UTILITY

CRASH DATE - JUNE, 1998

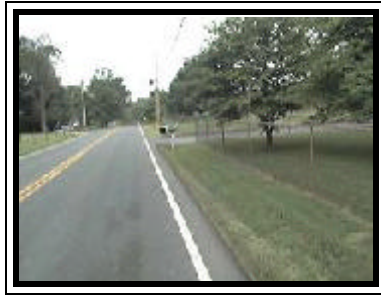
The 38 year old female driver of the 1998 Nissan Pathfinder was operating the vehicle westbound (**Figure 1**) when she apparently lost consciousness due to low blood sugar (confirmed by EMS at the scene post-crash) and allowed the vehicle to drift off the right (north) pavement edge. Upon recognition of the impending harmful event, the 11 year old male front right passenger attempted to reach over and revive the driver, but to no avail.

Figure 1. Westbound approach for the 1998 Nissan Pathfinder.

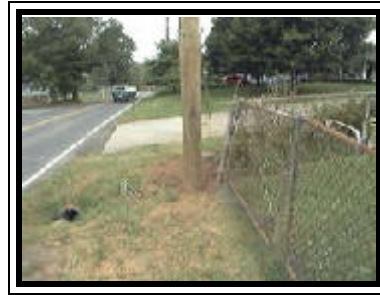
Figure 2. Utility pole impact location (pole replaced).

As the Nissan departed the north pavement edge of the two lane rural roadway, the front right area struck a small diameter mailbox post resulting in minor damage. The vehicle continued 9.5 meters (31.2 feet) in a westerly direction and impacted a (low profile) landscaping wall adjacent to a private driveway. This impact resulted in minor undercarriage damage. The vehicle continued for another 12.8 meters (42.0 feet) before contacting a utility pole guy wire (anchorage/stake uprooted) which resulted in minor (overlapping) frontal damage. At this point, the front right area struck a chain link fence resulting in minor damage. The front right area subsequently impacted a 30.5 cm (12.0 in) utility pole resulting in moderate (overlapping) damage (**Figure 2**). The impact induced deceleration was sufficient to deploy the Nissan's redesigned frontal air bag system. Although the impact was classified as out of scope (yielding object/overlapping damage), the damage algorithm of the WinSMASH program computed a (barrier equivalent) velocity change of 30.4 km/h (18.9 mph). The respective longitudinal component was -30.4 km/h (-18.9 mph). The Nissan rotated clockwise 100 degrees and re-entered the roadway where it came to rest perpendicular to the travel lanes facing northeast. **Table 1** identifies the Event number, the Object Struck and the respective Collision Deformation Classification (CDC) for each impact for the Nissan in the multiple event crash sequence.

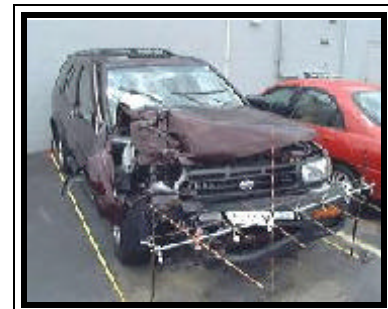
The Nissan Pathfinder sustained moderate (overlapping) frontal damage as a result of the impact with the utility pole (**Figure 3**). The direct contact damage began at the front right bumper corner and extended 35.0 cm (13.8 in) inboard. The impact deformed the full frontal width resulting in a combined direct and induced damage length (Field L) of 130.0 cm (51.2 in). Six crush measurements were documented at the level of the bumper: C1= 0 cm, C2= 0 cm, C3= 9.0 cm (3.5 in), C4= 21.0 cm (8.3 in), C5= 37.0 cm (14.6

Figure 3. Frontal damage to the 1998 Nissan Pathfinder.

in), C6= 54.0 cm (21.3 in). Damage was noted to the right fender which restricted the right front wheel/tire (not deflated) and jammed the right front door. The right wheelbase was displaced 22.0 cm (8.7 in). Superficial contact damage was documented on the right side surface which was attributed to the chain link fence impact. A small indentation was identified at the center portion of the front bumper from the guy wire impact. Minor damage was also noted to the front and center sections of the undercarriage from the landscaping wall impact. The windshield was fractured from exterior forces and (interior) occupant contact.

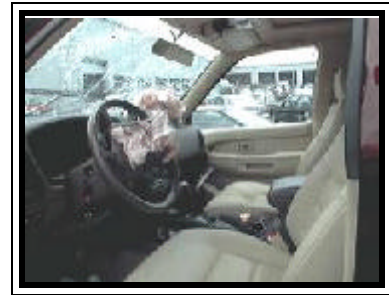
Interior damage to the Nissan identified through the NASS vehicle inspection was minimal and was attributed to occupant contact (**Figure 4**). A small indentation and scuff marks were documented to the driver knee bolster (rigid plastic type). The turn signal arm affixed to the steering column was deformed. Blood spattering was noted on the face of the driver air bag along with spattering to the lower left quadrant of the passenger air bag. Two small spider-web type fractures were identified at the left windshield area. The glove compartment door was found open and deformed along with a scuff mark to the right knee bolster. No deformation was noted to the steering wheel rim (tilt column set to the center position). Intrusions into the front right passenger space included 32.0 cm (12.6 in) of longitudinal toepan intrusion, 8.0 cm (3.1 in) of longitudinal instrument panel intrusion and 3.0 cm (1.2 in) of lateral door panel intrusion.

Figure 4. Interior view.

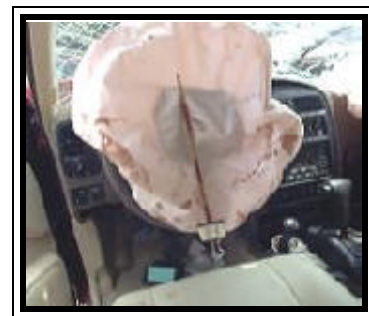
The 1998 Nissan Pathfinder was equipped with redesigned frontal air bags for the driver and front right passenger positions. The air bags had deployed as a result of the crash. The driver air bag was housed in the center of the steering wheel with a horizontally oriented flap tear seam (H-configuration). The flaps were asymmetrical in shape as the upper flap measured 14.0 cm (5.5 in) in width and 10.0 cm (3.9 in) in height while the lower flap measured 14.0 cm (5.5 in) in width and 8.0 cm (3.1 in) in height. Although no contact evidence was identified on the exterior surface of the module cover flaps, blood spattering was noted on the upper and lower sections the air bag which was attributed to the driver's hand injury. The NASS researcher measured the diameter of the driver air bag at 62.0 cm (24.4 in) in its deflated state (**Figure 5**). The bag was tethered by two internal straps and vented by two ports located at the 10 o'clock and 2 o'clock sectors on the rear aspect of the air bag.

Figure 5. 1998 Nissan Pathfinder redesigned driver air bag.

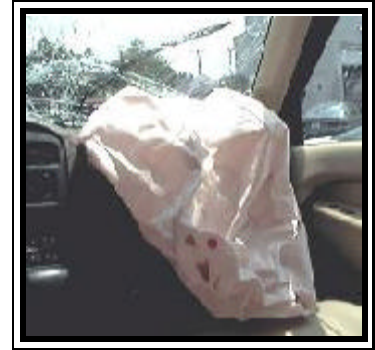
The front right passenger air bag deployed from a top mount module in the right instrument panel with a horizontally oriented flap tear seam (H-configuration). The cover flaps were rectangular in shape as the

upper flap measured 28.0 cm (11.0 in) in width and 7.0 cm (2.8 in) in height while the lower flap measured 28.0 cm (11.0 in) in width and 5.0 cm (2.0 in) in height. Although no contact evidence was identified on the exterior surface of the module cover flaps, blood spattering was noted to the lower left quadrant of the air bag which could be attributed to the driver's right hand injury or an unreported bloody nose sustained by the passenger. The NASS researcher measured the passenger air bag at 70.0 cm (27.6 in) in width and 58.0 cm (22.8 in) in height in its deflated state (**Figure 6**). No internal tether straps were present. The bag was vented by two ports located at the 10 o'clock and 2 o'clock sectors on the side aspect of the air bag. No cutoff switch was reported for the front right air bag.

Figure 6. 1998 Nissan Pathfinder redesigned passenger air bag.

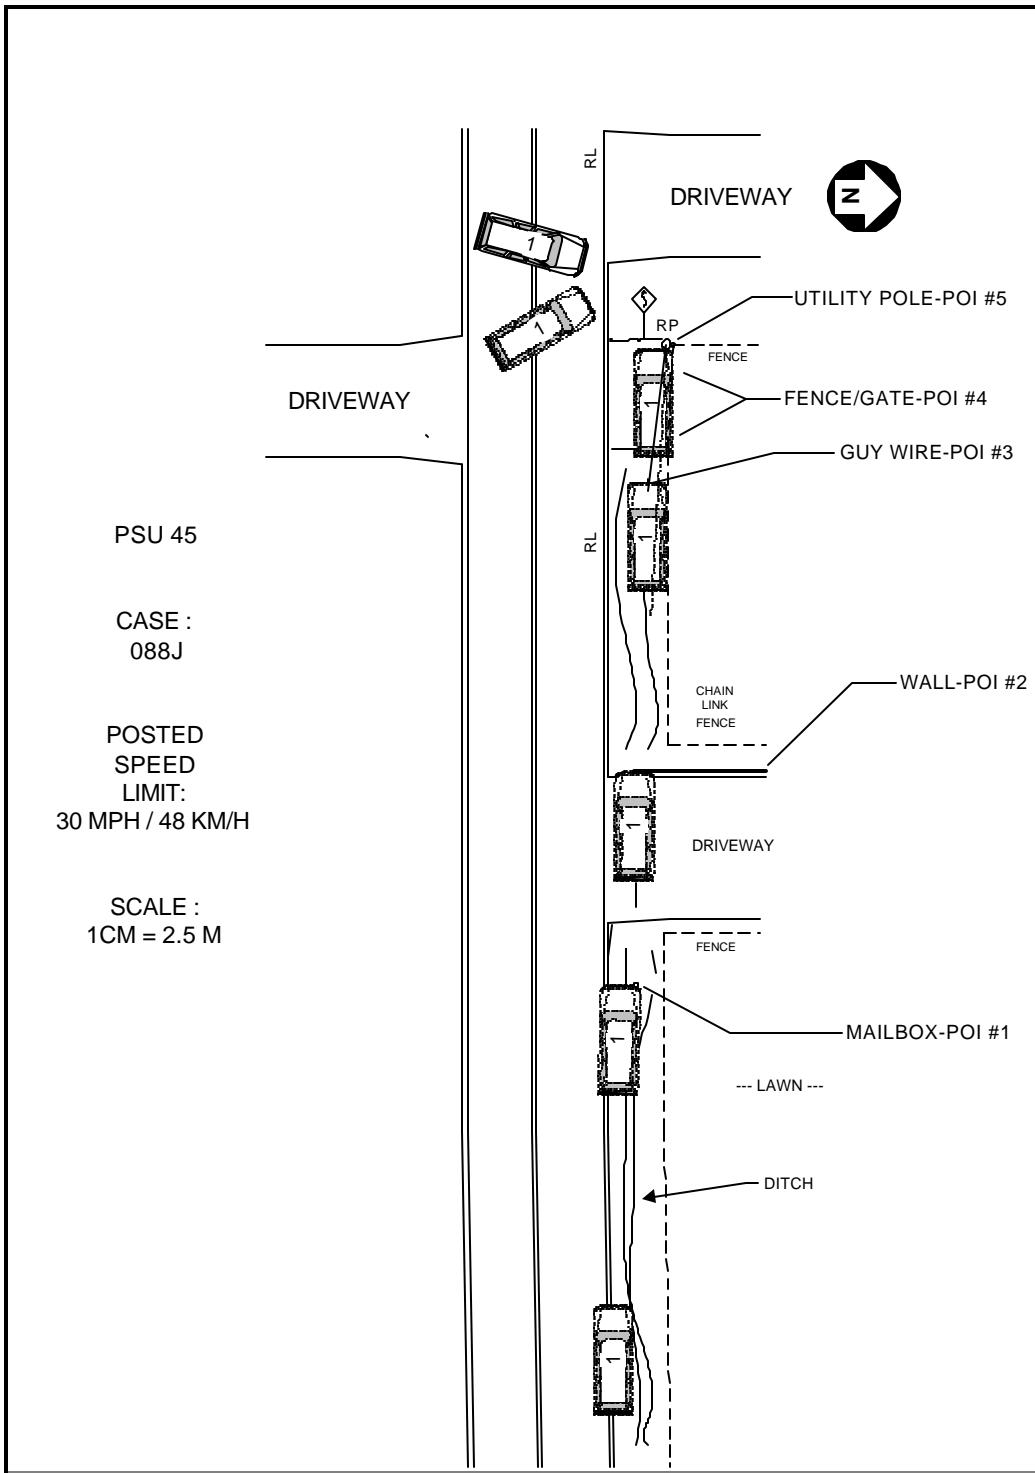
Figure 7. NASS Scene Diagram

This single vehicle crash occurred during the afternoon hours of June, 1998. At the time of the crash, it was daylight with no adverse conditions as the roads were dry. The crash occurred off the north pavement edge of a straight, two lane east/west (rural) asphalt roadway (see **Figure 7 - page 8**). The
