**REDESIGNED AIR BAG SPECIAL STUDY (RABSS)
SCI TECHNICAL SUMMARY REPORT**

NASS CDS CASE NO. 1998-45-160C

RABSS VEHICLE - 1998 NISSAN SENTRA XE

CRASH DATE - NOVEMBER, 1998

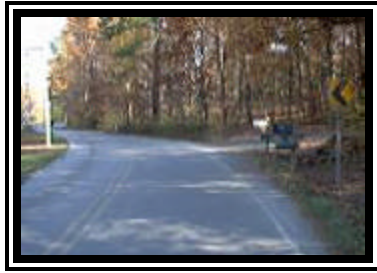
The 33 year old male driver of the 1998 Ford Expedition was operating the vehicle eastbound and reportedly accelerating out of a left curve (**Figure 1**) when the vehicle began to fishtail on the wet pavement. The Ford driver reported no avoidance maneuvers as the vehicle rotated counterclockwise into the opposing westbound lane. The 51 year old male driver of the 1998 Nissan Sentra was operating the vehicle westbound (**Figure 2**) at a (driver reported) speed of 48 km/h (30 mph) when he observed the eastbound Ford encroach into his lane of travel. Upon recognition of the impending harmful event, he braked in avoidance remaining in the westbound lane prior to the collision.

Figure 1. Eastbound approach for the 1998 Ford Expedition.

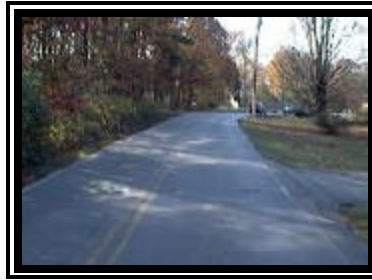
Figure 2. Westbound approach for the 1998 Nissan Sentra.

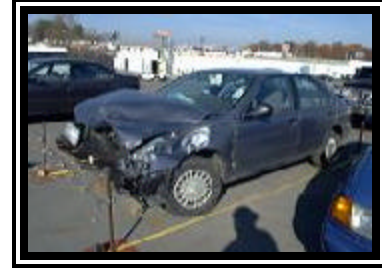
The 1998 Nissan Sentra XE sustained moderate frontal damage as a result of the impact with the Ford Expedition (**Figure 3**). The direct contact damage began at the front left bumper corner and extended 126.0 cm (49.6 in) inboard. The impact deformed the full frontal width resulting in a combined direct and induced damage length (Field L) of 138.0 cm (54.3 in). Six crush measurements were documented at the level of the reinforcement bar (*bumper fascia separation*): C1= 8.0 cm (3.1 in), C2= 30.0 cm (11.8 in), C3= 24.0 cm (9.4 in), C4= 14.0 cm (5.5 in), C5= 2.0 cm (0.8 in), C6= 0 cm. The Collision Deformation Classification (CDC) for this impact to the Nissan Sentra was 11-FDEW-2 with a principal direction of force of (-)30 degrees. A wheel imprint was noted to the reinforcement bar attributed to the right rear wheel of the Ford. The left fender was deformed rearward which restricted the left front wheel/tire (not deflated). The hood was deformed up and rearward from engagement against the side surface of the Ford. The windshield was fractured from exterior impact forces (only).

Figure 3. Frontal damage to the 1998 Nissan Sentra XE.

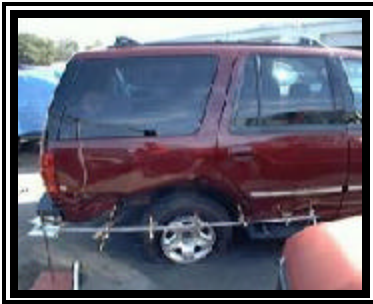
Figure 4. Right rear side surface damage to the 1998 Ford Expedition.

The 1998 Ford Expedition XLT sport utility vehicle sustained moderate right rear side surface damage as a result of the impact with the Nissan Sentra (**Figure 4**). The direct (*and induced*) contact damage began 70.0 cm (27.6 in) forward of the right rear axle and extended rearward 162.0 cm (63.8 in). The CDC for this impact to the Ford Expedition was 02-RZEW-2 with a principal direction of force of (+)50 degrees. A maximum crush value of 21.0 cm (8.3 in) was identified aft of the right rear axle with direct contact damage noted to the right rear wheel (deflated not restricted).

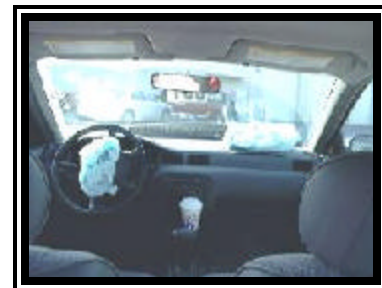
Damage to the interior surfaces of the Nissan Sentra were minimal and attributed to occupant contact (**Figure 5**). Scuff marks were documented on the left knee bolster (rigid plastic). No intrusions were found in the vehicle.

Figure 5. Interior view of the 1998 Nissan Sentra.

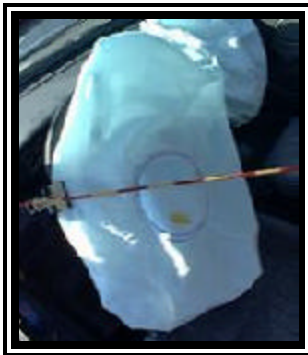
flap tear seam (H-configuration). The flaps were asymmetrical in shape as the upper flap measured 14.0 cm (5.5 in) in width and 11.0 cm (4.3 in) in height while the lower flap measured 14.0 cm (5.5 in) in width and 5.0 cm (2.0 in) in height. Although no contact evidence was identified on the exterior surface of the module cover flaps, small scuff marks were documented to the upper left quadrant of the air bag. The NASS researcher measured the diameter of the driver air bag at 50.0 cm (19.7 in) in its deflated state (**Figure 6**). The bag was tethered by two internal straps and vented by two ports located at the 11 o'clock and 1 o'clock sectors on the rear aspect of the air bag.

Figure 6. 1998 Nissan Sentra redesigned driver air bag.

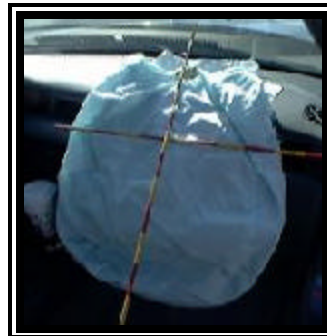
The front right passenger air bag deployed from the right top instrument panel area with a horizontally oriented flap tear seam (H-configuration). No contact evidence was identified on the air bag or exterior surface of the module cover flaps. The flaps were nearly symmetrical in shape as the forward flap measured 25.0 cm (9.8 in) in width and 8.0 cm (3.1 in) in height while the aft flap measured 25.0 cm (9.8 in) in width and 5.0 cm (2.0 in) in height. The NASS researcher measured the passenger air bag at 52.0 cm (20.5 in) in width and 55.0 cm (21.7 in) in height in its deflated state (**Figure 7**). No internal tether straps were present. The bag was vented by two ports located at the 10 o'clock and 2 o'clock sectors on the side aspect of the air bag. No cutoff switch was reported for the front right passenger air bag.

Figure 7. 1998 Nissan Sentra redesigned passenger air bag.

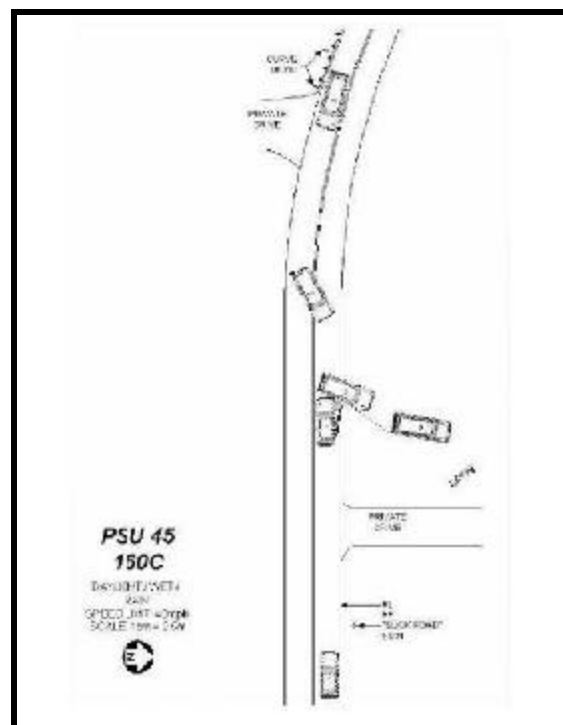
Figure 8. NASS Scene Diagram.

This two vehicle crash occurred during the morning hours of November, 1998. At the time of the crash, it was daylight with rainy conditions as the roads were wet. The crash occurred in the westbound lane of a level/asphalt two lane east/west county route (see **Figure 8 - page 5**) which curved left for eastbound traffic. "Slick pavement" and curve warning signs were present at the scene which had a posted speed limit of 64 km/h (40 mph).
