**REDESIGNED AIR BAG SPECIAL STUDY (RABSS)
SCI TECHNICAL SUMMARY REPORT**

NASS RABSS CASE NO. 1998-45-801E

RABSS VEHICLE - 1998 FORD F-150 PICKUP TRUCK

CRASH DATE - JULY, 1998

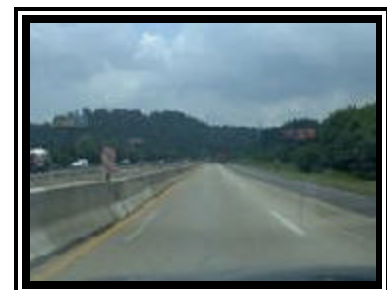
Figure 1. Southbound approach for the 1998 Ford F-150 pickup truck.

The 20 year old male driver of the 1998 Ford F-150 pickup truck was operating the vehicle southbound when he apparently had fallen asleep and allowed the vehicle to depart the left (east) pavement edge of the northbound lanes (**Figure 1**).

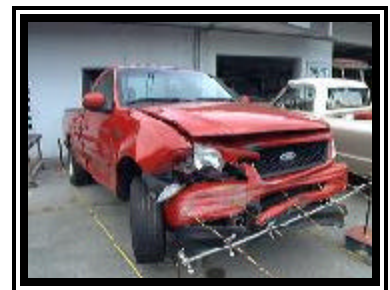
The Ford pickup sustained moderate frontal damage as a result of the impact with the second concrete barrier (**Figure 2**). The direct contact damage began at the front right bumper corner and extended 69.0 cm (27.2 in) inboard. The impact deformed the full frontal width resulting in a combined direct and induced damage length (Field L) of 165.0 cm (65.0 in). Six crush measurements were documented at the level of the bumper: C1= 3.0 cm (1.2 in), C2= 4.0 cm (1.6 in), C3= 9.0 cm (3.5 in), C4= 15.0 cm (5.9 in), C5= 19.0 cm (7.5 in), C6= 28.0 cm (11.0 in). Induced

Figure 2. Frontal damage to the 1998 Ford F-150 pickup truck.

damage was noted to the right fender which restricted the right front wheel/tire (not deflated) and jammed the right door. The right wheelbase was displaced 7.0 cm (2.8 in). Superficial contact damage was identified on the left side of the Ford which was attributed to the first barrier impact. The damage began 10.0 cm (3.9 in) aft of the front left bumper corner and extended rearward 500.0 cm (196.9 in). This damage pattern deflated the left side wheels (not restricted). The windshield was fractured from interior occupant contact (only).

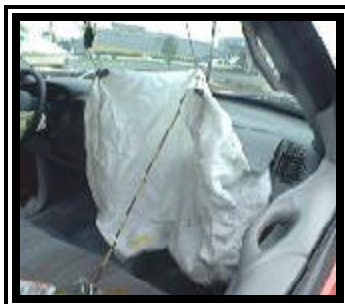
Figure 5. 1998 Ford F-150 redesigned passenger air bag.

in the right instrument panel with a single cover flap design hinged at the top aspect. The cover flap was rectangular in shape which opened in an upward direction toward the windshield and measured 39.0 cm (15.4 in) in width and 18.0 cm (7.1 in) in height. Although no contact evidence was identified on the exterior surface of the module cover flap, smudge marks were documented to the lower left quadrant of the air bag. The NASS researcher measured the passenger air bag at 55.0 cm (21.7 in) in width and 65.0 cm (25.6 in) in height in its deflated state (**Figure 5**). No vent ports or internal tether straps were present. A cutoff switch was found on the center instrument panel and was set to the on position.

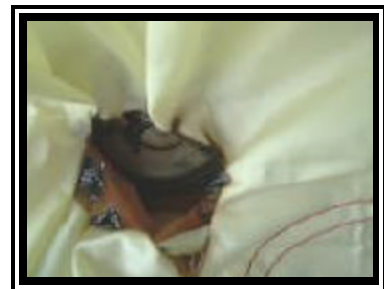
burn (**Figure 3**) was noted to the upper left quadrant of the air bag from deflation against the inflator. The NASS researcher measured the diameter of the driver air bag at 54.0 cm (21.3 in) in its deflated state (**Figure 4**). The bag was tethered by two internal straps and vented by two ports located at the 11 o'clock and 1 o'clock sectors on the rear aspect of the air bag.

Figure 3. Thermal burn to the driver air bag.

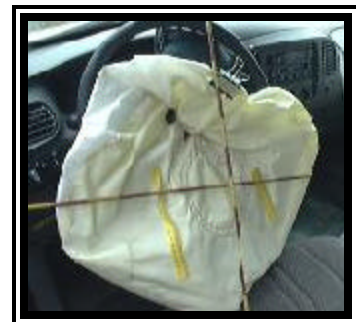
Figure 4. 1998 Ford F-150 redesigned driver air bag.

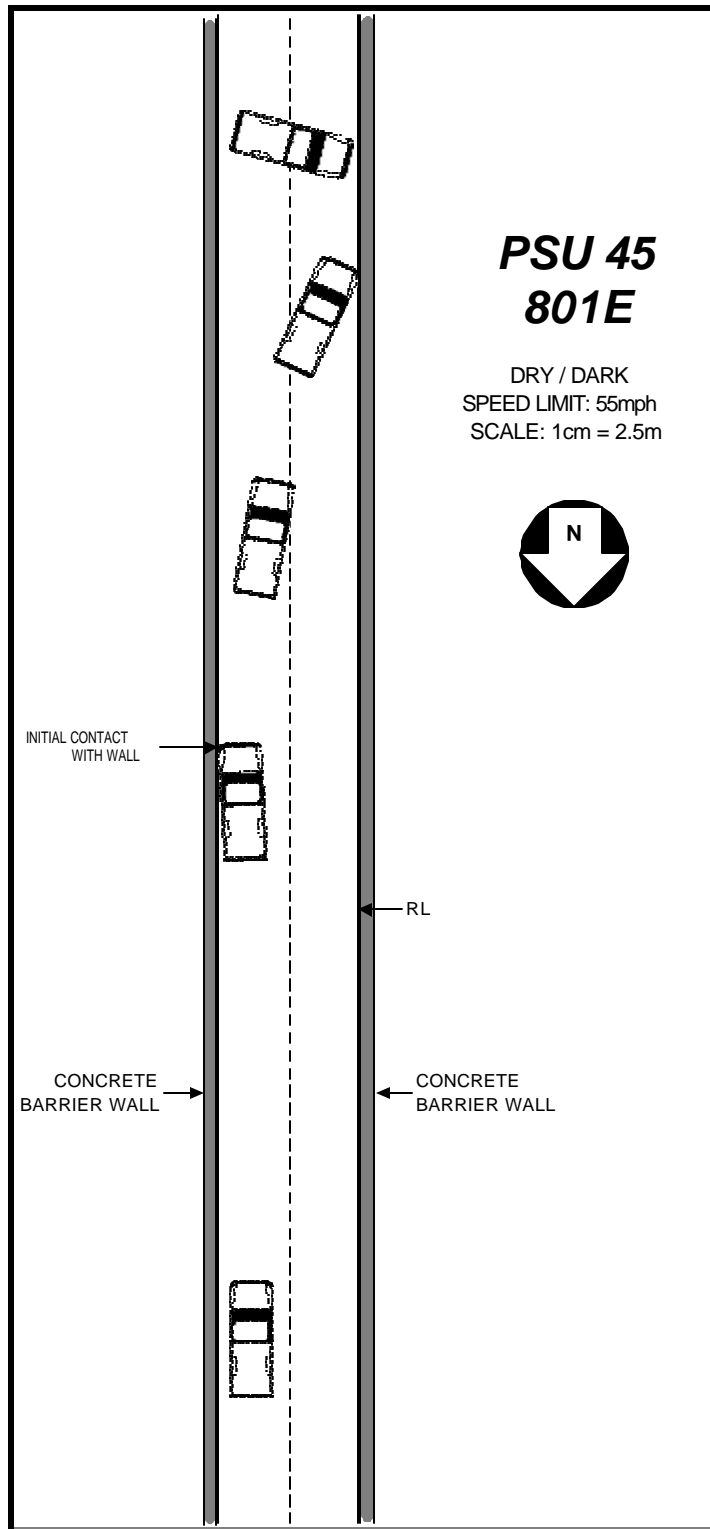
Figure 6. NASS Scene Diagram

This single vehicle crash occurred during the early morning hours of July, 1998. At the time of the crash, it was dark with no adverse conditions as the roads were dry. The crash occurred off the southbound lanes of a 4-lane north/south asphalt roadway (see **Figure 6 - page 6**) which was divided by concrete jersey barriers. The area was designated as a construction zone for highway improvements. No traffic controls were present at the scene which had a posted speed limit of 89 km/h (55 mph).
