**REDESIGNED AIR BAG SPECIAL STUDY (RABSS)
SCI TECHNICAL SUMMARY REPORT**

NASS RABSS CASE NO. 1998-45-803E

RABSS VEHICLE - 1999 CHEVROLET TAHOE SPORT UTILITY

CRASH DATE - AUGUST, 1998

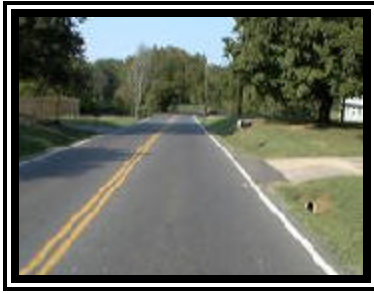
The 38 year old male driver of the 1999 Chevrolet Tahoe sport utility was operating the vehicle westbound when he crested a hill and observed a westbound non-contact vehicle stopped in the roadway waiting to make a left turn (**Figure 1**). Upon recognition of the impending harmful event, he steered right/braked in avoidance and exited the north pavement edge, traversing a private driveway and lawn area.

Figure 1. Westbound approach for the 1999 Chevrolet Tahoe sport utility.

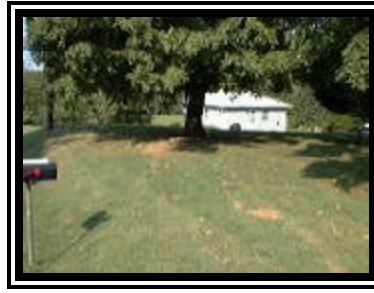
Figure 2. Struck tree.

As the Chevrolet exited the north pavement edge of the 2 lane roadway, the front right area impacted a 60.0 cm (23.6 in) diameter tree that was located 7.3 meters (24.0 ft) outboard of the north edgeline (**Figure 2**). The impact resulted in moderate damage. The Collision Deformation Classification (CDC) for this impact to the Chevrolet Tahoe was 12-FZEW-3. The impact induced deceleration was sufficient to deploy the Chevrolet's redesigned frontal air bag system. The WinSMASH damage and trajectory algorithm computed an impact speed of 36.5 km/h (22.7 mph) with a computed (barrier equivalent) velocity change of 33.5 km/h (20.8 mph). The respective longitudinal component was -33.0 km/h (-20.5 mph). The Chevrolet rotated clockwise 20 degrees and came to rest in close proximity to the point of impact facing northwest.

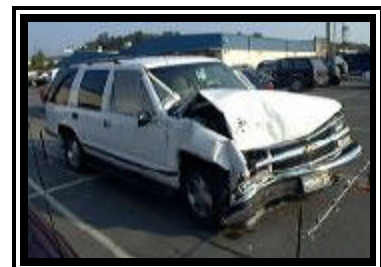
Figure 3. Frontal damage to the 1999 Chevrolet Tahoe sport utility.

The Chevrolet Tahoe sustained moderate frontal damage as a result of the impact with the tree (**Figure 3**). The direct contact damage began 15.0 cm (5.9 in) left of the front right bumper corner and extended 50.0 cm (19.7 in) inboard. The impact deformed the full frontal width resulting in a combined direct and induced damage length (Field L) of 168.0 cm (66.1 in). Six crush measurements were documented at the level of the bumper: C1= 0 cm, C2= 6.0 cm (2.4 in), C3= 17.0 cm (6.7 in), C4= 34.0 cm (13.4 in), C5= 56.0 cm (22.0 in), C6= 53.0 cm (20.9 in). The hood was displaced up and rearward from engagement against the tree. Induced damage was noted to the right fender which restricted the right front wheel/tire (not deflated). The right wheelbase was displaced 15.0 cm (5.9 in). The windshield was fractured from exterior forces (only).

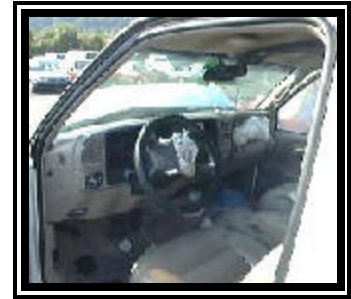
Interior damage to the Chevrolet identified through the NASS vehicle inspection was minimal and was attributed to occupant contact (**Figure 4**). Smudge marks were identified on the lower section of the driver air bag. Scuff marks were documented on the left knee bolster. No deformation was noted to the steering wheel rim (tilt column set to the center position). No intrusions were found in the vehicle.

Figure 4. Interior view.

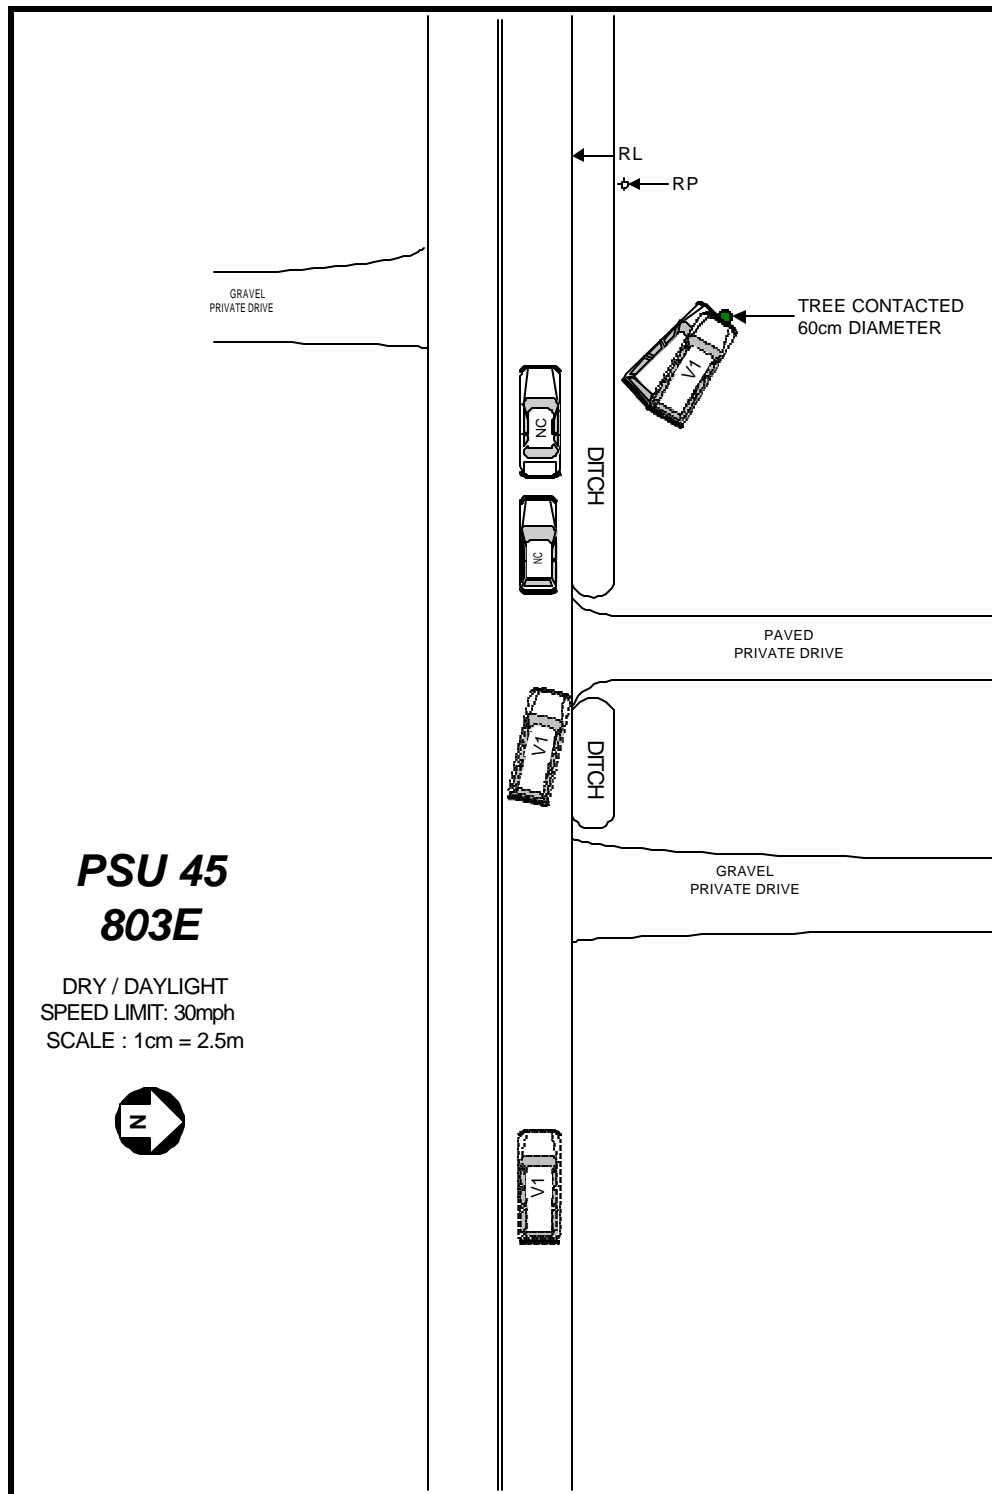
Figure 7. NASS Scene Diagram

This single vehicle crash occurred during the morning hours of August, 1998. At the time of the crash, it was daylight with no adverse conditions as the roads were dry. The crash occurred off the north pavement edge of a straight, 2 lane east/west asphalt roadway (see **Figure 7 - page 5**). No traffic controls were present at the scene which had a posted speed limit of 48 km/h (30 mph).
