**REDESIGNED AIR BAG SPECIAL STUDY (RABSS)
SCI TECHNICAL SUMMARY REPORT**

NASS RABSS CASE NO. 1998-45-804J

RABSS VEHICLE - 1998 HONDA CIVIC LX

CRASH DATE - NOVEMBER, 1998

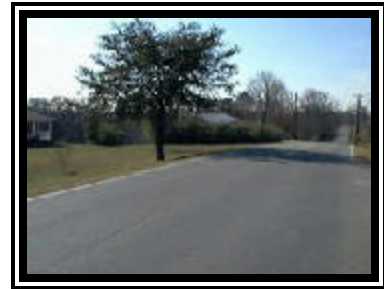
As the Honda Civic departed the left (south) pavement edge of the 2 lane rural roadway, the front right area struck a large diameter tree resulting in severe damage (**Figure 1**). The impact induced deceleration was sufficient to deploy the Honda's redesigned frontal air bag system. The damage and trajectory algorithm of the WinSMASH program computed an impact speed of 26.9 km/h (16.7 mph) with a (barrier equivalent) velocity change of 40.9 km/h (25.4 mph). The specific longitudinal component was -31.4 km/h (-19.5 mph). The Collision Deformation Classification (CDC) for this impact to the Honda was 01-FREE-5. The vehicle rotated counterclockwise approximately 180 degrees before coming to rest in close proximity to the point of impact facing northeast.

Figure 1. Westbound approach for the 1998 Honda Civic LX.

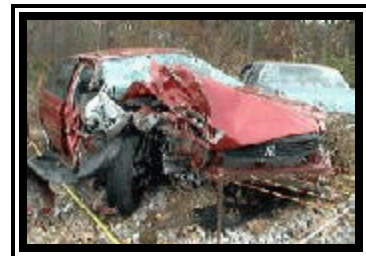
The Honda Civic sustained severe frontal damage as a result of the impact with the tree (**Figure 2**). The direct contact damage began at the front right bumper corner and extended 36.0 cm (14.2 in) inboard. The impact deformed the full frontal width resulting in a combined direct and induced damage length (Field L) of 55.0 cm (21.7 in). Six crush measurements were documented at the level of the reinforcement bar (bumper fascia

Figure 2. Frontal damage to the 1998 Honda Civic LX.

separation): C1 = 9.0 cm (3.5 in), C2 = 17.0 cm (6.7 in), C3 = 31.0 cm (12.2 in), C4 = 44.0 cm (17.3 in), C5 = 53.0 cm (20.9 in), C6 = 70.0 cm (27.6 in). The hood was displaced up and rearward from engagement against the tree. The right fender was displaced rearward to the A-pillar which restricted/deflated the right front wheel/tire and shattered the side glazing (**Figure 3**). Induced buckling was noted to the roof area between the A-pillar and B-pillar. The windshield was fractured from exterior forces and the (interior) front right air bag module cover flap. Extrication damage was documented to the right A-pillar (cut) and right front door (removed).

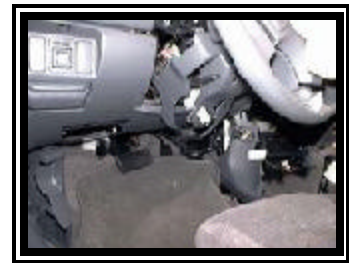
Interior damage to the Honda Civic identified through the NASS vehicle inspection was moderate and was attributed to occupant contact (**Figure 4**). The front left restraint energy management loop deployed at the lower anchorage point (belt cut by EMS during the driver's extrication from the vehicle). In addition, loading marks were documented to the D-ring at the upper anchorage point. Blood spattering was noted to the (left) upper and lower quadrants of the driver air bag and left section of the passenger air bag. The left knee bolster was deformed (rigid plastic type). The steering column cover panel was fractured (tilt column set to center position) with 1.0 cm (0.4 in) of deformation to the lower section of the steering wheel rim (**Figure 4**). The brake pedal was deformed forward into the (intruded) toepan. The center instrument panel was fractured and displaced to the right with smudge marks noted to the mid section. An indentation was documented on the right mid-instrument panel with make-up transfers to the surrounding area (**Figure 5**). The floor mounted transmission lever was displaced to the right. The windshield was fractured from the front right air bag module cover flap. Longitudinal intrusions into the front right passenger space included 18.0 cm (7.1 in) of toepan intrusion and 26.0 cm (10.2 in) of instrument panel intrusion. A 7.0 cm (2.8 in) longitudinal toepan intrusion was also documented to the driver space.

Figure 4. Bolster/column damage.

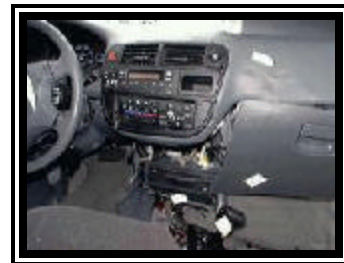
Figure 5. Instrument panel damage.

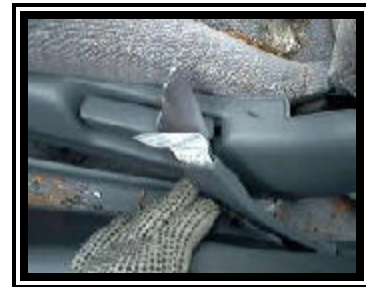
At impact, she initiated a forward/lateral trajectory in response to the 1 o'clock impact force and loaded the manual belt which resulted in fractures of the left 6th and 7th ribs, contusions to the abdomen, a lacerated ileum, mesentery and colon. Belt *usage* was confirmed by the deployment of the energy management loop at the lower anchorage point and webbing cut during the driver's extrication from the vehicle (**Figure 8**). Belt *placement* was evidenced by the nature of injuries sustained relative to the extent of the occupant kinematic response pattern into the right instrument panel. Given the direction of force and counterclockwise (post-impact) rotation of the vehicle, contact to the driver redesigned air bag was unlikely. Her lower extremities loaded the knee bolster/steering column resulting in fractures of the left tibia/fibula and bilateral contusions (distal to the knee), evidenced by the fractured knee bolster and steering column panel. She sustained an additional fracture of the tibia (medial malleolus) from contact to the (intruded) toepan. Loading to the brake pedal resulted in a fractured right heel and dislocated ankle as evidenced by the deformed brake pedal in conjunction with pre-impact brake marks documented at the crash site.

Figure 8. Energy management loop deployment at lower anchorage point (belt cut by EMS).

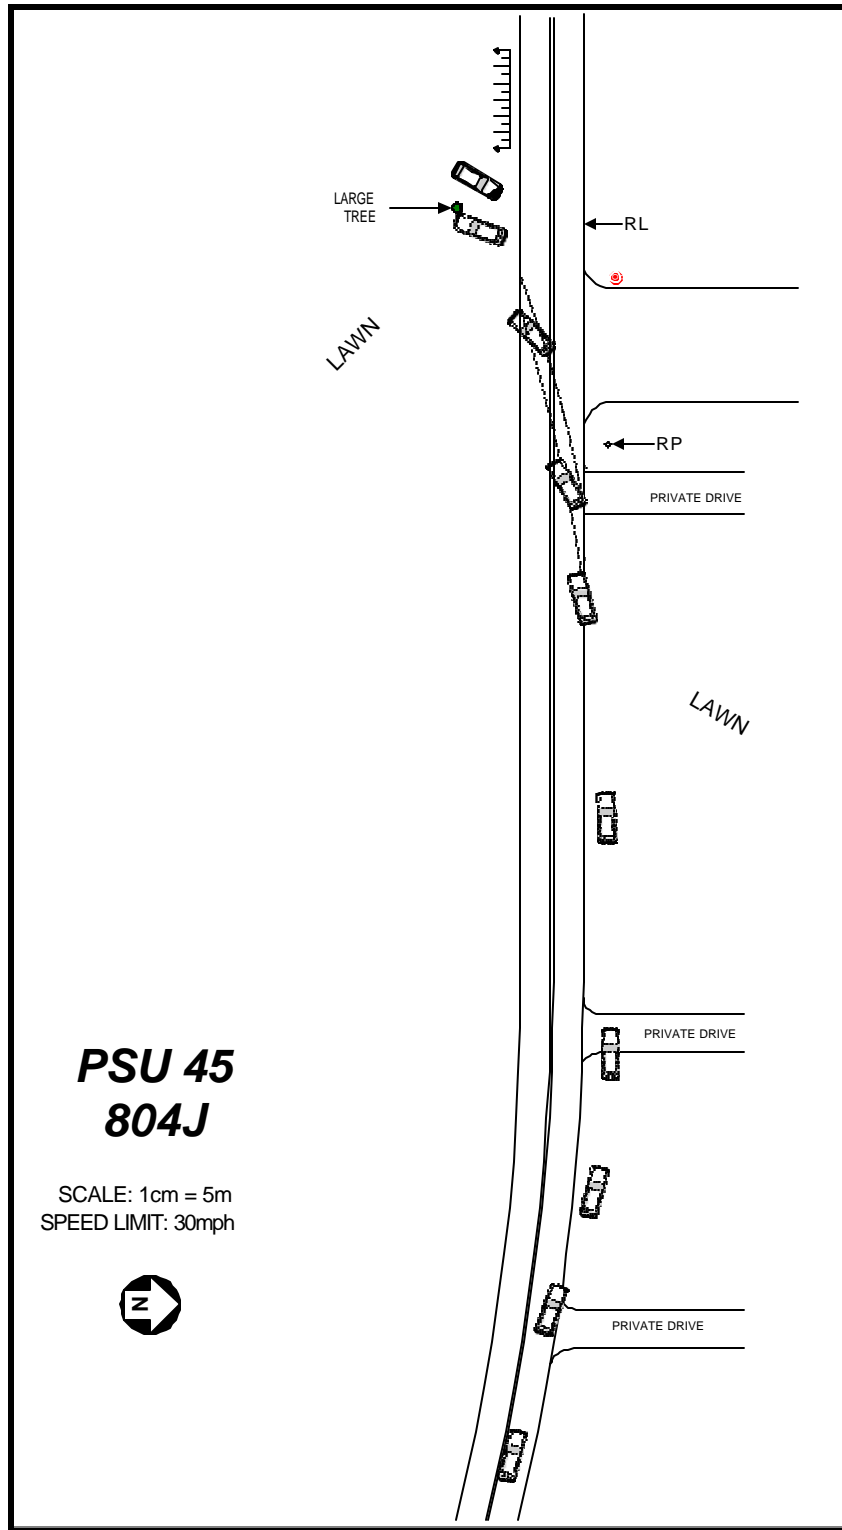
Figure 9. NASS Scene Diagram

This single vehicle crash occurred during the early morning hours of November, 1998. At the time of the crash, it was dark (no street lights) with no adverse conditions as the roads were dry. The crash occurred off the south pavement edge of an east/west 2 lane rural (asphalt) roadway which curved to the left for westbound traffic (see **Figure 9 - page 7**). The speed limit at the crash scene was 48 km/h (30 mph).
