Remote, Redesigned Air Bag Special Study
Dynamic Science, Inc., Case Number (1998-048-070C)
1998 Ford Taurus 4-door sedan
Alabama
August/1998

Summary

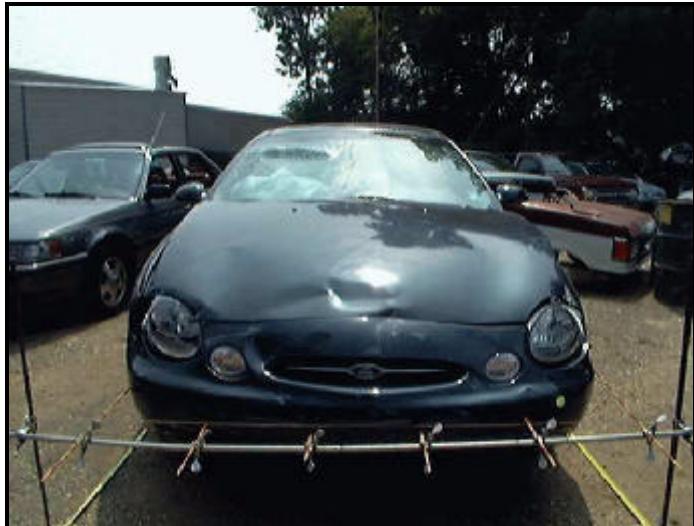
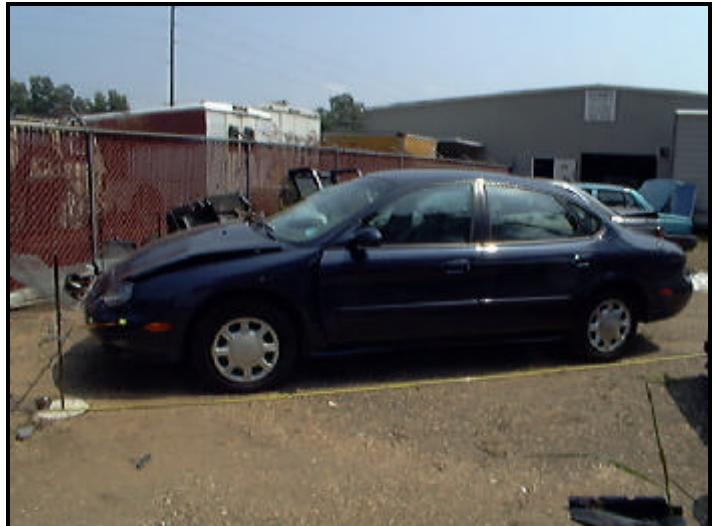
Figure 3. Exterior Vehicle 1 (1998 Ford Taurus)

Figure 4. Exterior Vehicle 1 (1998 Ford Taurus)

Plane of Impact	Field L cm/in.	C1 cm/in.	C2 cm/in.	C3 cm/in.	C4 cm/in.	C5 cm/in.	C6 cm/in.
Bumper	155	15	4	2	3	5	12
	61	5.9	1.6	0.8	1.2	2	4.7

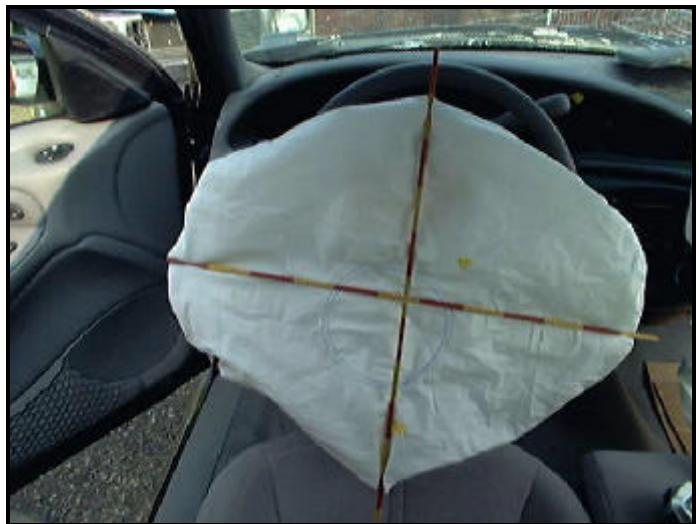
The front left air bag was housed in the steering wheel hub and was concealed by asymmetrical H-configuration cover flaps. The circular air bag was equipped with two tethers and two vent ports. Saliva was found on the air bag from contact with the driver's face. The bag was not damaged.

Figure 5. Driver side air bag - Vehicle 1

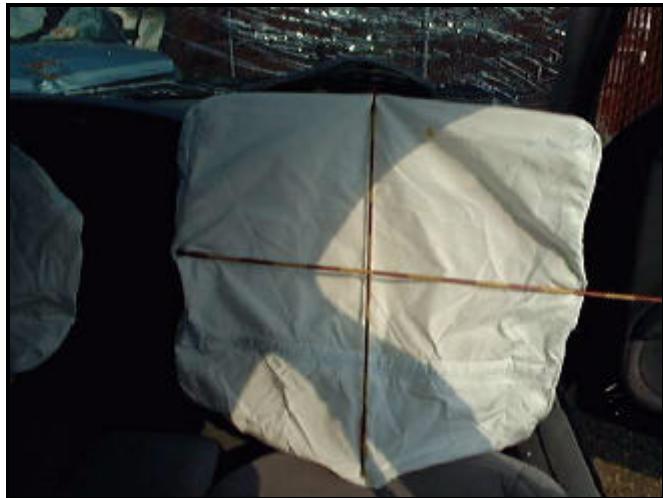
The front right air bag was located in the top-instrument panel position. The single air bag module cover flap was an irregularly shaped rectangular configuration. The rectangular air bag was equipped with two tethers but no vent ports. There were several small cuts apparent in the bag which were caused by broken glass. There was no evidence of occupant contact to the bag.

Figure 6. Passenger side air bag - Vehicle 1

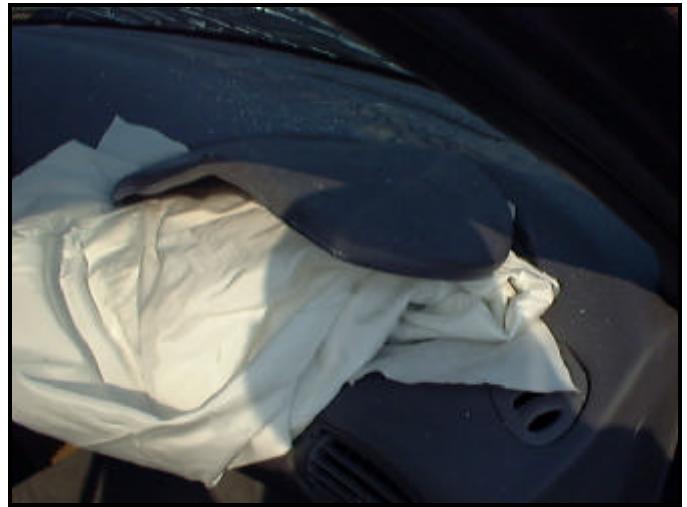
Figure 7. Passenger side air bag flap - Vehicle 1

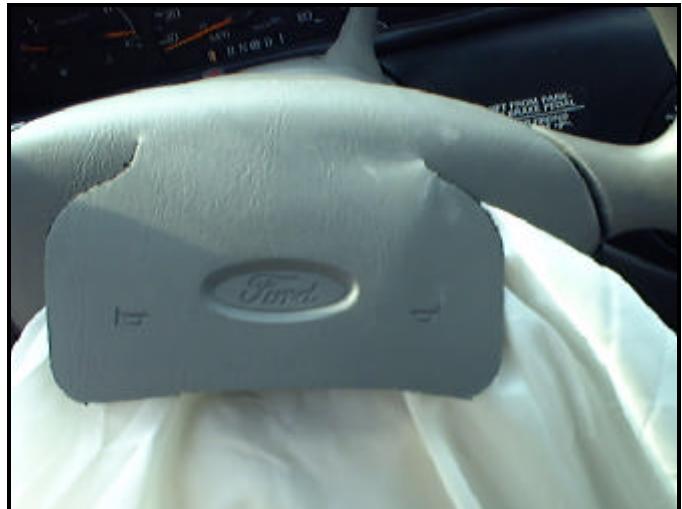
Occupant #	Injury	Injury Severity (AIS)	Injury Mechanism
1	Metacarpus fracture (Avulsion fracture base of left thumb)	2	Air bag cover flap
1	5 cm (2 in) forehead abrasion	1	Air bag
2	Thoracic spine strain	1	Impact force
2	Cervical spine strain	1	Impact force

Figure 8. Source of injury - Vehicle 1, Occupant 1

At impact, the occupants were prevented from any further frontal movement by the locked lap/shoulder restraints. It does appear however, that the driver (occupant 01) had moved far enough forward to engage the deploying air bag-causing the facial abrasion. A saliva transfer was found on the bag. The driver reported that his left hand was resting on the steering wheel hub at the time of the crash, and the air bag flaps appear to have contacted his left thumb-causing the metacarpus fracture. There was no evidence of contact with the passenger side air bag by occupant 02. It appears that the cervical and thoracic spine strains sustained by case occupant 02 were caused by the force of the impact, rather than contact with any component of the vehicle's interior.
