Remote, Redesigned Air Bag Special Study

Dynamic Science, Inc., Case Number (1998-048-801A)

1998 Ford F150 4 x 2 pickup

August/1998

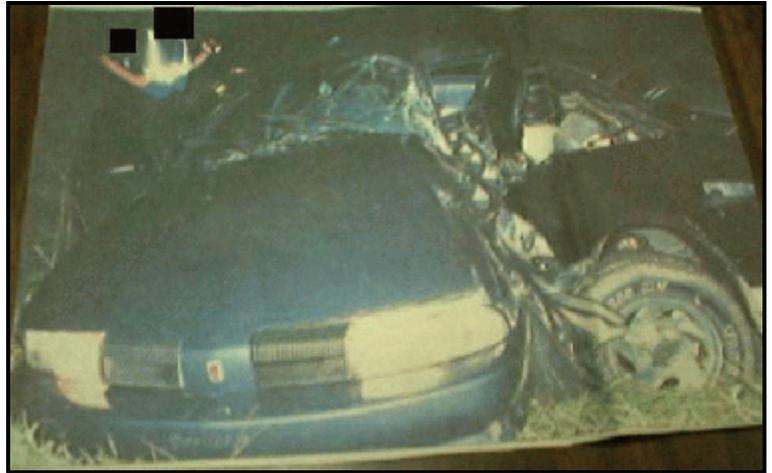
Figure 1. Final rest (police photo)

Vehicle 1 was pushed laterally in a westerly direction through the intersection and onto the median. Vehicle 2 remained in contact with Vehicle 1 until the vehicles came rest.

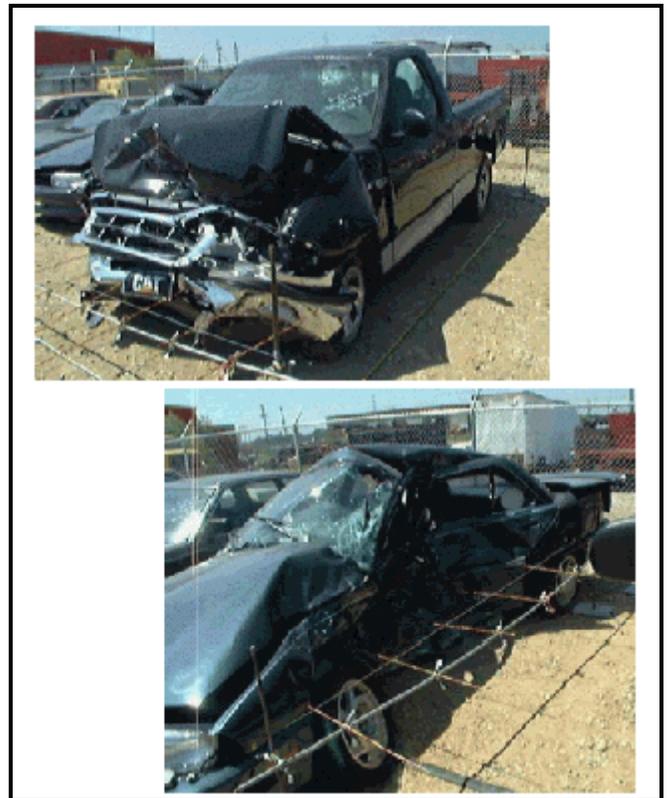
Figure 2. Exterior Vehicle 1 (Achieva) and Vehicle 2 (Ford F150)

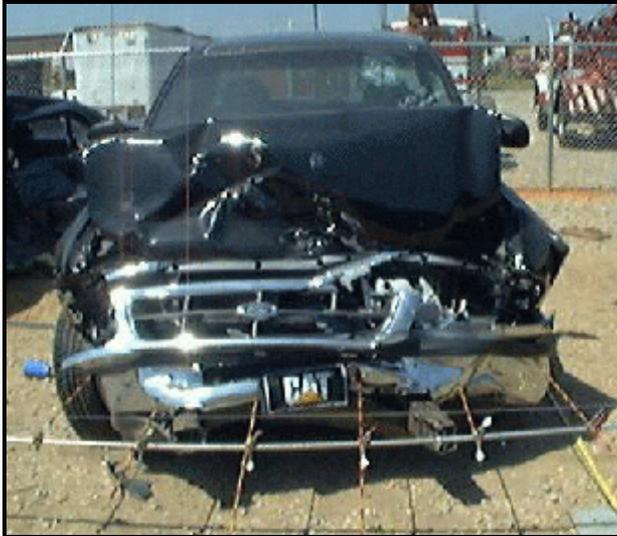
Figure 3. Exterior, Vehicle 2 (1998 Ford F-series pickup)

Plane of Impact	Field L cm/in.	C1 cm/in.	C2 cm/in.	C3 cm/in.	C4 cm/in.	C5 cm/in.	C6 cm/in.
Bumper	178	71	57	52	37	35	63
	70.1	28	22.4	20.5	14.6	13.8	24.8

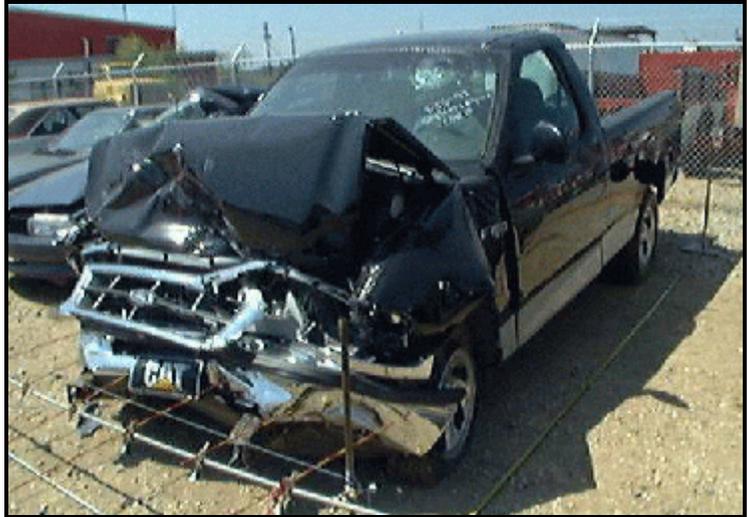
Figure 4. Exterior, Vehicle 2 (1998 Ford F-series pickup)

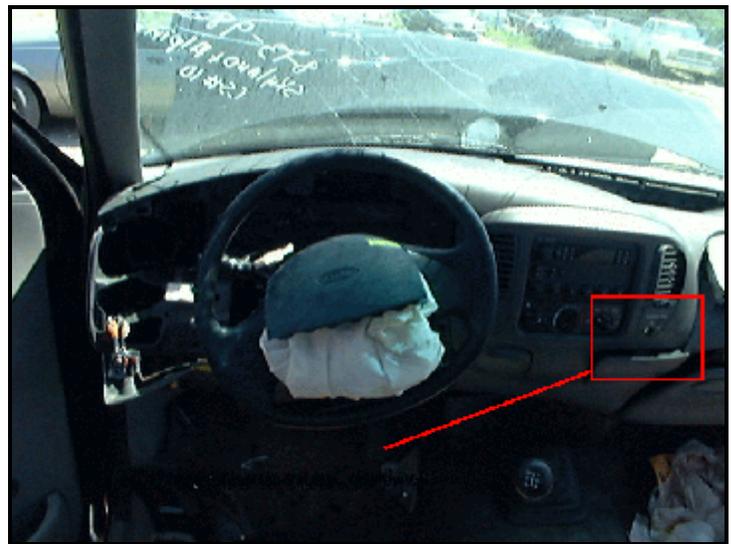
The Ford F150 pickup truck was equipped with a redesigned air bag system which consisted of a crash sensor control module, air bag lamp, and front left and front right air bag modules which housed air bags and depowered inflator units, and a front right air bag shut off switch.

Figure 5. Interior, case vehicle. Box indicates location of air bag shut off switch.

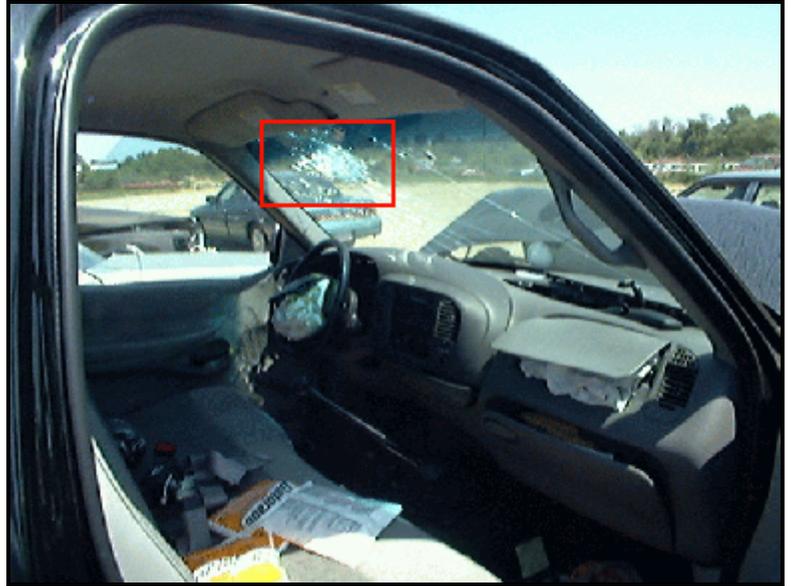
Injury	Injury Severity (AIS)	Injury Mechanism
Concussion	2	Windshield
Bilateral knee abrasions	1	Lower instrument panel
Chest contusion	1	Air bag
Left side rib fracture (9)	1	Lower steering wheel rim

At impact, the unrestrained driver initiated a forward trajectory in response to the frontal impact force. He went forward and engaged the deploying air bag. The driver wrapped around the steering wheel; this motion allowed the driver's upper body to go forward causing his head to come into contact with the windshield—causing the head injury, and allowed the driver's lower left side to come into contact with the lower steering wheel rim—causing the rib fracture and deforming the steering wheel. The driver continued forward and engaged the lower instrument with both knees—causing abrasions to both knees and causing damage to the panel.

Figure 6. Interior, case vehicle. Box shows head contact.
