Remote, Redesigned Air Bag Special Study

Dynamic Science, Inc., Case Number (1998-049-149C)

1998 Ford Contour

September/1998

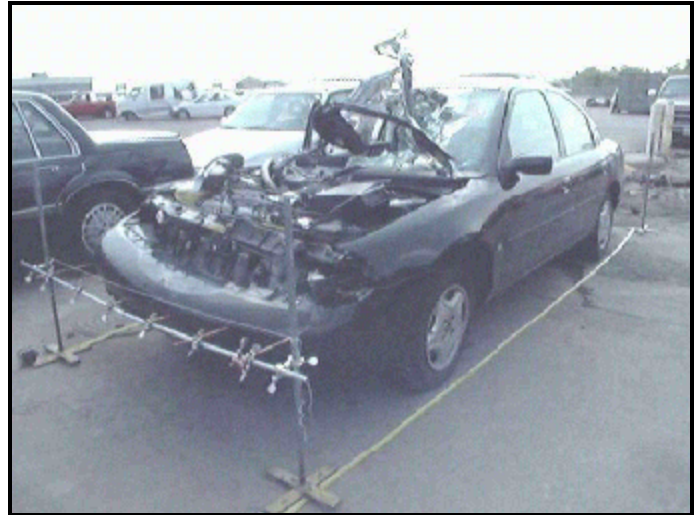
**Figure 1.** Exterior, Vehicle 2 (Ford Contour)

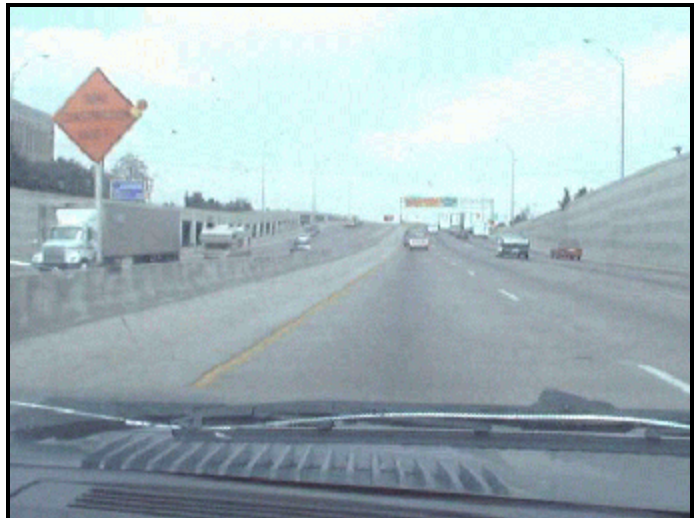
**Figure 2.** Crash scene, point of impact.

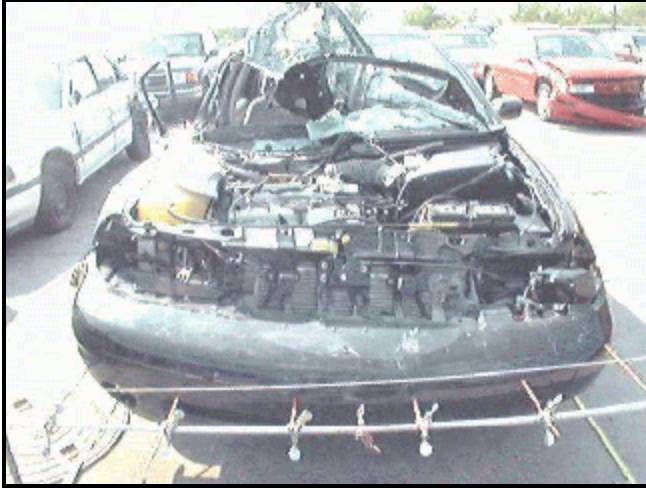
**Figure 3.** Exterior, Vehicle 2 (1998 Ford Contour sedan)

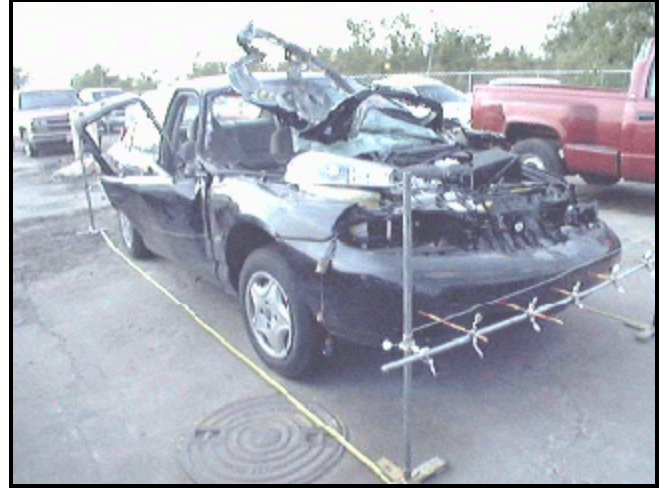
**Figure 4.** Exterior, Vehicle 2 (1998 Ford Contour sedan)

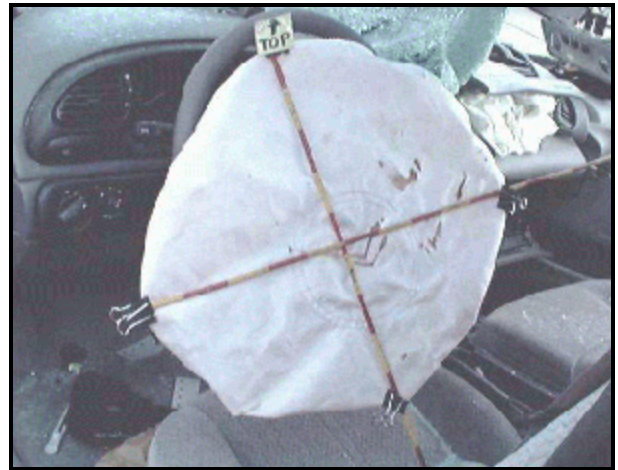
The front left air bag was housed in the steering wheel hub and was concealed by asymmetrical H-configuration cover flaps which were not damaged. The circular air bag was equipped with two tethers and two vent ports. Contact evidence consisting of blood was found primarily on the right side of the front of the bag and on the top cover flap. The bag was not damaged in the crash.

**Figure 5.** Interior, case vehicle. Driver's side air bag.

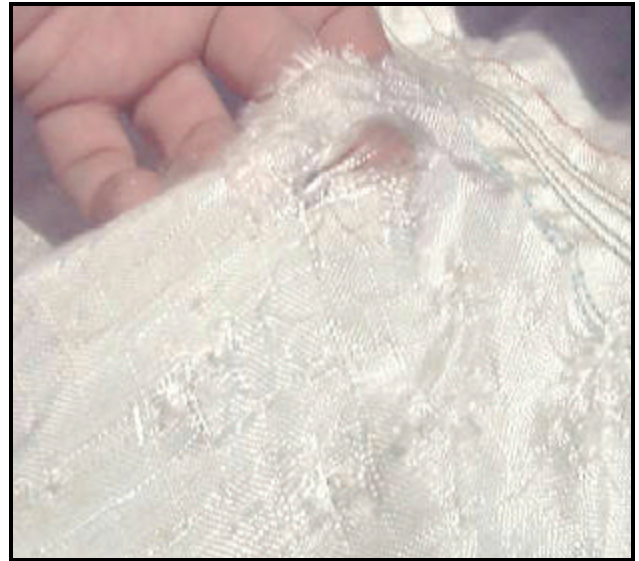
The front right air bag was housed in the mid-instrument panel position. The single air bag cover flap was a rectangular configuration and was not damaged. The rectangular air bag was equipped with one vent port and no tethers. Contact evidence consisting of blood was found on the top half of the front of the bag. The air bag showed many areas of damage consisting of holes and fraying to the top of the bag from contact with the intruded windshield and hood.

**Figure 6.** Interior, case vehicle. Passenger's side air bag damage (holes & fraying).

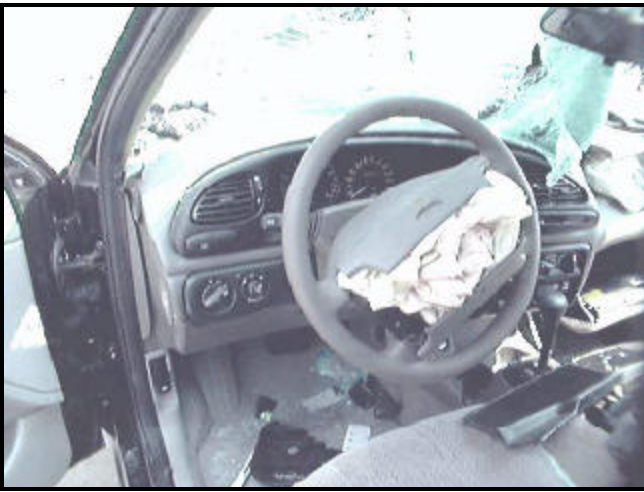
**Figure 7.** Interior, case vehicle. Case occupant 01 position.

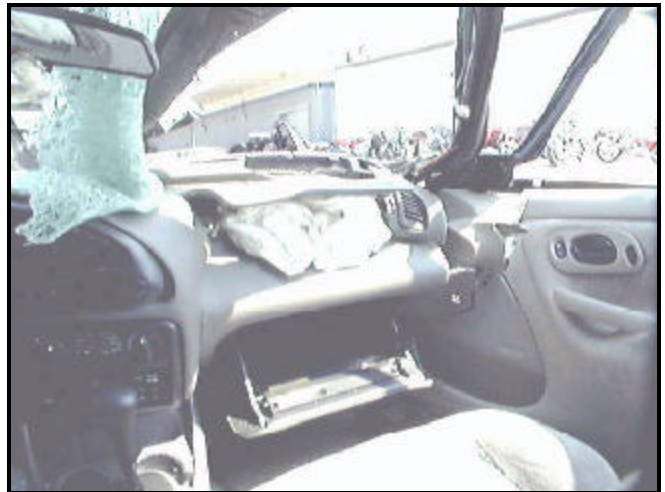
**Figure 8.** Interior, case vehicle. Case occupant 02 position.
