Remote, Redesigned Air Bag Special Study

Dynamic Science, Inc., Case Number (1998-049-206C)

1999 Chevrolet Corvette

December/1998

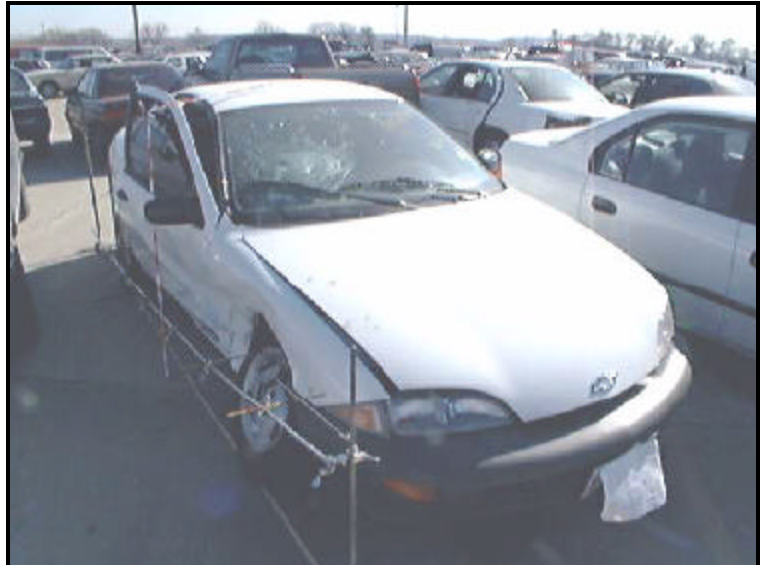
**Figure 1.** Exterior, Vehicle 1 (1997 Chevrolet Cavalier)

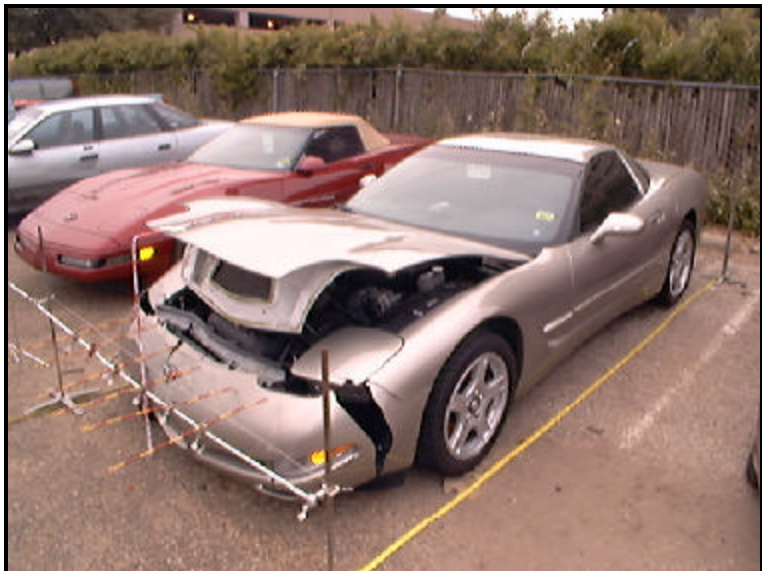
**Figure 2.** Exterior, Vehicle 2 (1999 Chevrolet Corvette)

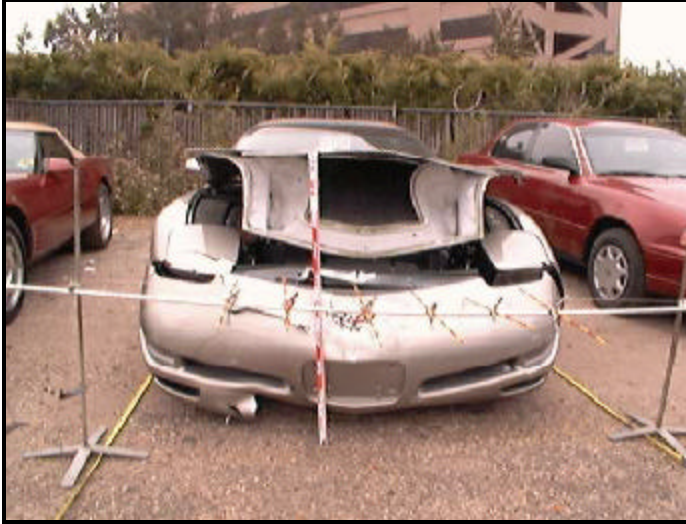
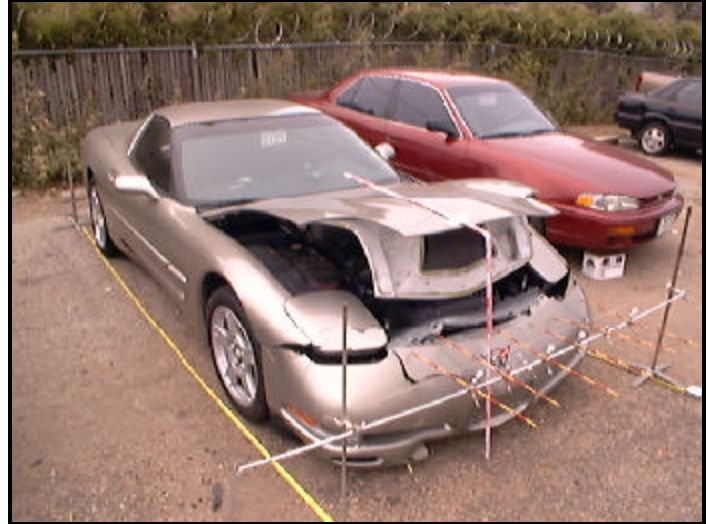
Model year, make and model	1999 Chevrolet Corvette
VIN	1G1YY22G5X5
CDC	11FDEW1

**Figure 4.** Exterior, Vehicle 2 (1999 Chevrolet Corvette)

**Figure 5.** Exterior, Vehicle 2 (1999 Chevrolet Corvette)

Plane of Impact	Field L cm/in.	C1 cm/in.	C2 cm/in.	C3 cm/in.	C4 cm/in.	C5 cm/in.	C6 cm/in.
Bumper	103	8	13	14	19	20	12
	40.6	3.1	5.1	5.5	7.5	7.9	4.7

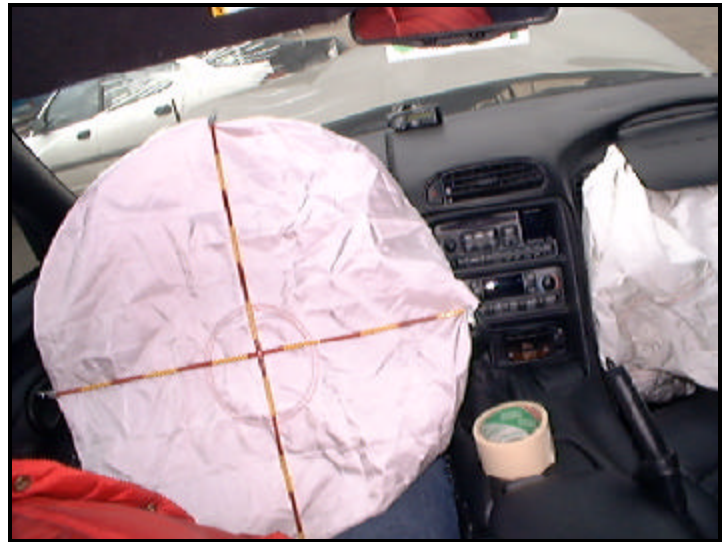
The front left air bag was housed in the steering wheel hub and was concealed by symmetrical I-configuration cover flaps which were not damaged. The circular air bag was equipped with two tether straps and two vent ports. Contact evidence consisting of a small cloth transfer was found on the lower half of the front of the bag from contact with the driver's chest. The air bag was not damaged in the crash.

**Figure 6.** Interior, case vehicle. Driver's side air bag.

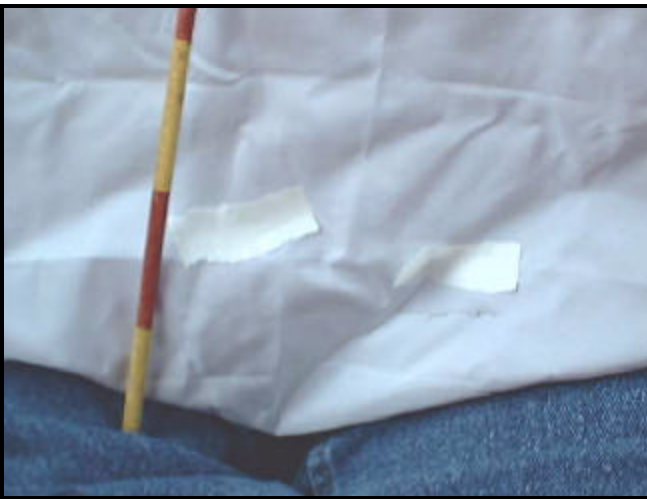
At impact, the driver reacted to the 345 degree principle direction of force by moving forward and slightly left. The driver is believed to have engaged the deploying air bag with his chest-causing no injuries (see figure 7). The driver reported that the force of the deploying air bag propelled his left hand into the windshield-causing the left wrist contusion (see figure 8). No other injuries were sustained by the case occupant. The driver required on-scene medical treatment only for this injury.

**Figure 7.** Interior, case vehicle. Air bag contact.

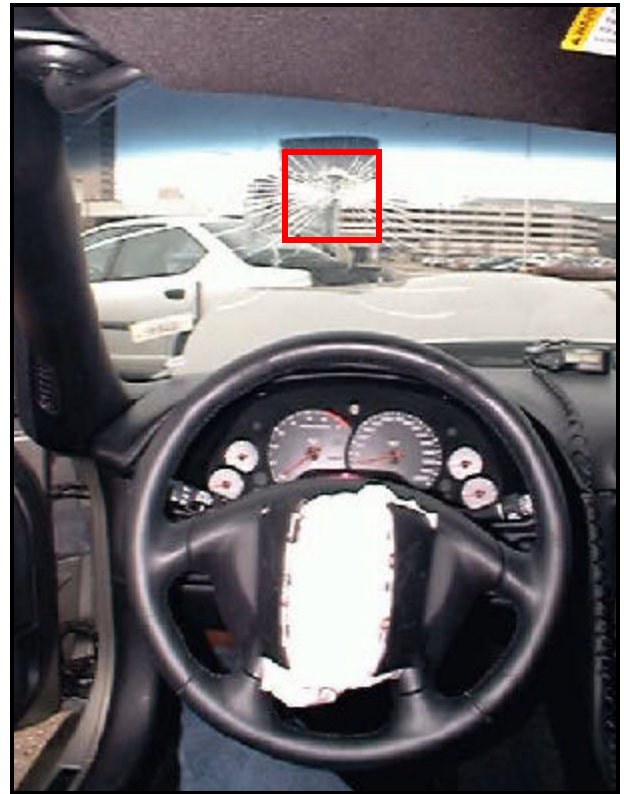
The interior of the Chevrolet Corvette sustained minor damage from occupant contact. There were no areas of intrusion into the passenger compartment. The driver reported that his left wrist contacted the driver side air bag and windshield. A spider web crack was noted on the windshield indicative of occupant contact.

**Figure 8.** Interior, case vehicle. Box shows w/s contact.
