Remote, Redesigned Air Bag Special Study

Dynamic Science, Inc., Case Number (1998-049-810G)

1998 Ford Explorer compact utility vehicle

***Summary***

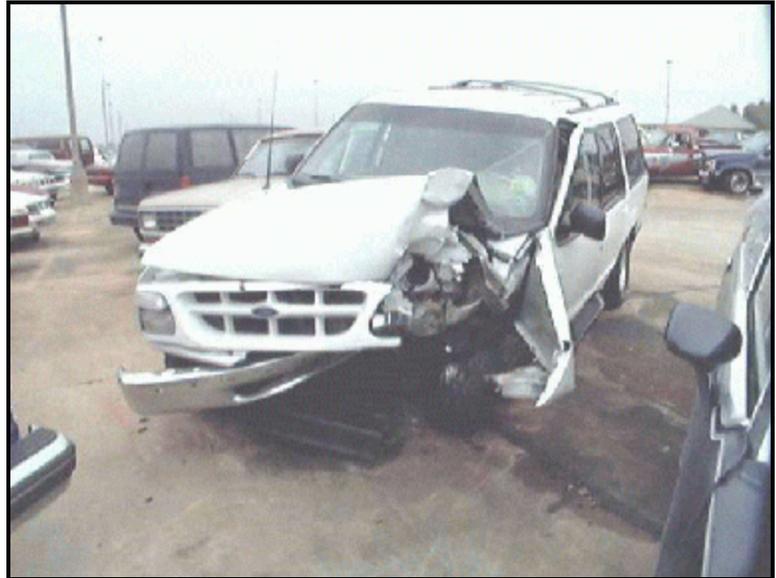
As Vehicle 1 was passing through an uncontrolled intersection, the driver lost control and the vehicle drove up onto the concrete median strip. The front plane of Vehicle 1 then struck the concrete base of a street light pole (12FLEE3). A Delta V was calculated, utilizing WinSMASH, as 48 kmph (30 mph).

**Figure 1.** Exterior, Vehicle 1 (Ford Explorer)

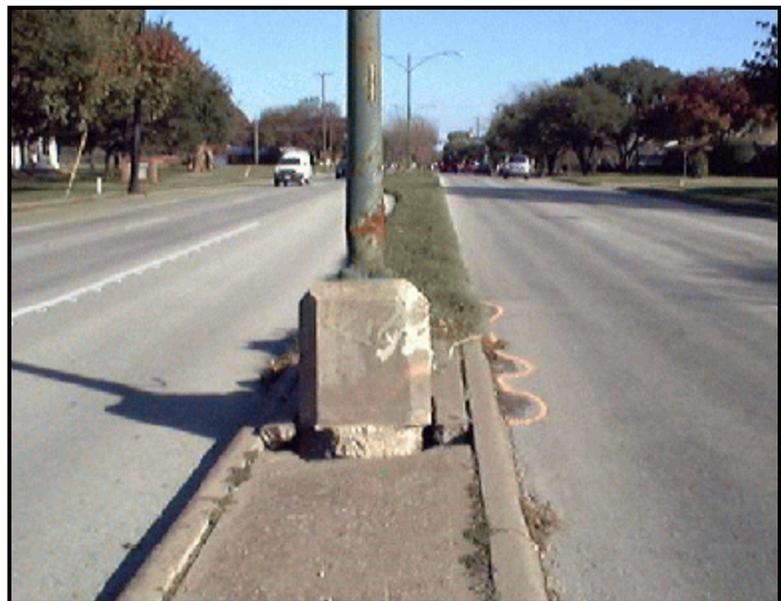
**Figure 2.** Struck light pole

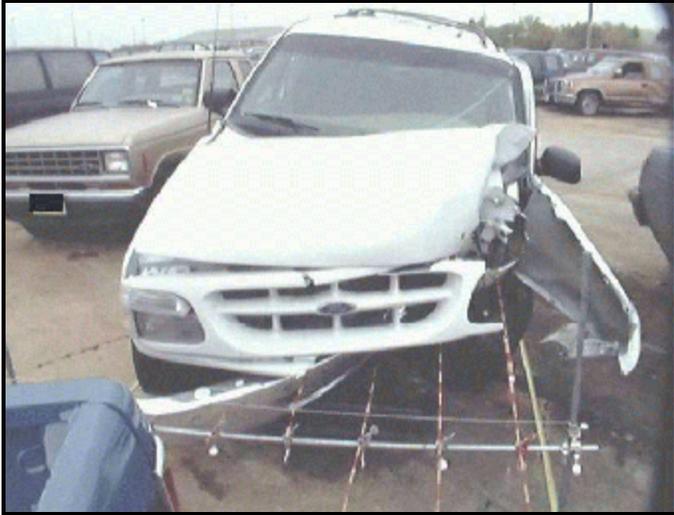
**Figure 3.** Exterior, Vehicle 1 (Ford Explorer SUV)

Plane of Impact	Field L cm/in.	C1 cm/in.	C2 cm/in.	C3 cm/in.	C4 cm/in.	C5 cm/in.	C6 cm/in.
Bumper	109	77	66	44	21	4	0
	42.9	30.3	26	17.3	8.3	1.6	0

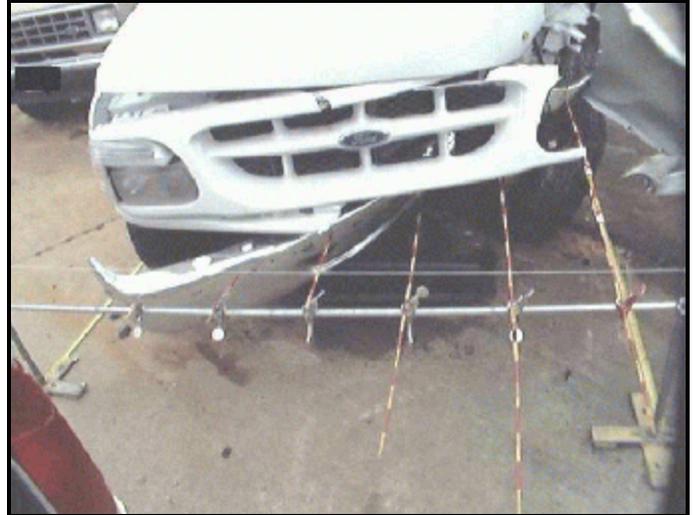
**Figure 4.** Exterior, Vehicle 1 (Ford Explorer SUV)

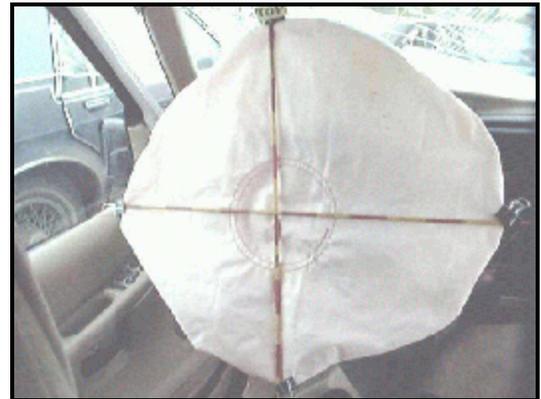
The front left air bag was housed in the steering wheel hub and was concealed by asymmetrical H-configuration cover flaps. The circular air bag was equipped with two tethers and two vent ports. Contact evidence consisting of blood was found on the upper right and lower left quadrants of the front of the bag from contact with the driver's face. A small thermal burn was discovered on the back/left of the bag measuring approximately 2.5 cm (1 in). The air bag flaps were not damaged.

**Figure 5.** Interior, case vehicle. Driver's side air bag

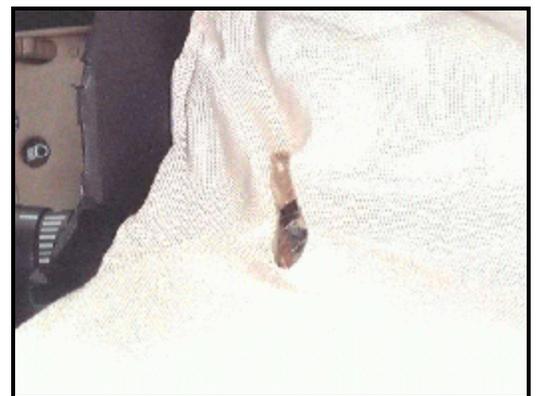
**Figure 6.** Interior, case vehicle. Driver's side air bag thermal burn

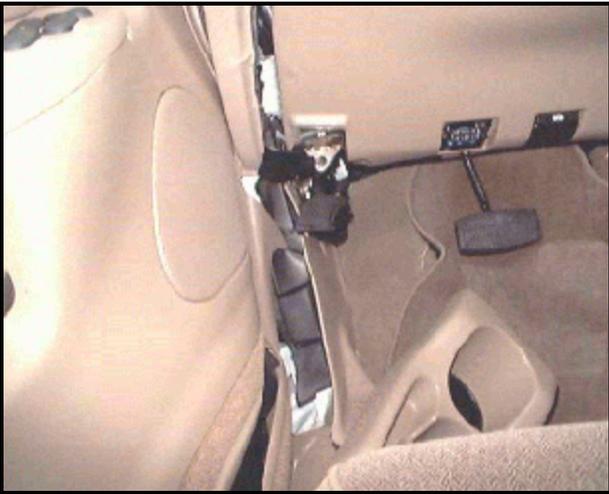
At impact, the case occupant reacted to the 360 degree principle direction of force by moving sharply forward and loading the lap/shoulder restraint. As the restraints locked, further frontal movement of the occupant was prevented. The driver had moved far enough forward to impact the left instrument panel with his left knee. The mirror had been pushed out of place and blood appeared on the left side interior surface and seat belt webbing. The driver also engaged the deploying driver's side air bag. Blood was found on the front of the bag from contact with the driver's face. The case occupant was treated at the scene for his injuries and was released without being transported. The nature and severity of his injuries are not known.

**Figure 7.** Interior, case vehicle. Occupant contact to left instrument panel.

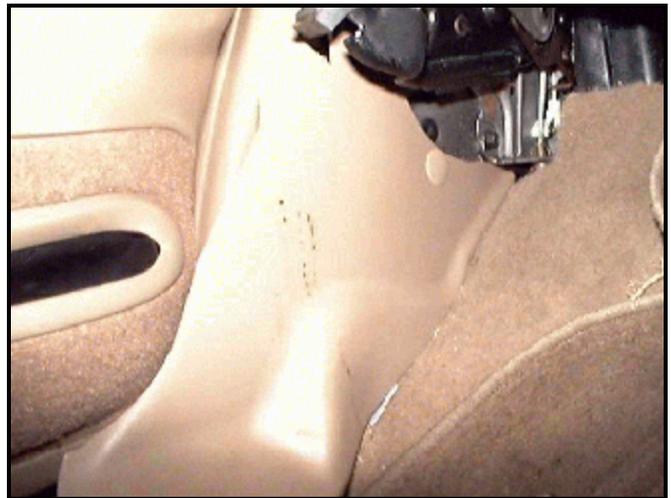
The interior of the Ford Explorer sustained moderate damage from intrusion and occupant contact. There was a moderate amount of intrusion of the left toe pan, left side panel, and roof. The steering assembly and rear seats also shifted during the crash. The intruded values are reported in Table 4. There was occupant contact damage to the left instrument panel, left side interior surface, rearview mirror and driver's side air bag.

**Figure 8.** Interior, case vehicle. Occupant contact to left side interior surface.
