**VERIDIAN REMOTE REDESIGNED AIR BAG DEPLOYMENT
INVESTIGATION
SCI TECHNICAL SUMMARY REPORT**

NASS/SCI COMBO CASE NO. 1998-72-013C

VEHICLE - 1998 PONTIAC SUNFIRE

LOCATION - STATE OF ILLINOIS

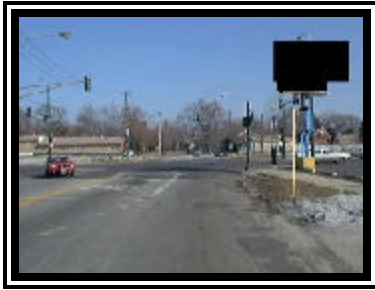
The 69 year old male driver of the 1997 Mercury Grand Marquis was operating the vehicle eastbound (**Figure 1**) when he failed to observe the red overhead traffic signal as he proceeded straight through the urban 4-leg intersection. The 54 year old female driver of the 1998 Pontiac Sunfire was operating the vehicle northbound (**Figure 2**) when she observed the eastbound Mercury cross her path of travel. No pre-impact brake marks were documented at the scene indicative of driver avoidance maneuvers.

Figure 1. Eastbound approach for the 1997 Mercury Grand Marquis.

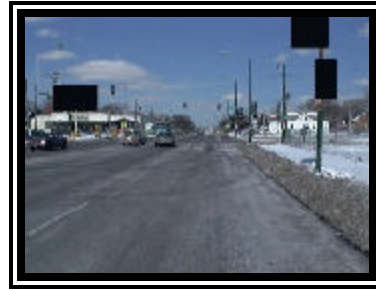
Figure 2. Northbound approach for the 1998 Pontiac Sunfire.

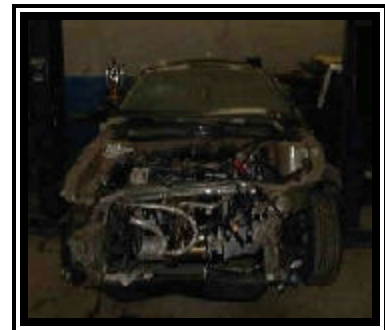
The 1998 Pontiac Sunfire sustained moderate frontal damage as a result of the impact with the Mercury Grand Marquis (**Figure 3**). No

Figure 3. Front end repairs to the 1998 Pontiac Sunfire.

crush data was obtained as the vehicle was under repair at the time of inspection, however, visual observation of the damage revealed approximately 17.0 cm (6.7 in) of end shifting to the right which necessitated incrementation of the principal direction of force. The *estimated* Collision Deformation Classification (CDC) for this impact to the Pontiac was 70-FDEW-2 with a direction of force of (-)60 degrees. The bumper assembly, hood, and fenders were removed with no apparent induced damage to the door structures. The windshield was fractured from exterior impact forces and possibly the front right passenger air bag flap.

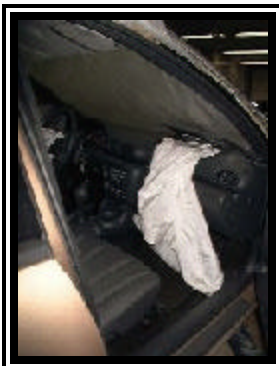
Figure 6. 1998 Pontiac Sunfire redesigned passenger air bag.

The front right passenger air bag deployed from the right top instrument panel area with a single cover flap design hinged at the forward aspect (**Figure 6**). No contact evidence was identified on the air bag or exterior

surface of the module cover flap. The cover flap was rectangular in shape and measured 31.0 cm (12.2 in) in width and 13.0 cm (5.1 in) in height. The NASS researcher measured the passenger air bag at 40.0 cm (15.7 in) in width and 60.0 cm (23.6 in) in height in its deflated state. The bag was tethered by two internal straps. No vent ports or cutoff switch was reported for the front right passenger air bag.

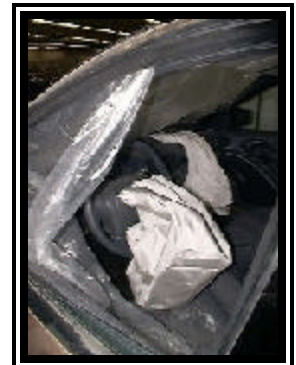
cm (7.9 in) in width and 7.0 cm (2.8 in) in height. The NASS researcher measured the diameter of the driver air bag at 44.0 cm (17.3 in) in its deflated state (**Figure 5**). The bag was tethered by two internal straps and vented by two ports located at the 10 o'clock and 2 o'clock sectors on the rear aspect of the air bag.

Figure 5. 1998 Pontiac Sunfire redesigned driver air bag.
