Remote, Redesigned Air Bag Special Study

Dynamic Science, Inc., Case Number (1998-073-111J)

1998 Dodge Caravan

September/1998

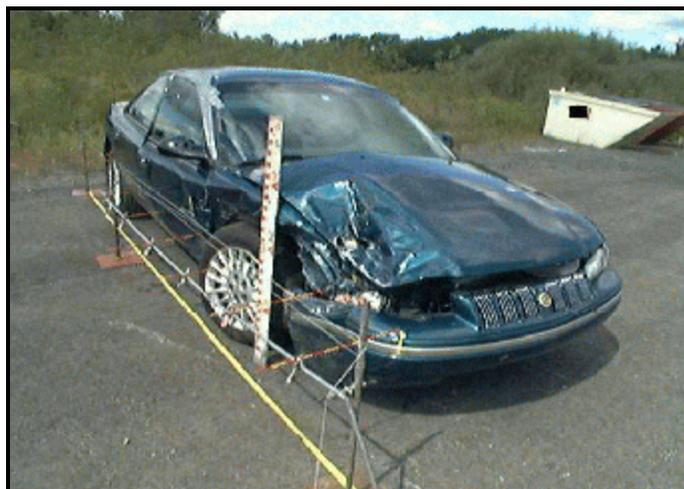
Figure 1. Exterior, Vehicle 1 (Chrysler Concorde)

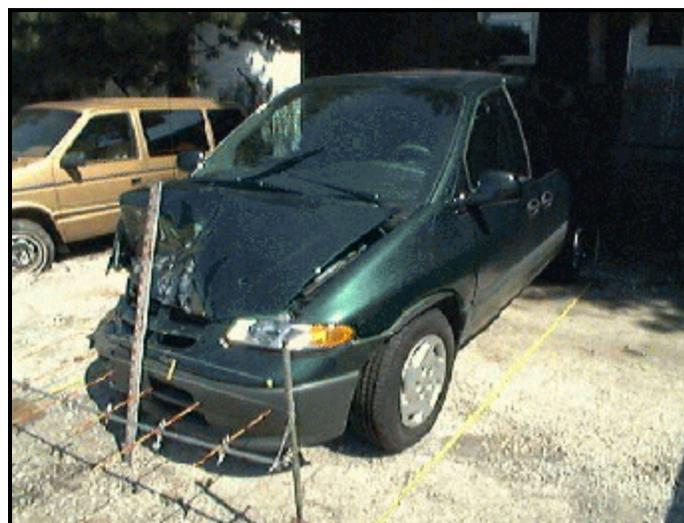
Figure 2. Exterior, Vehicle 2 (Dodge Caravan)

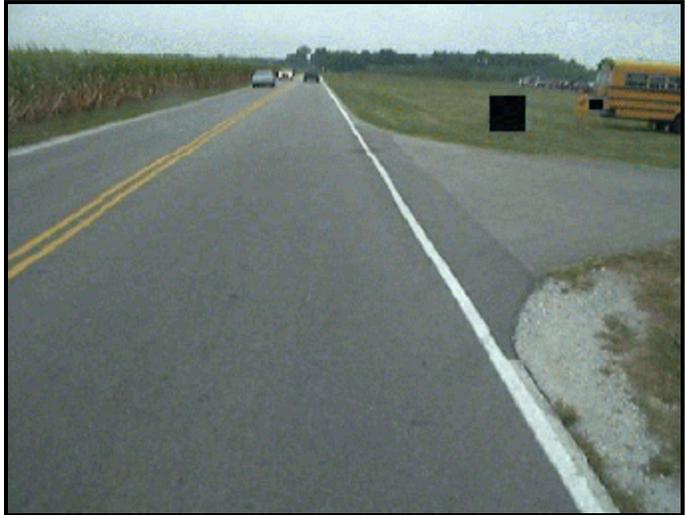
Figure 3. Crash scene, Vehicle 2 approach to impact.

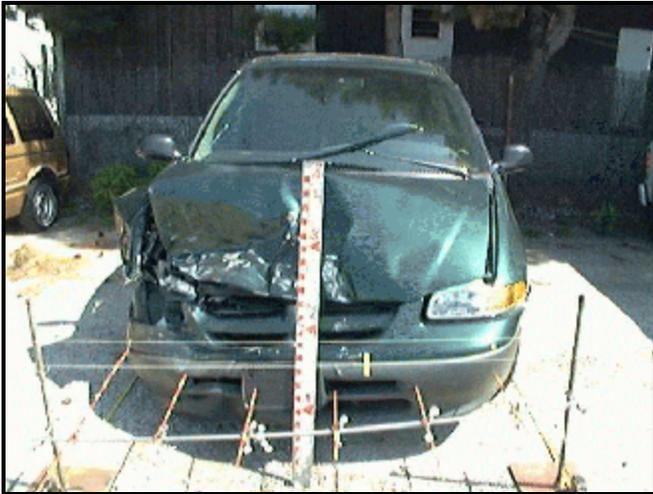
Figure 4. Exterior, Vehicle 2 (1998 Dodge Caravan)

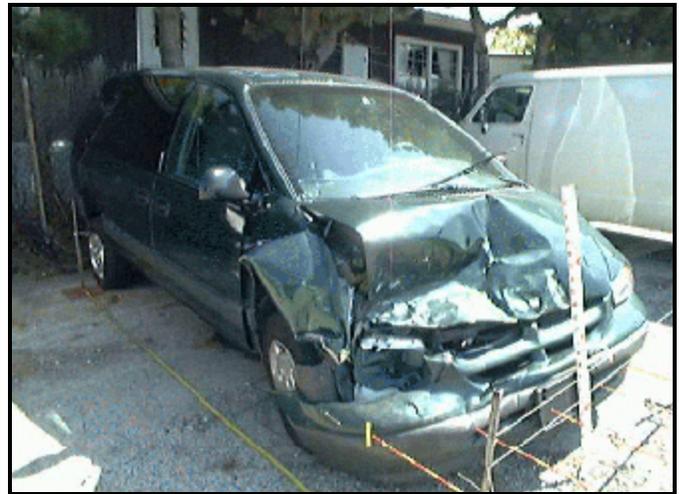
Figure 5. Exterior, Vehicle 2 (1998 Dodge Caravan)

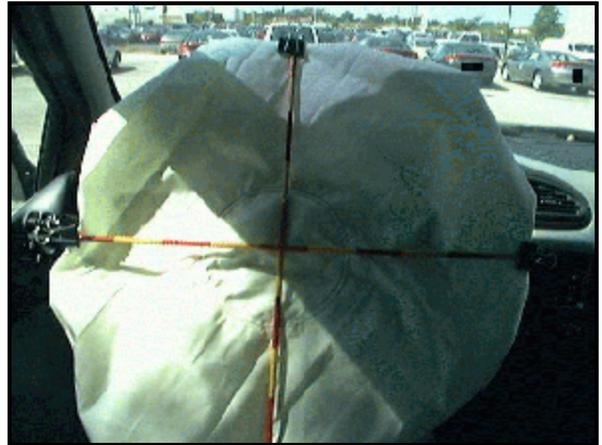
The front left air bag was housed in the steering wheel hub and was concealed by a single rectangular shaped cover flap which was not damaged. The circular air bag was equipped with two tether straps and no vent ports. The bag was not damaged in the crash.

Figure 6. Interior, case vehicle. Driver side air bag.

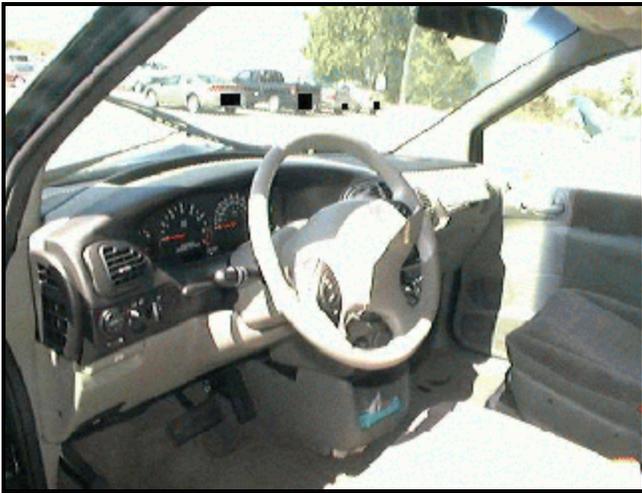
Figure 7. Interior, case vehicle

The interior of the Dodge Caravan sustained minor damage from passenger compartment intrusion. There was a moderate amount of intrusion of the toe pan on the right side of the vehicle. The intruded values are reported in Table 4. There was occupant contact evidence to the driver side air bag only.
