Remote, Redesigned Air Bag Special Study

Dynamic Science, Inc., Case Number (1998-74-805E)

1998 Honda Civic

November/1998

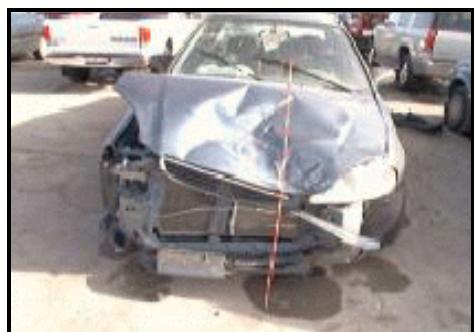
**Figure 3.** Exterior, Vehicle 1 (Honda)

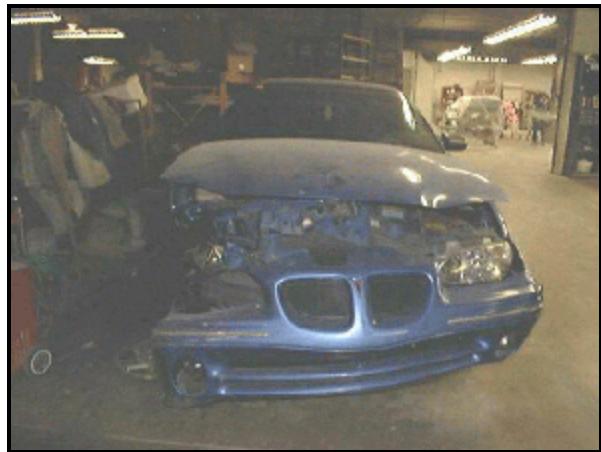
**Figure 4.** Exterior, Vehicle 2

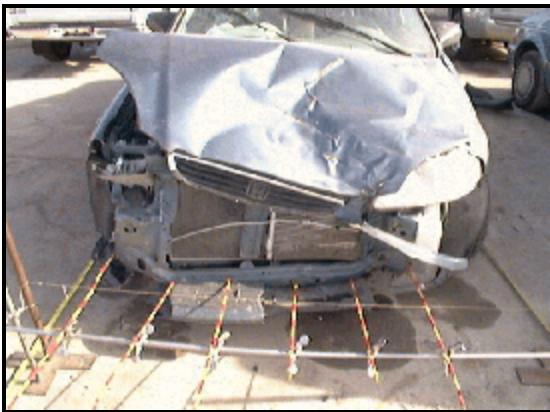
Plane of Impact	Field L cm/in.	C1 cm/in.	C2 cm/in.	C3 cm/in.	C4 cm/in.	C5 cm/in.	C6 cm/in.
Front Bumper	108	3	11	14	12	7	3
	42.5	1.2	4.3	5.5	4.7	2.8	1.2

**Figure 5.** Front view of damage

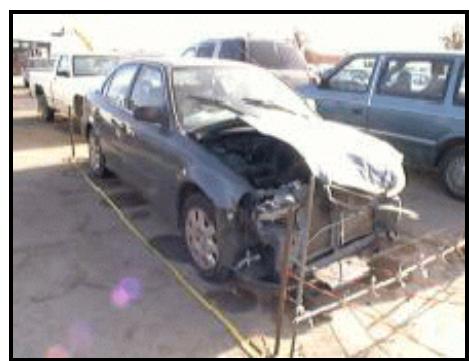
**Figure 6.** Three-quarter view of frontal damage

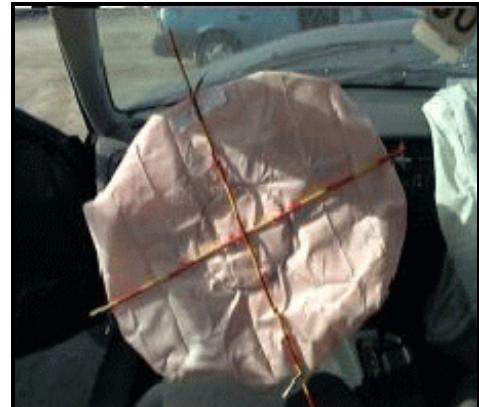
**Figure 7.** Driver's front air bag

The drivers air bag is housed in the steering wheel hub and encases the nylon air bag unit. The double, horizontal, module cover flaps are asymmetric in design and opened at their designated tear points. The circular air bag is 63 cm (24.8 in.) in diameter and is equipped with two tether straps and two exhaust vent port holes. The vent ports are located at the 11 and 1 o'clock positions respectively. The rigid plastic knee bolster was undamaged and did not reveal any detectable occupant contacts.

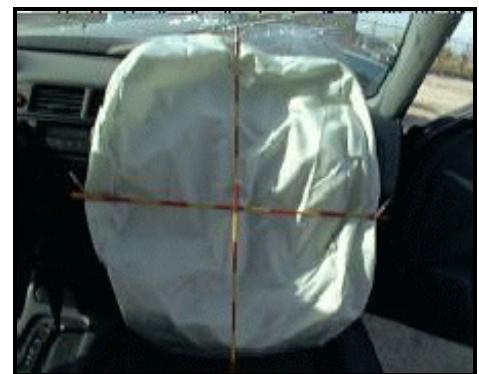
**Figure 8.** Passenger front air bag

The front, right passenger air bag is located on the instrument panel (top mount). The module deployment door is rectangular in shape and is equipped with double horizontal cover flaps that are symmetrical in design (23 cm wide x 5 cm in height). Upon deployment, the encased air bag fully deployed. The non-tethered air bag was undamaged and was equipped with two vent port holes which are at the 9 and 3 o'clock positions.

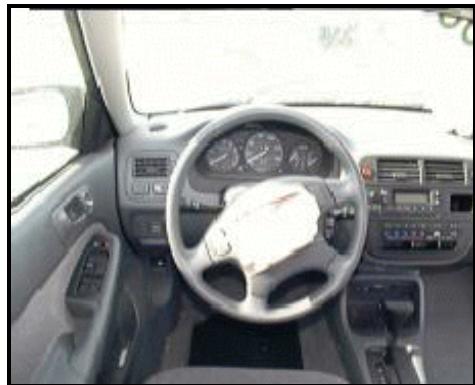
She responded to the 11 o'clock direction of force by moving forward and to the left. She loaded the applied lap and shoulder belt webbing which prohibited extended movement of her upper and lower torso. The driver's right knee contacted the hard plastic knee bolster which resulted in a contusion (AIS-1). As the vehicle rotated in a clockwise direction, the left side of her scalp impacted the left window frame area. This contact was not confirmed by occupant contact evidence, but resulted in a left parietal scalp contusion (AIS-1) and a cervical strain (AIS-1). She rebounded back into the seat back support and remained in her respective seated position.

**Figure 9.** Driver's seated position
