Remote, Redesigned Air Bag Special Study

Dynamic Science, Inc., Case Number (1998-076-801G)

1998 Nissan Altima

August/1998

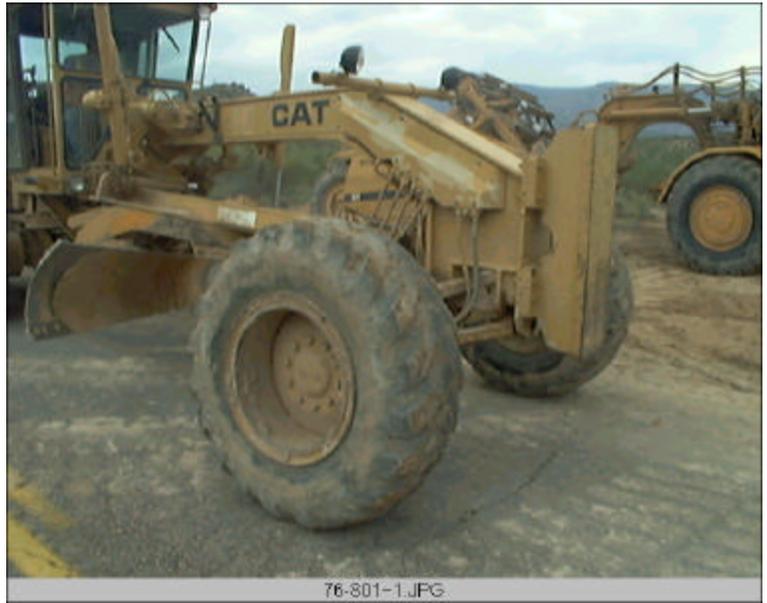
Figure 1. Exterior, Vehicle 1 (CAT Road Grader)

Vehicle 1 was not damaged in the crash and did not need to be towed.

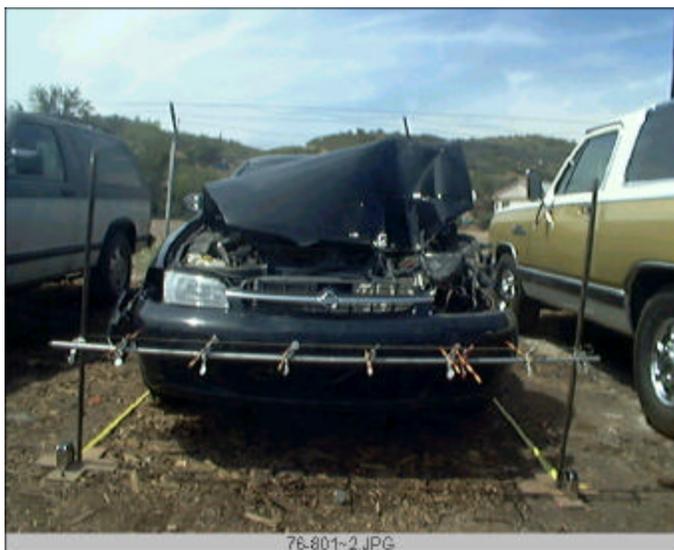
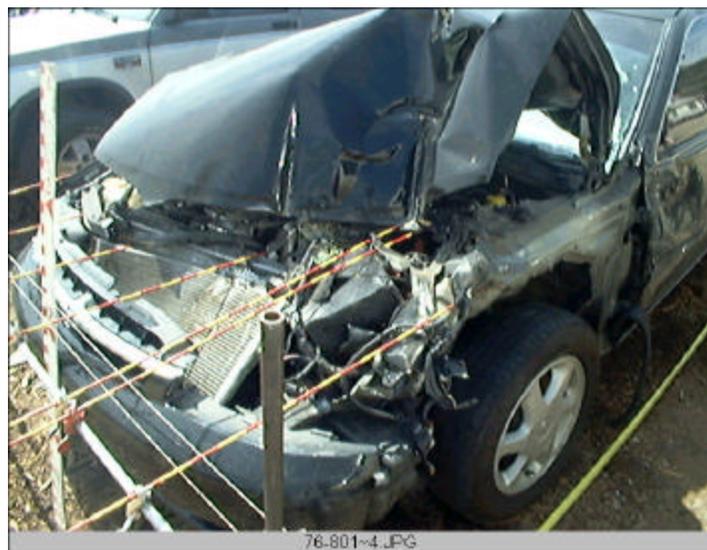
As Vehicle 2 was approaching, the driver of Vehicle 1 attempted a U-turn from the east road side onto the southbound travel lane. The driver of Vehicle 2 applied the brakes, which locked-up, and slid into Vehicle 1. The front plane of Vehicle 2 (12FYEW3) impacted the front plane of Vehicle 1 (unknown CDC) in the southbound travel lane.

Vehicle 2 sustained heavy damage to the hood and engine area, and was towed from the scene due to damage.

Figure 3. Exterior, Vehicle 2 (1998 Nissan Altima)

Figure 4. Exterior, Vehicle 2 (1998 Nissan Altima)

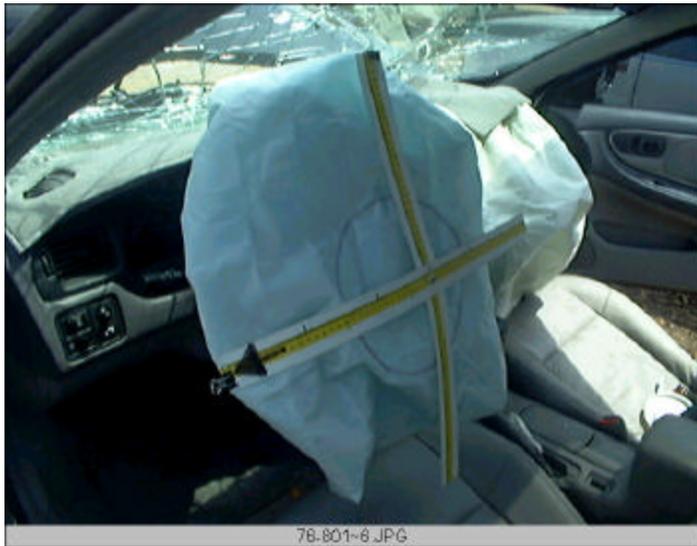
The front-left air bag was housed in the steering wheel hub and was concealed by asymmetrical H-configuration cover flaps. The circular air bag was equipped with two tethers and two vent ports. A small skin transfer was found on the air bag.

Figure 5. Interior, Vehicle 2 - Driver side air bag

At impact, the occupants were prevented from any further frontal movement by the locked lap/shoulder restraints. It does appear, however, that the driver (occupant 01) had moved far enough forward to engage the deploying air bag- producing a small skin transfer on the bag. At this point his right knee struck the knee bolster-causing the knee contusion and damaging the knee bolster. There was no evidence of contact with the passenger side air bag by occupant 02. It appears that the cervical strains sustained by case occupants 02, 03, and 04 were caused by the force of the impact, rather than contact with any component of the vehicle's interior.

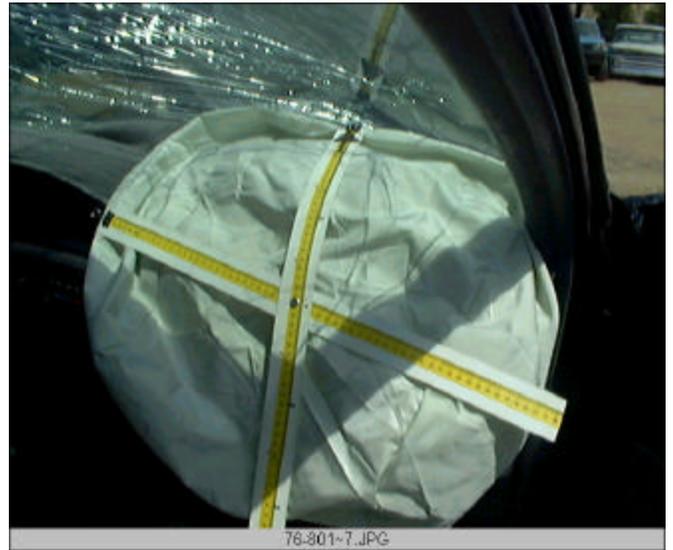
Figure 6. Interior, Vehicle 2 - Passenger side air bag

equipped with tethers but contained one vent port. There were no indications of damage or contact to either the air bag or the module cover.

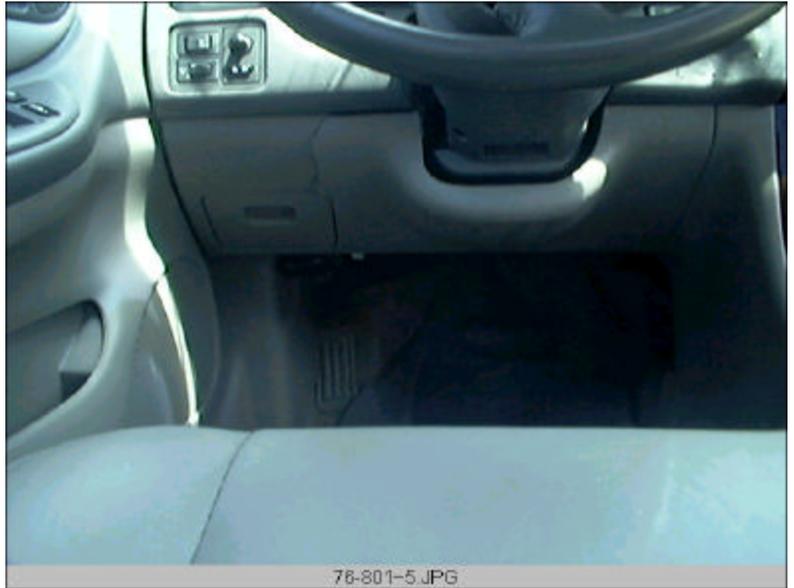
The interior of the Nissan Altima sustained minor damage from intrusion and occupant contact. There was a minimal amount of intrusion of the windshield in the left and center positions. The intruded values are reported in Table 4. There was occupant contact damage to the knee bolster and driver's side air bag.

| Occupant # | Injury | Injury Severity (AIS) | Injury Mechanism |
|---|---|---|---|
| 1 | Right knee contusion | 1 | Knee bolster |

Figure 7. Interior, Vehicle 2 - Area of contact, occupant 01
