Remote, Redesigned Air Bag Special Study

Dynamic Science, Inc., Case Number (1998-082-801E)

1998 Mercury Tracer

Washington

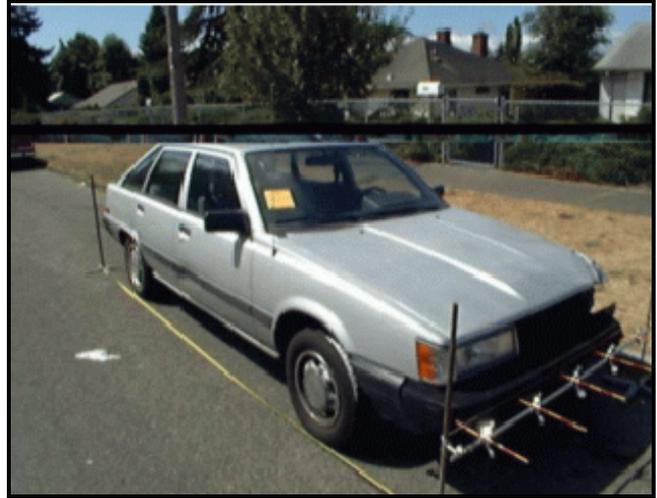
Figure 1. Exterior, Vehicle 1 (Toyota Camry)

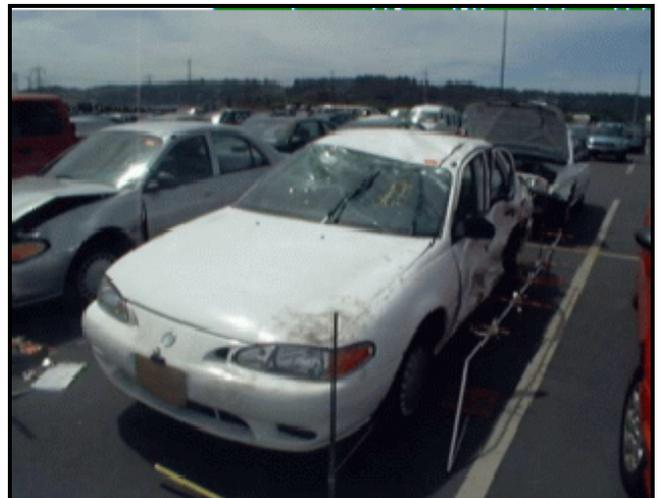
Figure 2. Exterior, Vehicle 2 (Mercury Tracer)

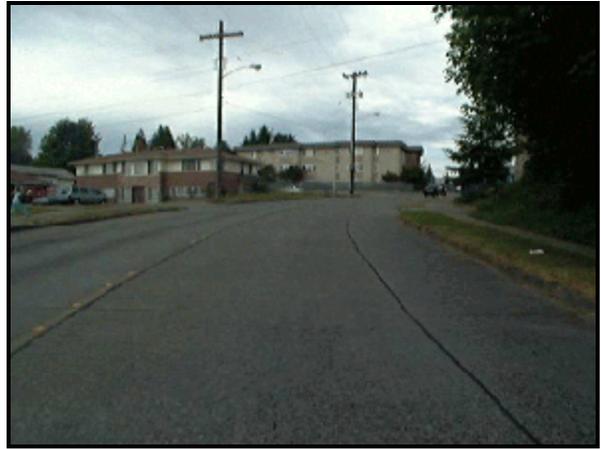
As Vehicle 1 approached Vehicle 2, it drifted over the double yellow painted line and entered the northbound travel lane. The front plane (12FLEE3) of Vehicle 1 struck the left plane (11LZEW3) of Vehicle 2 in the northbound lane (event 1). This impact caused Vehicle 1 to strike the right curb with the right wheels (event 2) causing rim damage to the right rear wheel (01RBWN3). Vehicle 2 then continued onto the sidewalk where it rolled over two quarter turns to the right (event 3) and came to rest on the roof (00TDDO3).

Figure 3. Crash scene, Vehicle 1 approach path

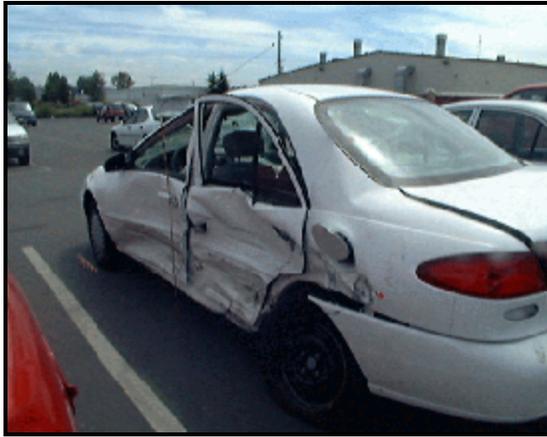
Figure 4. Exterior, Vehicle 2 (1998 Mercury Tracer)

Plane of Impact	Field L cm/in.	C1 cm/in.	C2 cm/in.	C3 cm/in.	C4 cm/in.	C5 cm/in.	C6 cm/in.
Mid-door	246	0	12	13	7	11	0
	96.9	0	4.7	5.1	2.8	4.3	0

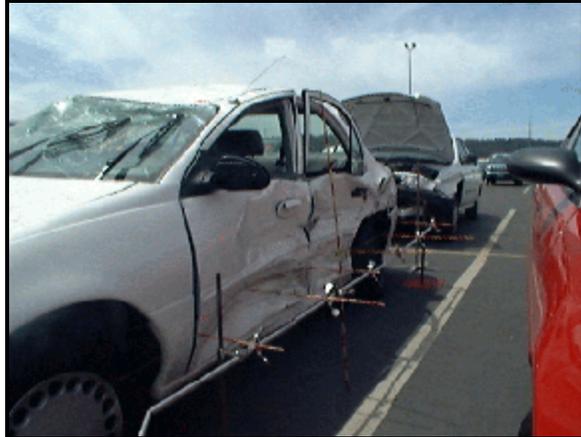
Figure 5. Exterior, Vehicle 2 (1998 Mercury Tracer)

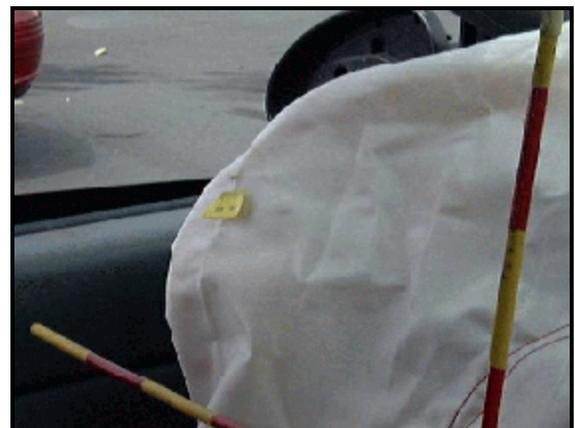
The front left air bag was housed in the steering wheel hub and was concealed by asymmetrical H-configuration cover flaps which were not damaged in the crash. The circular air bag was equipped with four tether straps and two vent ports. Contact evidence consisting of “black smears” and blood spots was found on the front of the bag. A small tear was also found on the upper left quadrant of the front of the bag possibly as a result of contact with glass from the

Figure 6. Driver's air bag damage

front left glazing.

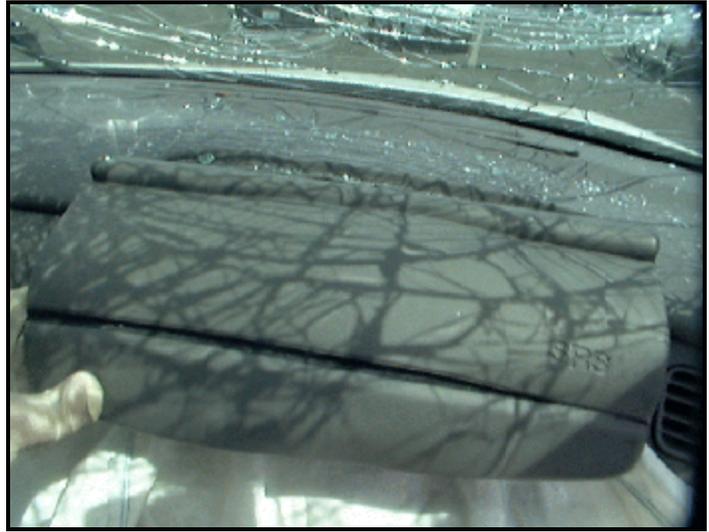
The front right air bag was housed in the mid-instrument panel position and was concealed by a rectangular cover flap. The flap had partially split horizontally along a seam as the bag deployed, but did not become detached. The rectangular air bag was equipped with no tether straps and two vent ports. Contact evidence consisting of two blood spots was found on the front of the air bag. The bag was not damaged in the crash.

Figure 7. Passenger's air bag cover flap damage

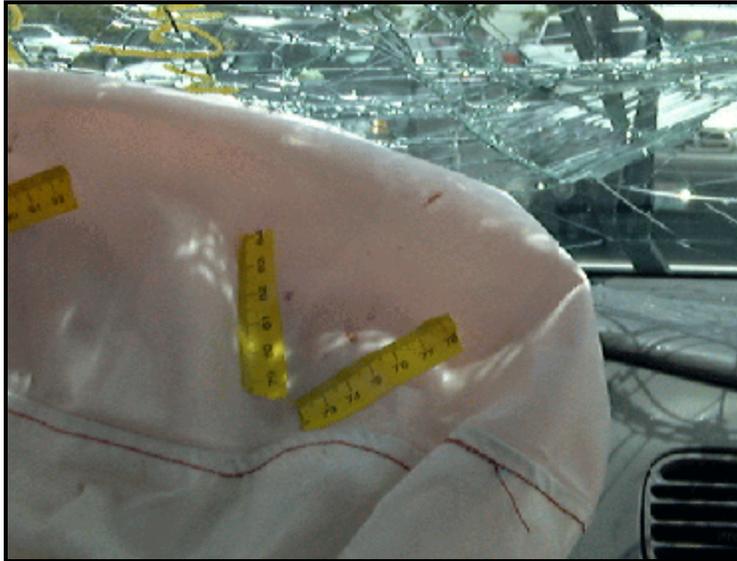
Figure 8. Driver's air bag contact evidence

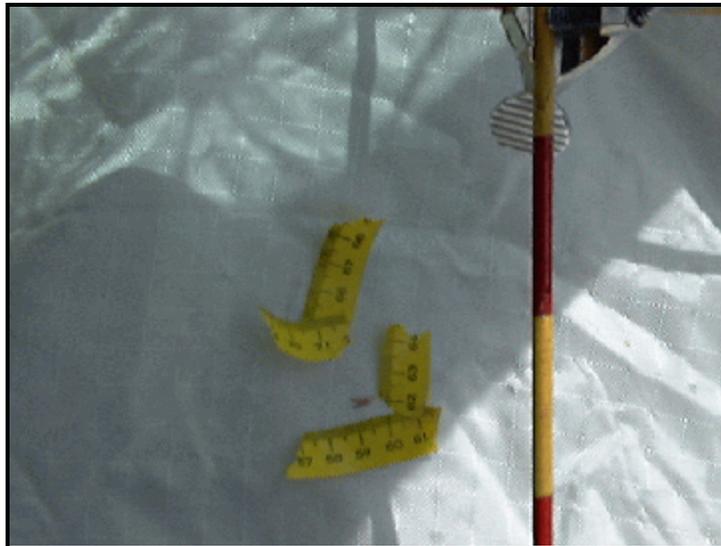
Figure 9. Passenger's air bag contact evidence
