Special Crash Investigation Air Bag Investigation
On-scene Investigation / Vehicle vs Tree
Dynamic Science, Inc. / Case Number: DS98002
1994 Ford Taurus GL 4-door Station Wagon
Washington
December, 1997

Dynamic Science, Inc.
Accident Investigation
Case Number: DS98002

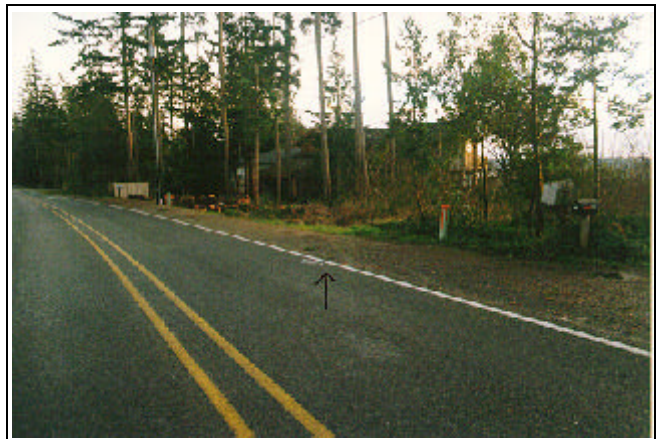
The collision took place on a residential, north/south oriented, two lane undivided, level, asphalt roadway (see Figure 1). Just prior to the area of the collision, the roadway begins to curve slightly to the left. Both sides of the roadway are bordered by dirt and gravel shoulders. It was dusk and there were no street lights. There were no traffic controls present, and the posted speed limit was 81 km/h (50 mph).

Figure 1. Police photograph of scene.

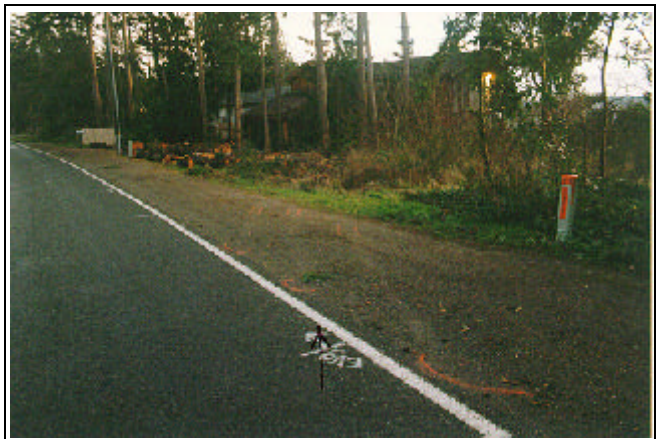
Vehicle 1, a 1994 Ford Taurus GL 4-door station wagon driven by an 86-year-old male (178 cm / 70 in, 73 kg / 160 lb¹), was traveling southbound at a police reported speed of 64-81 km/h (40-50 mph). For an unknown reason, the driver of Vehicle 1 failed to negotiate the left curve and drove off the right roadway edge. Vehicle 1 traveled approximately 15.2 m (50 ft) off the road and into a vacant lot before colliding head on into a 34 cm (13.4 in) diameter fir tree (see Figures 1-3). The police

Figure 2. Police photograph of scene towards impact.

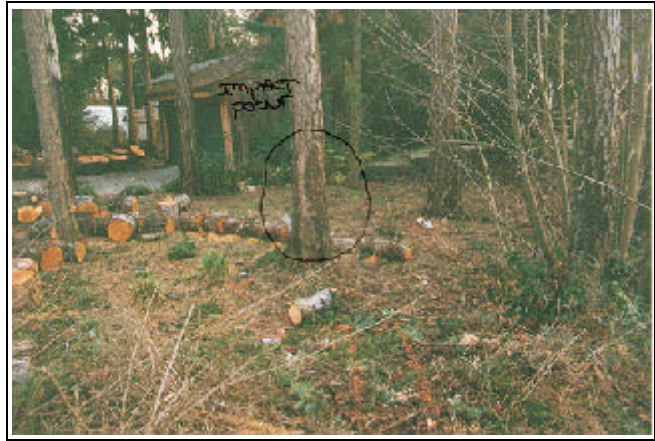
noted that no skid marks were present on the roadway, but there was 15.2 m (50 ft) of tire impression left on the hard packed dirt shoulder. On impact with the tree, the driver's and front right passenger's air bags deployed. Vehicle 1 came to final rest heading south-west in contact with the tree. The driver was conscious at the scene, and when he was interviewed by the investigating police officer, the driver stated that he did not know why he left the roadway.

Figure 3. Police photo of tree.

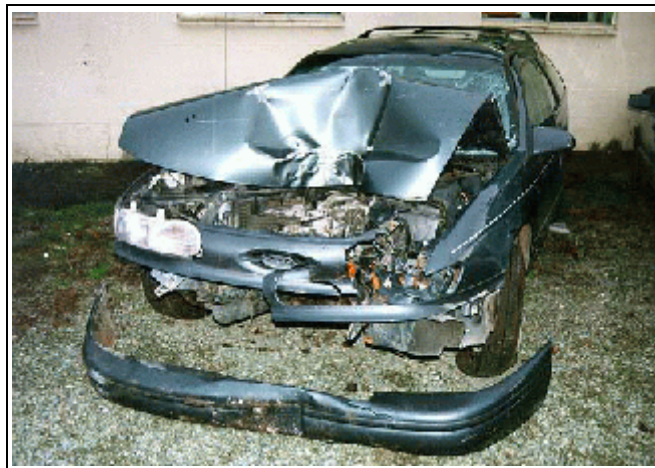
Vehicle 1 sustained severe damage to the entire front end (see Figure 4). A CDC of 12FYEN2 with a 0 degree PDOF was assigned to the damage. Maximum crush was measured at C³ and equaled 43.5 cm (17.1 in). The barrier portion of the WinSmash² algorithm computed a total Delta-V of 29.1 km/h (18.1 mph), a longitudinal Delta-V of -29.1 km/h (-18.1 mph), and a lateral Delta V of 0. The results fit the collision model and appear reasonable. Vehicle 1 was towed from the scene due to damage.

Figure 4. Frontal damage to vehicle.

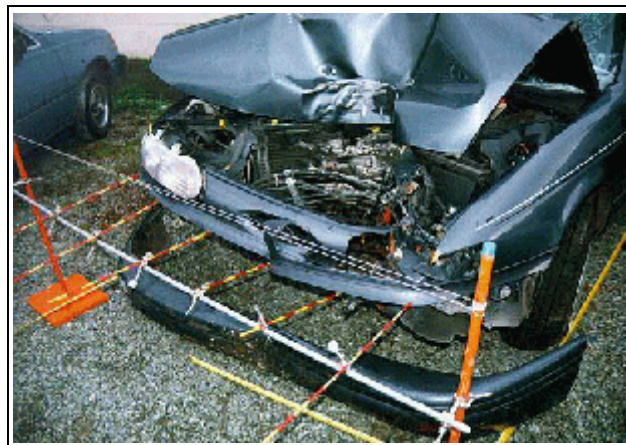
| Damage Description: | Major-total front end damage, hood, grille area, front right fender, and windshield. The roof top buckled. The left front tire was flat and restricted. The front axle was damaged, and the steering linkage broke free. | |

Figure 6. Exterior damage.

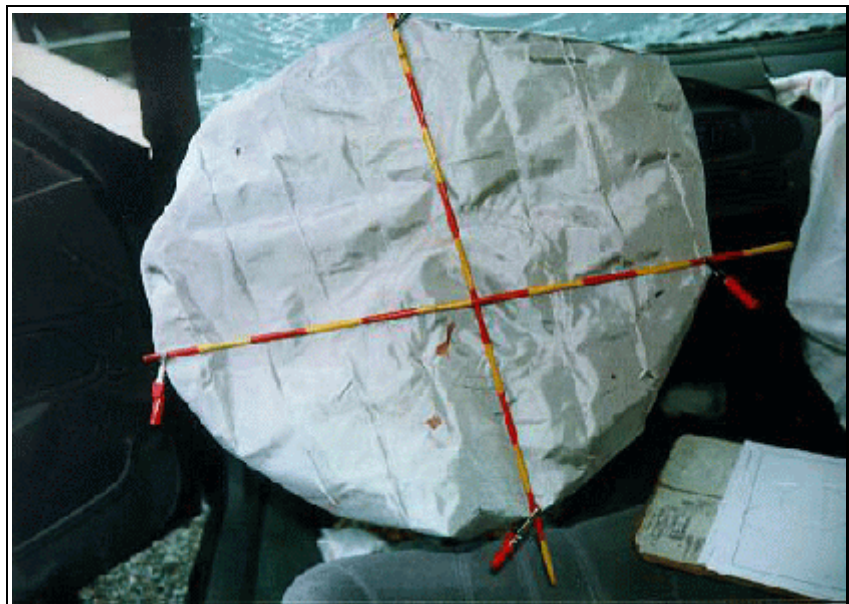
Vehicle 1 was equipped with a driver's air bag and top-mounted front right passenger's air bag. The steering wheel hub mounted driver's air bag was circular and measured 51 cm (20 in) in diameter. It had two tethers and two rear vent ports at the 11 and 01 o'clock positions, and there were seven vertical folds. The air bag had a maximum excursion of 30 cm (11.8 in). There were black linear smudges along the back top part of the air bag near the left vent port, these linear smudges are consistent with contact with the module covers as the air bag unfolds. There driver's air bag was burned near the left vent port by the exhaust gases. The dual module covers opened in a typical "H" configuration, and the upper and lower module covers were not deformed nor damaged. There was blood splattered about the lower left face of the driver's air bag as well as the back top and lower right areas. These blood spots are attributed to the lacerations to the head and right hand of the driver.

Figure 7. Driver's air bag.

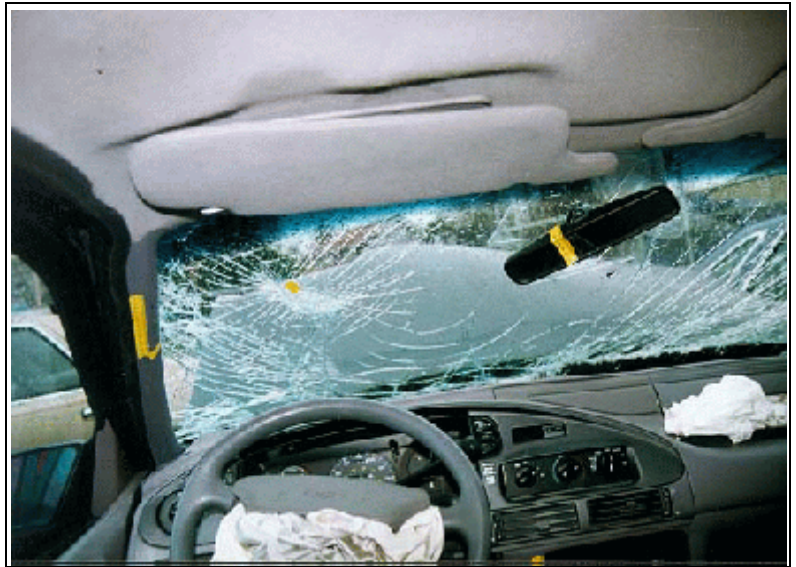
The autopsy report was the source for injuries of the driver. The driver sustained blunt impact (AIS 7) to the head and chest. There was a fracture (AIS 1) of the right 5th rib, and fracture (AIS 2) of C1-C2 cervical vertebra. The left forehead shows a diffuse contusion (AIS 1), discoloration of the entire forehead. There was a laceration (AIS 1) to the head. The left lower eye shows a crescent shaped contusion (AIS 1). The chest trauma is attributed to the steering wheel and the head injuries, including the cervical fracture, are attributed to the windshield; there was a spider web crack to the windshield directly above the steering wheel.

There were scattered cutaneous contusions and lacerations (both AIS 1) of the dorsum of the right hand. Injuries to the right hand were possibly the result of “flinging” by the air bag and the hand then striking the rear view mirror which was cracked. There were also scattered interrupted cutaneous contusions (AIS 1) with the right more severely involved than the left, and these changes occurred below the knee and were the result of contacting the left instrument panel and below.

Figure 8. Spider web to windshield from driver's head, and cracked rear view mirror from his right hand.

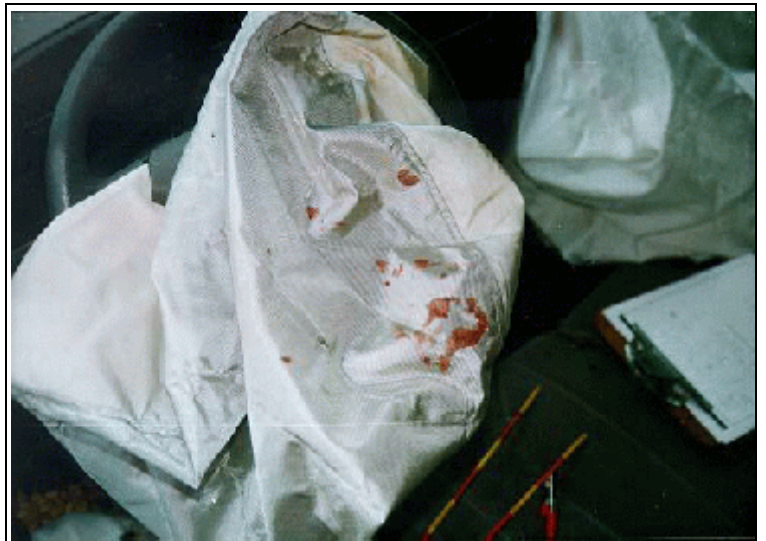
Figure 9. Blood on driver's air bag from lacerations to driver.
