DEPOWERED AIR BAG REPORT

CASE NUMBER - IN98-005
LOCATION - Texas
VEHICLE - 1998 FORD RANGER SUPERCAB
CRASH DATE - November, 1997

1. <i>Report No.</i> IN98-005	2. <i>Government Accession No.</i>	3. <i>Recipient's Catalog No.</i>	
4. <i>Title and Subtitle</i> On-site Depowered/Second Generation Air Bag Investigation Vehicle: 1998 Ford Ranger XL Supercab Location: Texas		5. <i>Report Date:</i> April 21, 1998

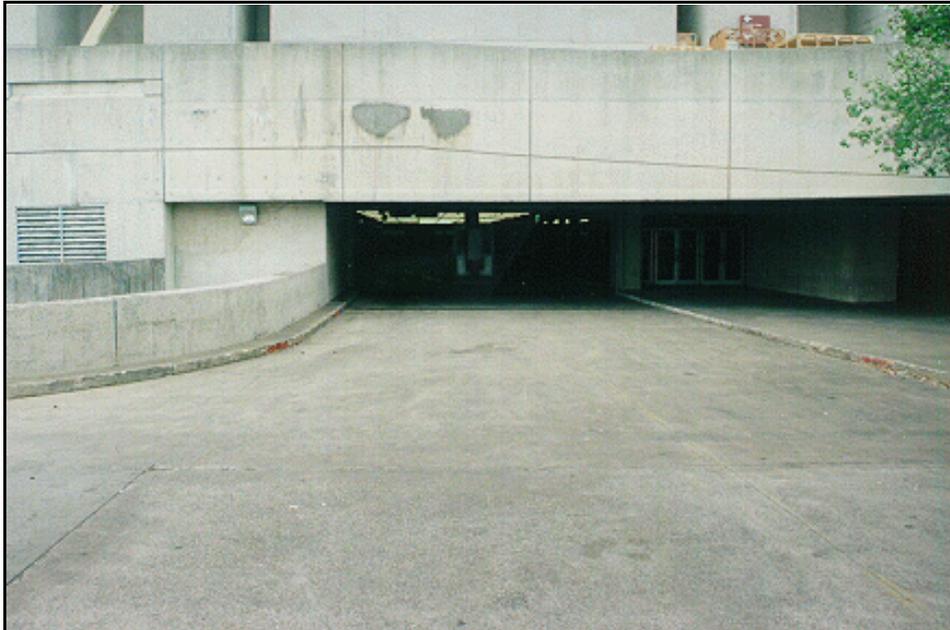
Figure 1: Case vehicle's eastbound approach toward impact with an overhead door that is raised in this view (case photo #1)

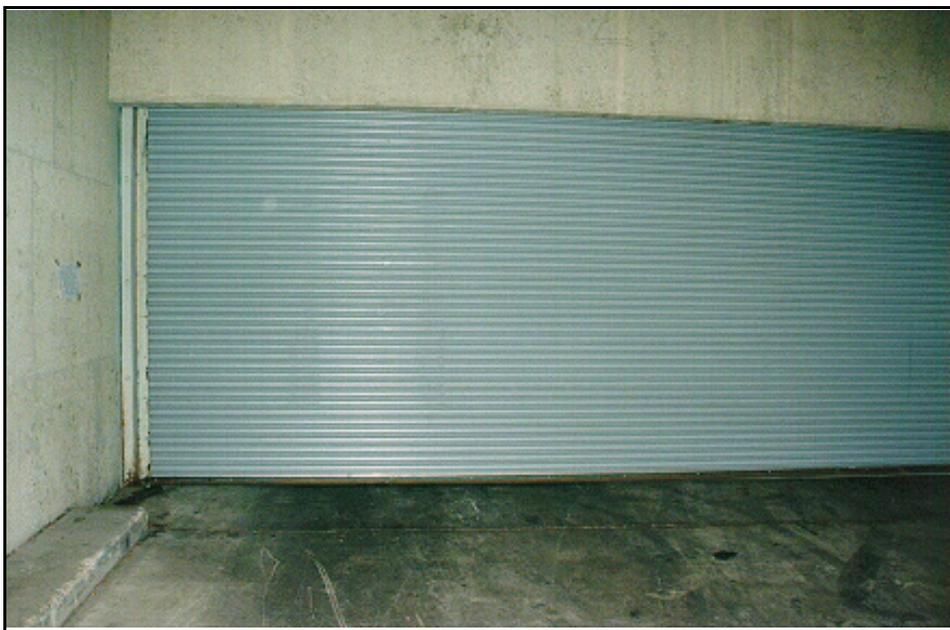
The overhead garage door was approximately 9 meters (30 feet) wide and 3.5 meters (12 feet) high. The damaged door had been replaced with an identical new installation. The door was made of longitudinal steel panels approximately 7.5 centimeters (3 inches) tall that were hinged along the top and bottom and traveled in a track on the sides. There was no sill or latch to engage the bottom edge of the door where it rested on the driveway. The evidence suggests that the case vehicle impacted the door with the front right corner of the vehicle aligned approximately at the center of the door. In this configuration, the left side of the pickup was close to the left edge of

the door. As the case vehicle impacted the door, the unsupported center of the door yielded more easily than the left side, resulting in greater crush on the left of the case vehicle. The impact caused the door panel to separate from the track on the left and the forward motion of the vehicle pushed the door structure aside as the vehicle traveled into the interior of the parking structure.

Figure 2: Object contacted--replacement door identical to original door (case photo #2)

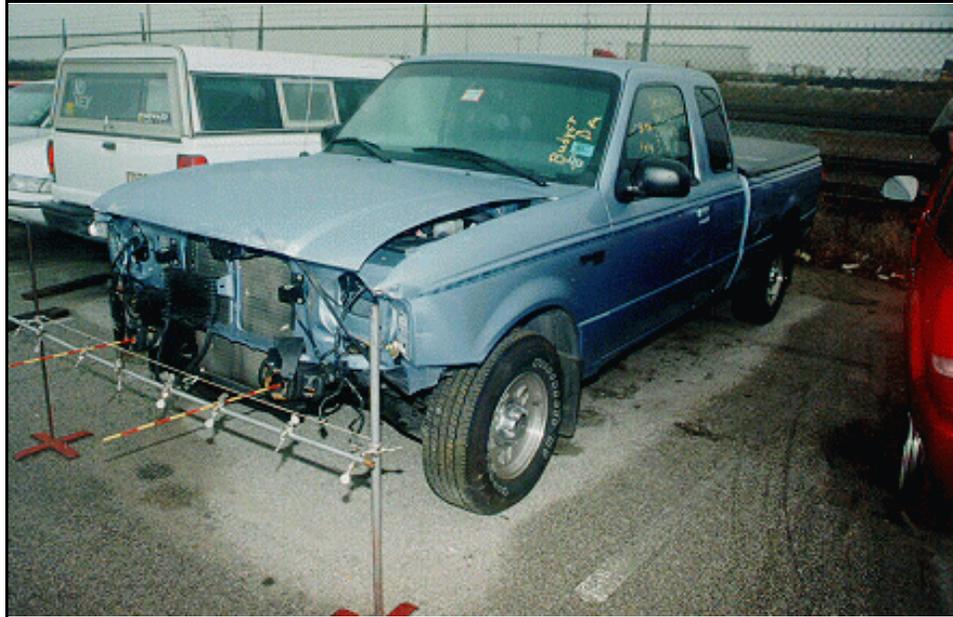
The case vehicle was a 1998 Ford Ranger XL, 4x2, extended Supercab pickup truck (VIN: 1FTYR14U5WP-----). When the case vehicle was inspected, the front bumper, grille, and headlight assemblies had been removed and both air bags had been cut out. Both doors remained closed and operational, and there was no crash-induced damage to any of the glazing. The backlight consisted of three glazing panels with the middle panel sliding horizontally to open it. The left fixed glazing panel of the backlight was broken out at the time of the inspection, but this damage was not due to the crash events. There was direct contact damage, consisting of light abrading and minor deformation, along the entire width of the leading edge of the hood and on the leading edges of both fenders, with minor induced buckling of the fenders. Crush measurements were obtained from the exposed frame rail ends, with a maximum crush of 14 centimeters (5.5 inches) on the left. The CDC was determined to be **12-FDEW-1**. Because the parking garage door yielded upon impact, the SMASH reconstruction program was used to calculate barrier equivalent speed. The computations indicate barrier equivalent speed 22 km.p.h. (14 m.p.h.). This was a crash of minor severity.

Figure 3: Front and left side of case vehicle (case photo #5)

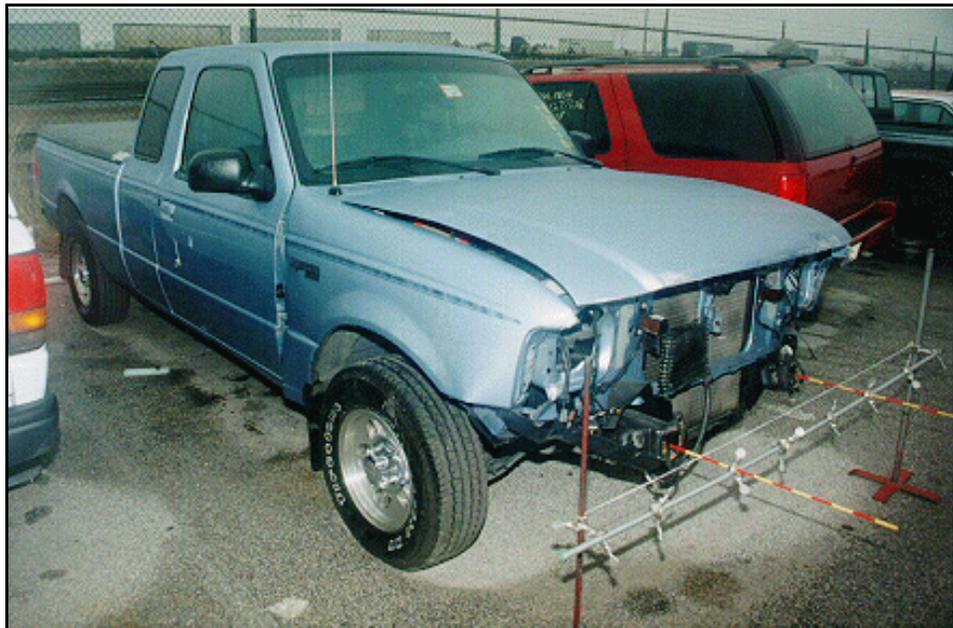
Figure 4: Front and right side of case vehicle (case photo #12)

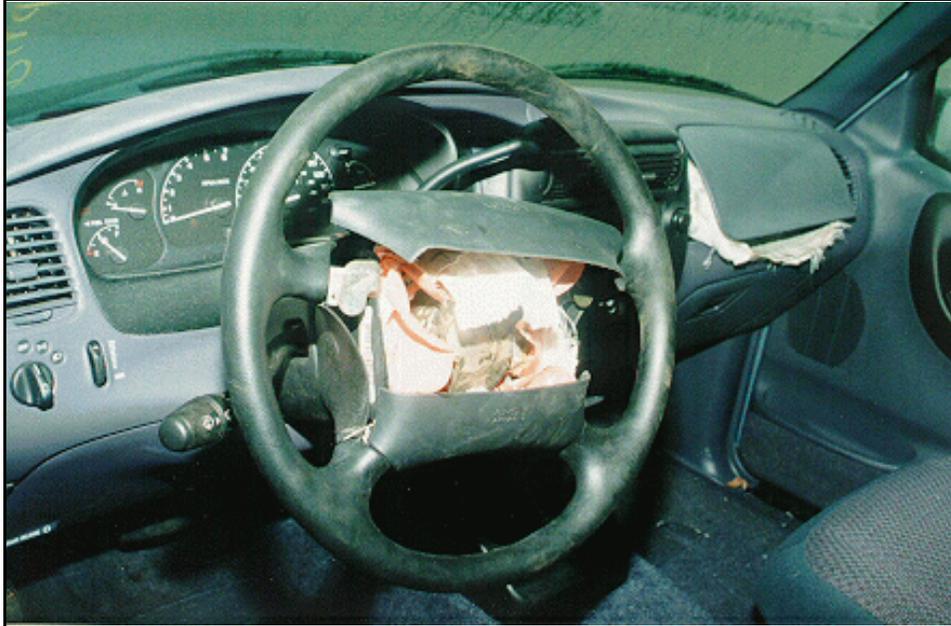
The driver's air bag was located in the steering wheel hub, with cover flaps in the H-configuration. The module cover flaps opened along the seams and there was no evidence of damage to the cover flaps. The front right passenger air bag was located in the middle of the instrument panel. The single flap opened along the seams with no evidence of damage to the cover flap. Both air bags were cut off and removed. The vehicle was fitted with manual three-point lap-and-shoulder safety belts in the two front seat outboard positions, neither of which showed any signs of use in this nearly-new vehicle. There was no evidence of occupant contact anywhere in the vehicle.

Figure 5: Case vehicle's steering wheel and cover flaps; note: driver air bag removed (case photo #13)

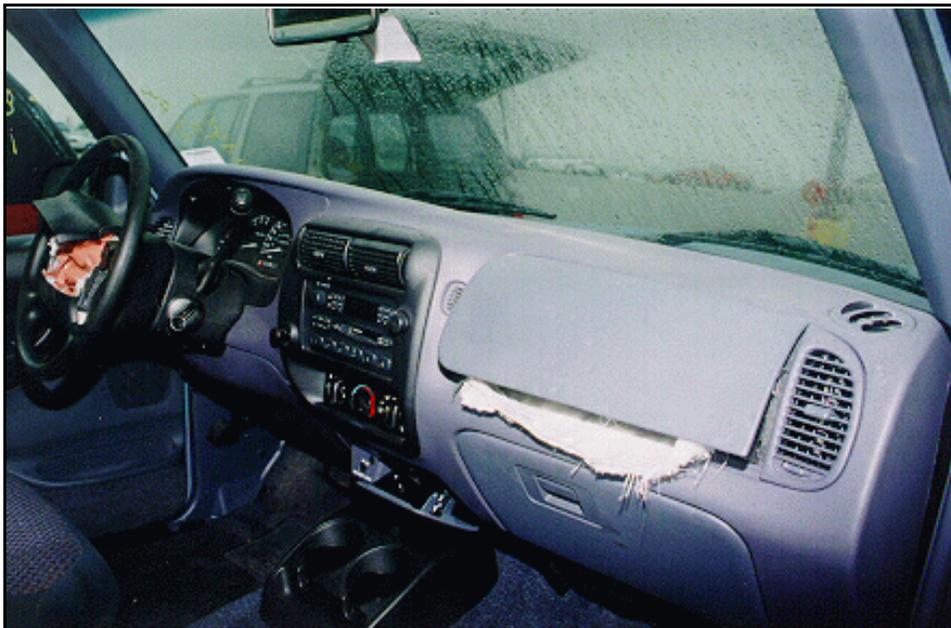
Figure 6: Case vehicle's front right cover flap; note: air bag removed (case photo #16)
