Remote Investigation/Passenger Vehicle vs. Heavy Truck/Front to Side Impact
Dynamic Science, Inc./ Case Number:DS98009
1998 Ford Crown Victoria, Four Door Sedan
Texas
February 1998

1. Report No. DS9809		2. Government Accession No.		3. Recipient Catalog No.	
4. Title and Subtitle In-Depth Accident Investigation				5. Report Date June 1998

Dynamic Science, Inc.
Crash Investigation
Case Number:DS98009

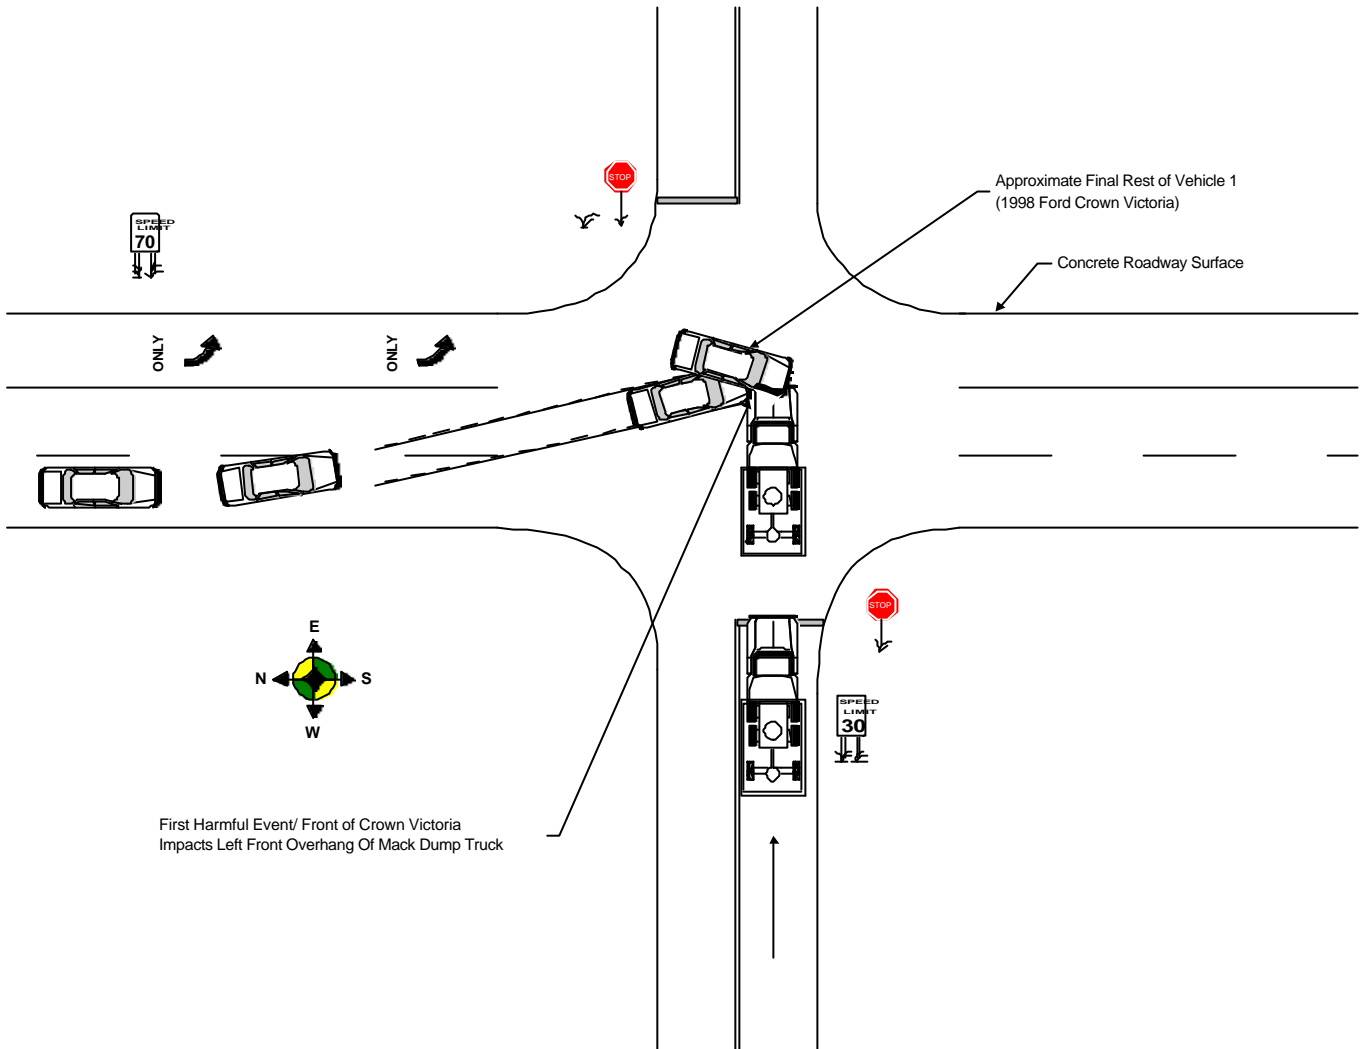
Figure 1. Scene diagram

The case vehicle was traveling southbound in lane 1 of the three lane (one way) roadway. The case vehicle was approaching a four-leg intersection at a driver estimated speed of 72 km/h to 80 km/h (45-50 mph).

The other vehicle was stopped at the southeast leg of the intersection. This leg of the intersection is controlled by a stop sign. The driver of the other vehicle started from a stop and proceeded to traverse the intersection heading westbound. The driver of the case vehicle detected the other vehicle slowly entering the intersection directly in front of his lane of travel. The driver steered to the left and applied his brakes, locking up the front tires, and initiating a longitudinal skid pattern. The front right of the case vehicle underrode the left front overhang of the other vehicle resulting in an estimated CDC of 12FRME6. The impact was sufficient enough to deploy both the left front and right front air bags.

The case vehicle rotated approximately 30 degrees in a clockwise rotation before coming to rest still fully engaged with Vehicle 2. The case vehicle sustained no intruding components and the damage severity rating would be considered minor. The hood was displaced rearward and folded

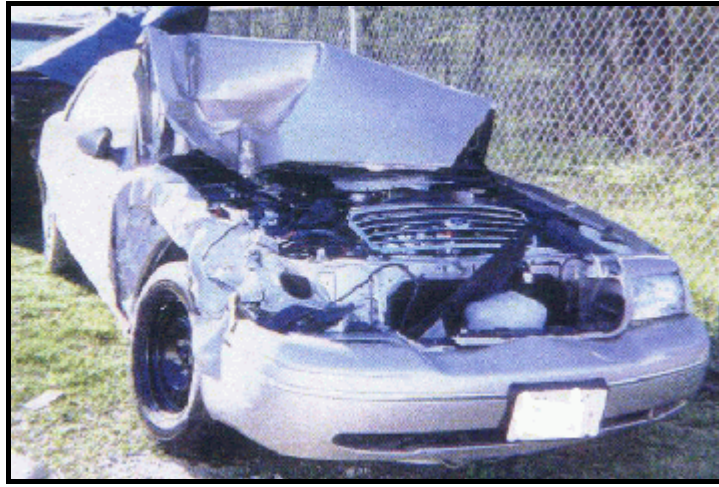
Figure 2. Case vehicle, Exterior

Description:	1998 Ford Crown Victoria four-door sedan
VIN:	2FAPP73W6WX
Odometer:	Unknown
Engine:	4.6 liter/ V8 cylinder
Reported Defects:	None
Cargo:	None Reported
Damage Description:	Minor- Underride damage isolated to the front right and above the bumper. Direct contact damage was estimated to be approximately 33 cm (13") which began at the right front corner. Direct contact extended beyond the leading edge (base) of the windshield glazing.
CDC:	12FRME6
Delta V:	Crash is beyond the scope of the WinSmash 1.2.1 program
