ON-SITE AIR BAG INVESTIGATION

CASE NUMBER - IN98-016
LOCATION - ILLINOIS
VEHICLE - 1995 HYUNDAI SONATA GL
CRASH DATE - February, 1998

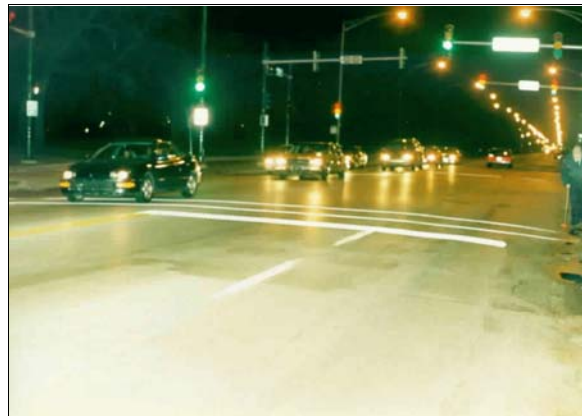
The case vehicle was traveling essentially southward in the inside, southbound lane of a four-lane, undivided, city street (**Figure 1**) and intended to continue its southerly travel path (i.e., there were two southbound lanes and two northbound lanes). Both the Oldsmobile and the Honda had been traveling south in the same lane of the same roadway as the case vehicle. The Honda was ahead of the Oldsmobile. The Oldsmobile and the Honda had both come to a stop at a four-leg intersection, intending to continue in their southerly travel paths once the traffic signal light changed. Based upon the underride impact configuration, the case vehicle's driver most likely braked just prior to the impact, causing the front of her vehicle to dip downwards. According to the Police Crash Report, the case vehicle's driver indicated that she was not aware of the impending collision. The crash occurred in the inside southbound lane of the roadway. The case vehicle's pre-impact travel speed is unknown, whereas the Oldsmobile and the Honda were stopped in traffic.

Figure 1: Follow-up police photo looking south-southeastward at approximate location of impact in inside southbound lane (case photo #01)

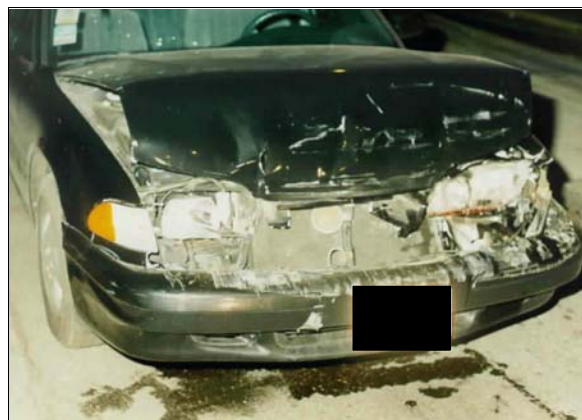
Figure 2: Follow-up police photo of case vehicle's frontal damage from impact with Oldsmobile; Note: classic underride damage pattern and scrapes on top of bumper (case photo #03)

The front (**Figure 2** above and **Figure 3**) of the case vehicle impacted and underrode the back (**Figure 4**) of the Oldsmobile, causing the case vehicle's driver and front right passenger supplemental restraints (air bags) to deploy. As a result of the initial crash event, the Oldsmobile was pushed forward causing the front of the Oldsmobile to impact the back of the Honda. According to the Police Crash Report, the police first learned of this crash **two hours** after it occurred. Consequently all vehicles had been moved before it was investigated. All three vehicles most likely came to rest slightly forward (i.e., southward) from their location at which they were initially struck; see **CRASH DIAGRAM** below.

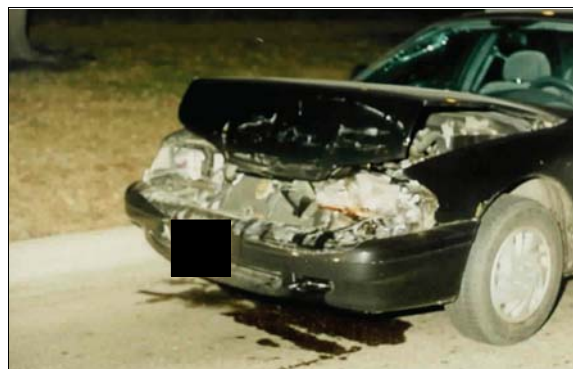
Figure 3: Follow-up police photo of case vehicle's front underride damage from impact with Oldsmobile viewed from left of front; Note: radiator leakage on pavement (case photo #04)

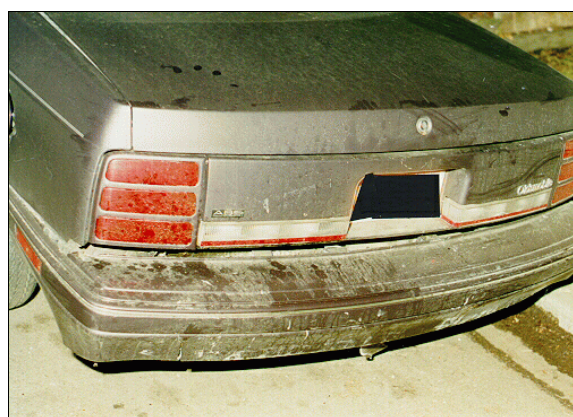
Figure 4: Damage to Oldsmobile's back bumper; Note: override damage pattern and radiator fluid stains on top surface of bumper (case photo #54)

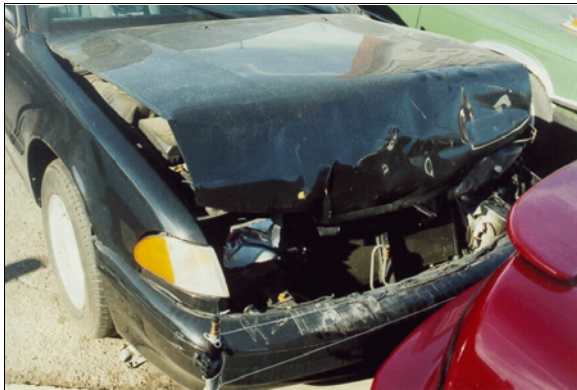
Figure 5: Case vehicle's frontal damage viewed from right of front in tow yard; Note: under-ride damage pattern and scrapes on top of front bumper (case photo #23)

The case vehicle's contact with the Oldsmobile involved almost the entire front surface (**Figures 5 and 6**). Direct damage began at the front left bumper corner and extended, a measured distance of 148 centimeters (58.3 inches), along the front bumper. Maximum crush was measured along the hood edge as 43 centimeters (16.9 inches) at C₁. However, the maximum residual crush was only 19 centimeters (7.5 inches) between C₃ and C₄. The case vehicle's front bumper fascia, grille, hood, radiator, right and left headlight assemblies, left turn signal assembly, and left fender were directly damaged and crushed rearward. None of the case vehicle's tires were physically restricted or deflated. The right turn signal assembly and both the right and left fenders sustained induced damage as well. The sunroof was buckled upward from the roof.

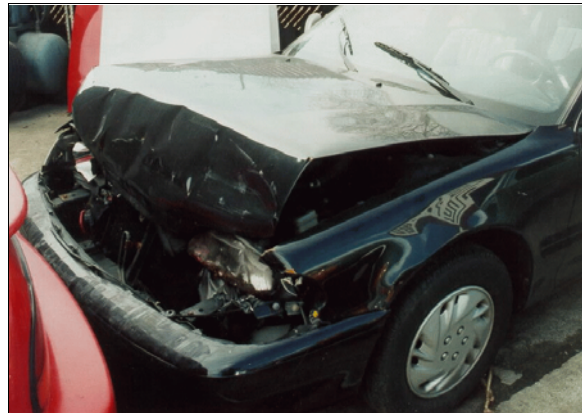
Figure 6: Case vehicle's frontal damage viewed from left of front in tow yard; Note: under-ride damage pattern and scrapes on top of front bumper (case photo #05)

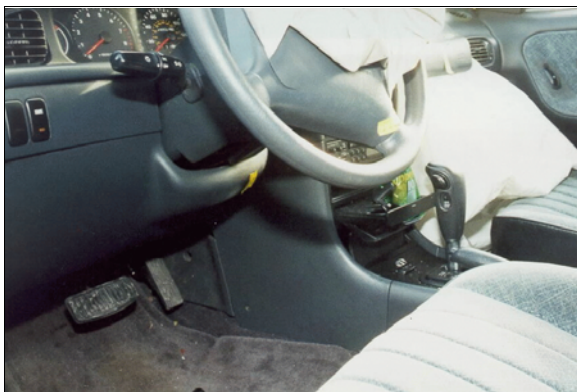
Figure 7: Case vehicle's driver seating area showing possible contact evidence on driver's knee bolster and steering wheel rim (case photo #26)

Inspection of the case vehicle's interior revealed what appeared to be a body oil transfer to the steering wheel rim (**Figure 7**). Furthermore, there were transfers, initially suspected to be skin, to the driver's knee bolster (**Figure 8**) and to the front right windshield's glazing (**Figure 9** below). Likewise, it was initially thought that there were four possible contact areas (i.e., body

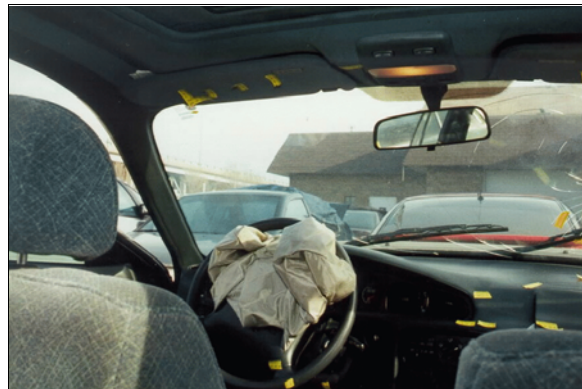
Figure 8: Case vehicle's deployed driver air bag and driver's greenhouse area showing contact to driver's sun visor and possible contact evidence on center instrument panel area (case photo #29)

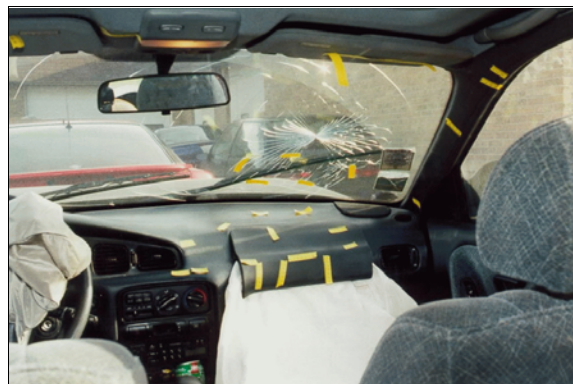
Figure 9: Case vehicle's deployed front right passenger air bag and greenhouse area showing contact evidence on front right sun visor, contacts to windshield's glazing, and possible evidence of contact to right "A"-pillar and front right air bag module's cover flap (case photo #34)

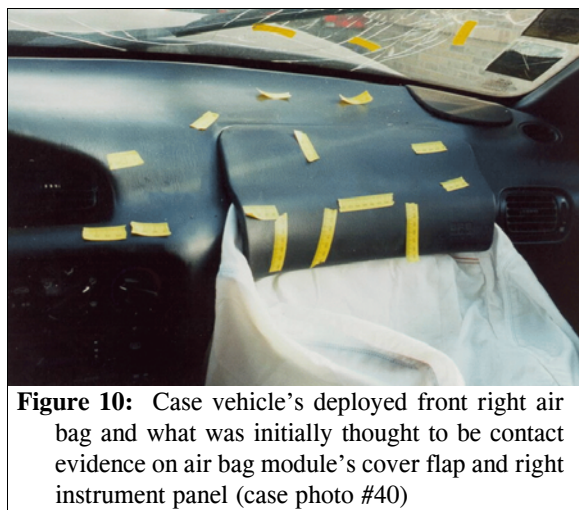
oil and skin transfers) on the front right air bag module's cover flap (**Figure 10**). However, the available medical evidence does not support direct contact between the front right child passenger and the module's cover flap. Furthermore, there is no deformation to the cover flap that indicates occupant loading. The most solid contact evidence was found on the sun visors. On the driver's sun visor there was a makeup smudge (**Figure 8** above) and on the front right sun visor there appeared to be a blood stain (**Figure 11**). Furthermore, there was a scrape and a hair deposit on the driver's side of the forward-mounted, overhead, interior light controls (**Figure 8** above). In addition, there were suspected body oil transfers on the center instrument panel (**Figure 8** above) and right "A"-pillar (**Figure 9**). The interior inspection found no evidence of intrusion to the occupant compartment and no evidence of loading to the steering column.

Figure 10: Case vehicle's deployed front right air bag and what was initially thought to be contact evidence on air bag module's cover flap and right instrument panel (case photo #40)

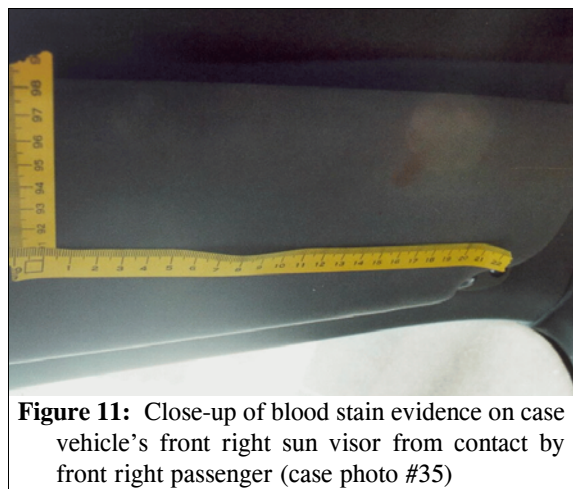
Figure 11: Close-up of blood stain evidence on case vehicle's front right sun visor from contact by front right passenger (case photo #35)

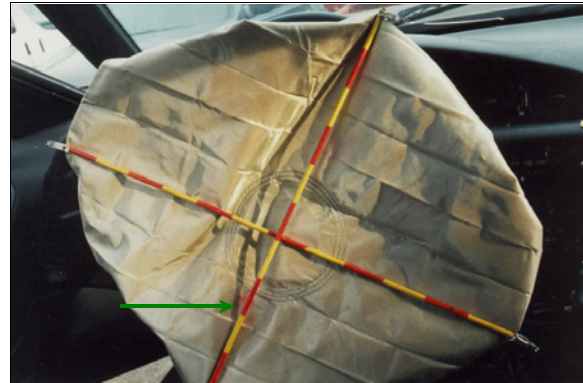
in the steering wheel hub. The module cover consisted of symmetrical “H”-configuration cover flaps made of thick vinyl with overall dimensions of 19.5 centimeters (7.7 inches) at the horizontal seam and 7 centimeters (2.8 inches) vertically. An inspection of the air bag module's cover flaps and air bag revealed that the cover flaps opened at the designated tear points, and there was no evidence of damage during the deployment to the air bag or the cover flaps. The driver's air bag was designed with two tethers, each approximately 13 centimeters (5.1 inches) wide, and they were attached to the center circular stitching. The driver's air bag had two vent ports, approximately 3 centimeters (1.2 inches) in diameter, located at the 10 and 2 o'clock positions. The deployed driver's air bag was elliptical with a height of approximately 53 centimeters (20.9 inches) and a width of approximately 64 centimeters (25.2 inches). Inspection of the driver's air bag revealed a facial makeup smear just outside the center circular stitching toward the 6 o'clock position (**Figure 12**).

Figure 12: Case vehicle's deployed driver air bag showing makeup smear (arrow) at bottom of center circular stitching (case photo #46)

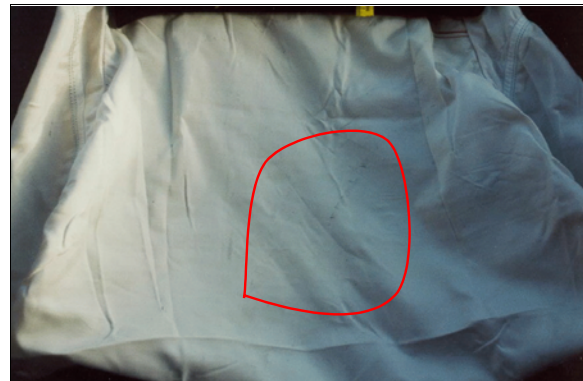
Figure 13: Top surface of case vehicle's deployed front right passenger air bag; Note: friction scuffs most likely from underneath surface of module's cover flap (case photo #52)

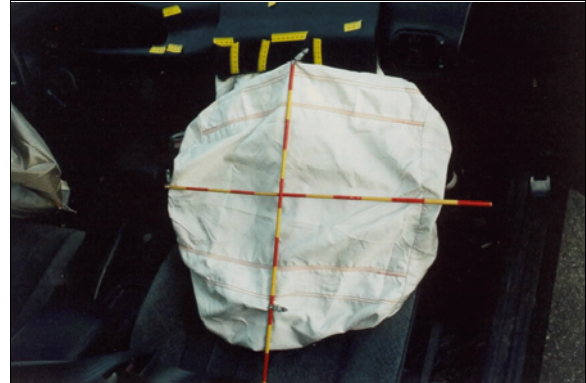
centimeters (20.5 inches). An inspection of the front right air bag's fabric revealed that no obvious contact evidence was readily apparent (e.g., oil/skin transfers or blood) on the air bag's front or top surfaces (**Figure 14**).

Figure 14: Front surface of case vehicle's deployed front right passenger air bag showing no obvious evidence of occupant contact and likely friction scuffs in left lower quadrant from module's cover flap (case photo #49)

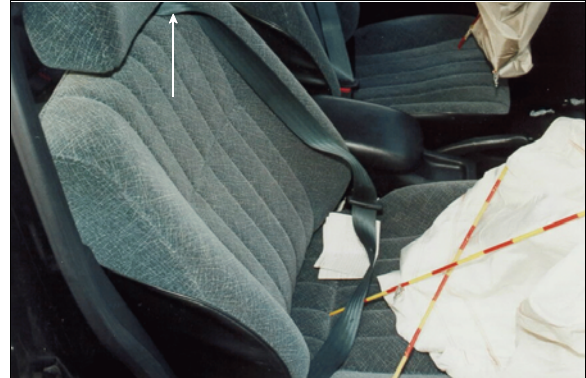
The case vehicle's front right passenger (i.e., granddaughter of driver) was not using her available, active, three-point, lap-and-shoulder, safety belt system. Furthermore, there was no evidence of belt pattern bruising and/or abrasions to the front right passenger's body, and the inspection of the front right passenger's seat belt webbing, "D"-ring, and latch plate showed no detectable evidence of loading. In addition, the safety belt's webbing had been positioned underneath the inboard side of the front right seat's adjustable head restraint so as to keep the webbing "snug" against the seat back (**Figure 15**).

Figure 15: Case vehicle's front right passenger safety belt showing belt's webbing routed underneath seat's adjustable head restraint (case photo #43)

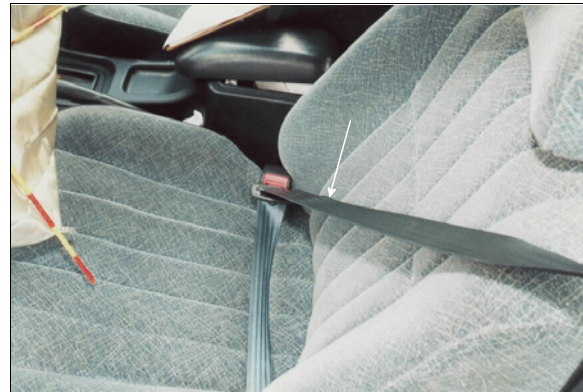
The case vehicle's driver was not using her available, active, three-point, lap-and-shoulder, safety belt system. Inspection of the driver's seat belt webbing, "D"-ring, and latch plate showed no detectable evidence of loading; however, there was evidence (i.e., a crease) on the webbing that indicated that this belt has been used in the past (Figure 17).

Figure 17: Case vehicle's driver safety belt showing recent (i.e., arrow points to crease in webbing) evidence of usage but not evidence of usage in this crash (case photo #42)

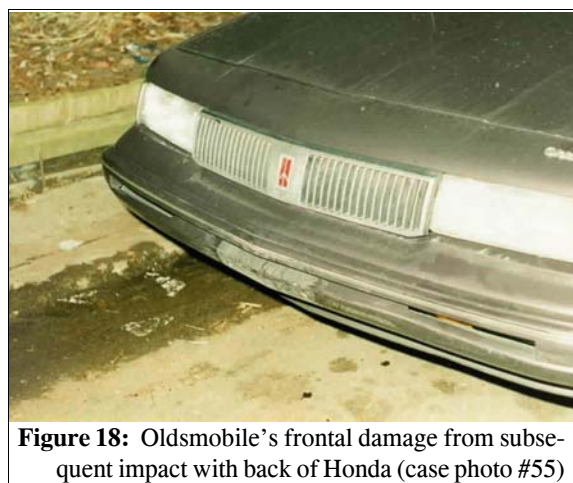
The Oldsmobile was inspected by the police at the driver's residence. Based on the available police photographs (**Figure 4** above and **Figure 18**), the CDCs for the Oldsmobile are estimated as: **06-BDEW-1 (180)** and **12-FDLN-1 (0)**. The Oldsmobile was driven from the scene.

Figure 18: Oldsmobile's frontal damage from subsequent impact with back of Honda (case photo #55)
