On-Site Investigation / Vehicle to Animal  
Dynamic Science, Inc. / Case Number: DS98020  
1996 Ford Taurus GL 4-door  
Colorado  
July, 1998

| 4. Title and Subtitle<br>In-Depth Accident Investigation | | | | 5. Report Date<br>March 28, 2000 | |

**Dynamic Science, Inc.  
Accident Investigation  
Case Number: DS98020**

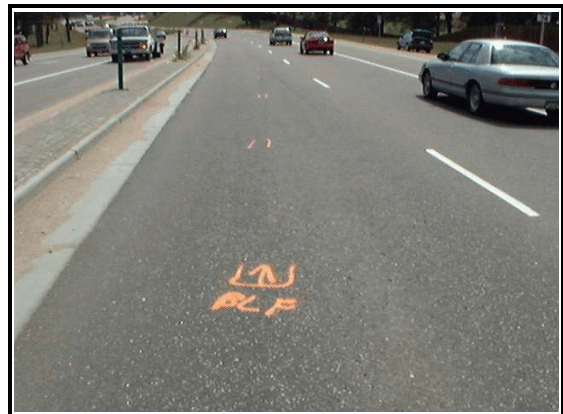
**Figure 1.** Area of impact and post-impact skid.

bumper. The elk was hurled into the path of Vehicle 1. The driver of Vehicle 1 remembers seeing the neck and shoulder of the elk. Just prior to striking the elk, the driver probably braked. Vehicle 1 struck the elk with its front left bumper, and the elk went underneath Vehicle 1. On impact, both of the air bags in Vehicle 1 deployed. After impact, the driver of Vehicle 1 continued braking until coming to rest 19.4 m (63.5 ft) south of the point of impact and left 19.4 m (63.5 ft) of front left locked wheel skid mark. Vehicle 1 came to final rest facing south.

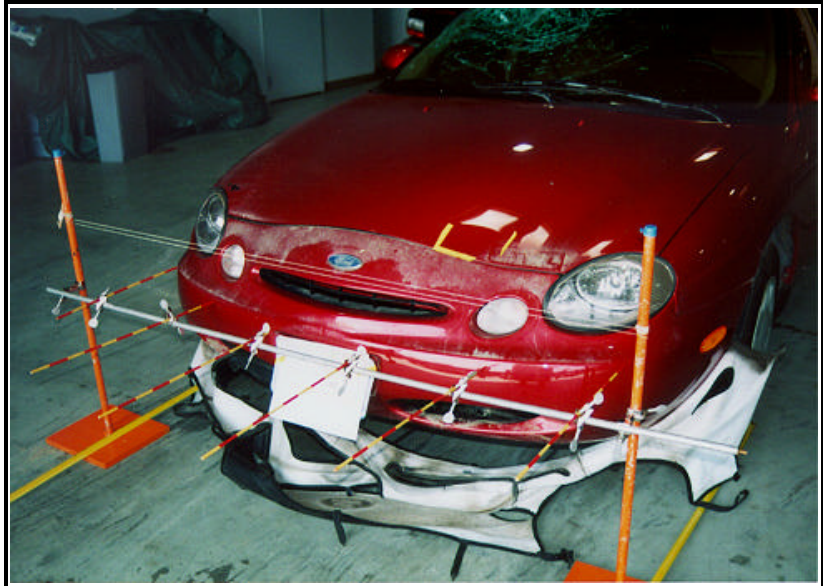
Vehicle 1 had minor damage to the front end. A CDC of 12FYEN1 was assigned to the damage, with a direct damage width of 13 cm (5.1 in). The maximum crush was 1 cm (.4 in) to the left front bumper at C<sup>1</sup>. In order to calculate a delta v, the barrier portion of the WinSmash reconstruction algorithm was used even though the collision is beyond its scope. WinSmash calculated a total delta v of 10.4 km/h (6.5 mph), and longitudinal delta v of -10.9 km/h (-6.8 mph). This a borderline reconstruction and the results appear low given that the air bags in Vehicle 1 deployed. Since the collision condition is beyond the scope of WinSmash, the elk was a yielding object, the results were not coded in the EDCS.

**Figure 2.** Exterior damage to Vehicle 1.

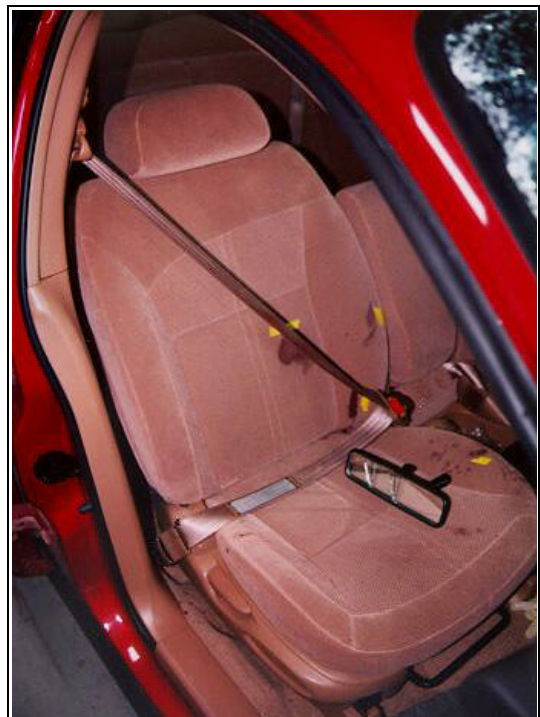
**Figure 3.** Blood spots on front right seat.

occupant had commented to the driver on prior occasions that the shoulder belt was uncomfortable to wear because it came across his face. The inspection of the vehicle revealed curling and fraying of the seat belts. There were also blood spots on the shoulder belt. These blood spots matched up with the blood spots on the seat back cushion, around the area where the front right occupant's head came to rest after the collision (see Figure 3). It is thought that the shoulder belt was behind the front right occupant and the shoulder belt was stained in this position.

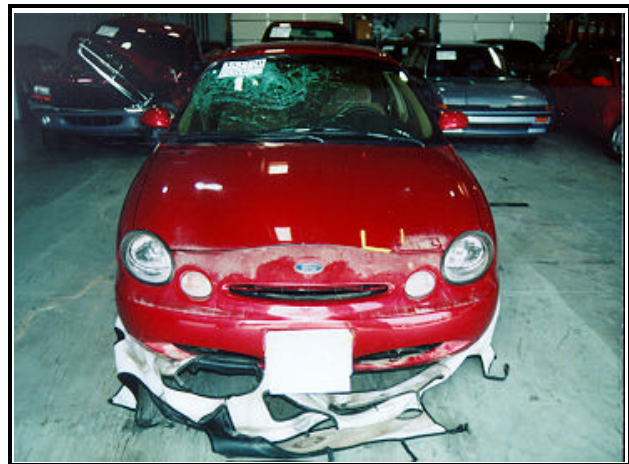
| Damage Description: | Minor contact damage to front bumper—minimal crush. | |

**Figure 5.** Exterior damage to Vehicle 1.

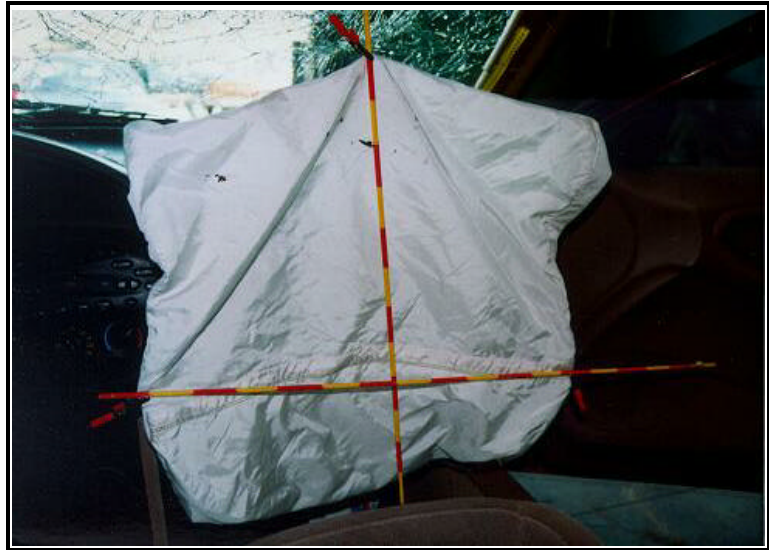
Vehicle 1 was equipped with dual front air bags. The driver's air bag was housed in the steering wheel hub and was concealed by symmetrical double horizontal module cover flaps. The circular air bag had two tether straps and no exhaust vent port holes. It measured 52 cm (20.5 in) in diameter. The lower instrument panel is equipped with a rigid plastic knee bolster. There were bluish streaks on the air bags that had been caused by rain.

**Figure 6.** Right front passenger air bag.

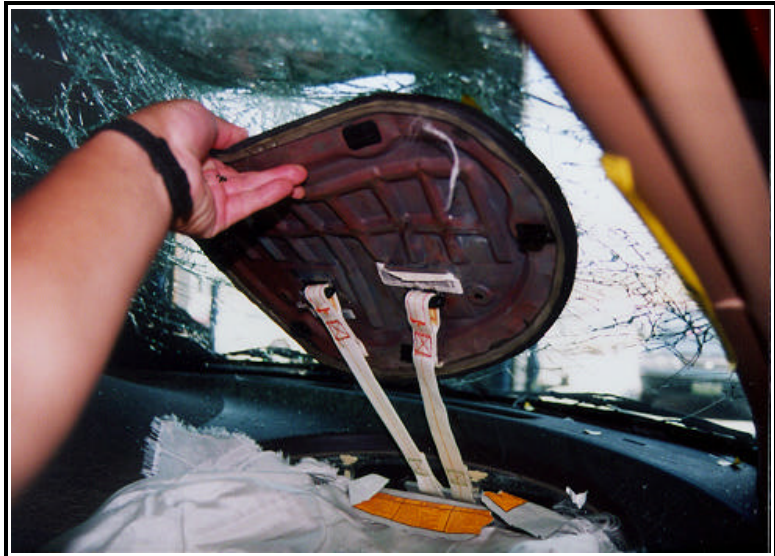
There was no evidence of the front right occupant contacting the windshield. There were air bag fibers all about the windshield, and there was no evidence of occupant contact to the front right module cover. The module cover was cut and deformed when it struck, starred and shattered the windshield. The plastic molding around the front right A-pillar was cracked more than likely by contact with the right hand of the front right occupant.

The front right passenger's air bag was located on the instrument panel, top surface plane, and incorporated a single air bag module cover with two nylon tethers (25.5 cm/10 in long) attached to it. The tethers allow the entire module cover to separate during deployment. The module cover flap is symmetrical and oblong with rounded flap corners. The front right passenger's module cover and air bag starred and cracked the laminated windshield glazing upon impact. The front right passenger's air bag measured 61 cm (24 in) x 59 cm (23.2 in). It was not tethered and had no exhaust vent port holes, and a maximum bag excursion of 67 cm (26.4 in). There was evidence of skin transfers on the air bag (see Figure 9). There were also several bluish transfers on the air bag (see Figure 10), that probably came from contact with the blue and white striped shirt or blue jeans that he was wearing.

**Figure 7.** Front right air bag module cover.

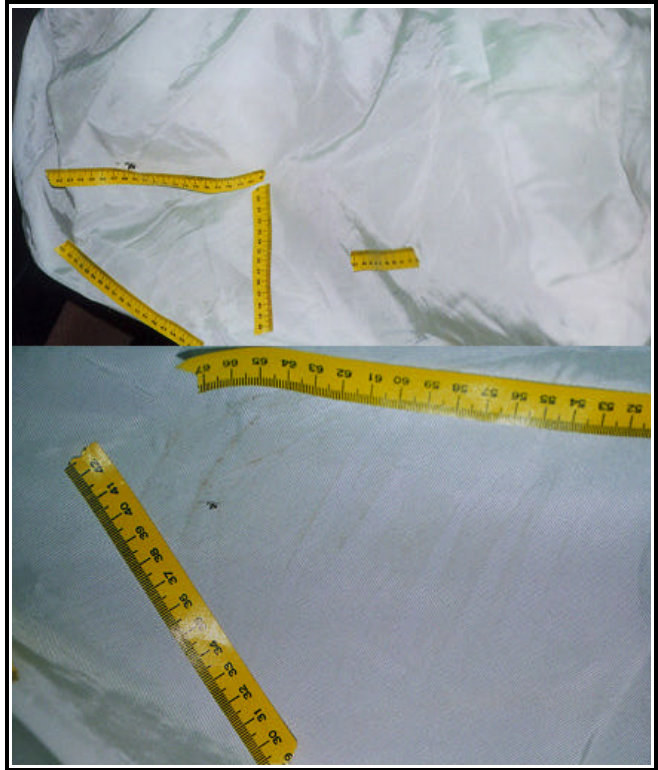
**Figure 9.** Skin transfer on front right air bag.

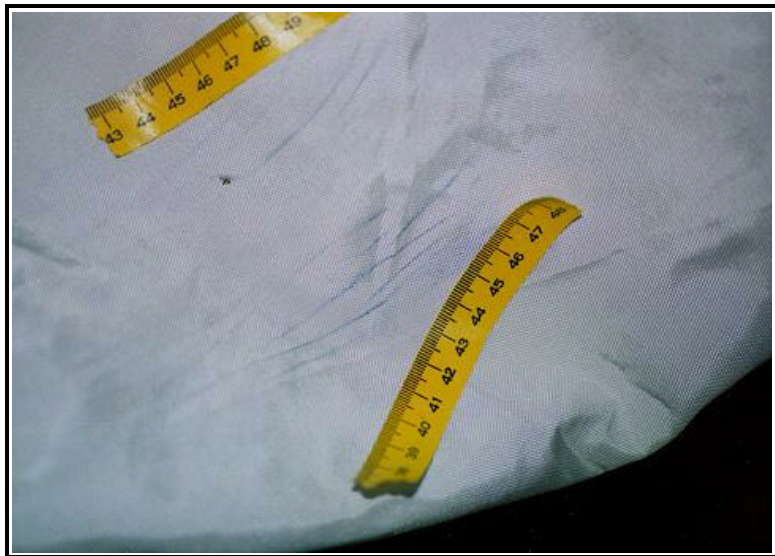
**Figure 8.** Bluish transfer on front right air bag.

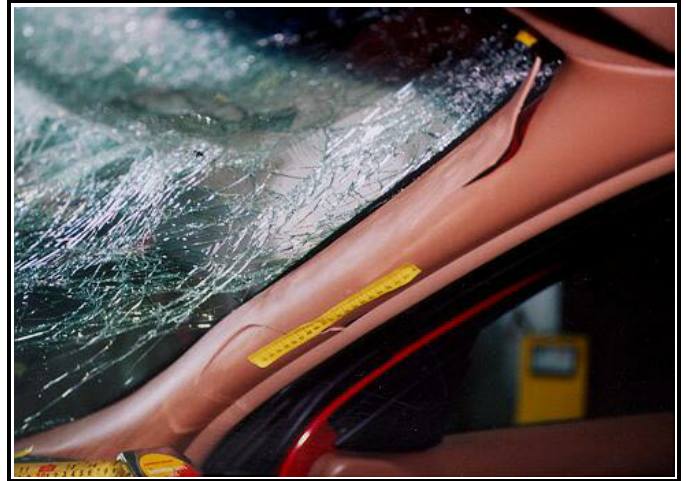
**Figure 10.** Right A pillar—possible right hand contact.
