# INDIANA UNIVERSITY

### **ON-SITE POTENTIAL SAFETY-RELATED DEFECT INVESTIGATION**

CASE NUMBER - IN98-022  
LOCATION - KANSAS  
VEHICLE - 1998 PONTIAC GRAND PRIX GT  
CRASH DATE - September, 1998

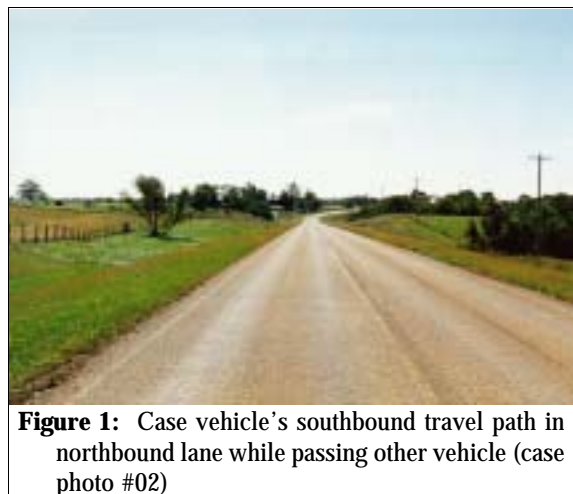
The case vehicle was traveling south (**Figure 1**) in the northbound lane of a two-lane, undivided, county roadway and was in the process of overtaking and passing another vehicle, intending to continue in her southward direction of travel. During the passing maneuver both the case vehicle's driver and front right passenger air bags deployed inadvertently.

**Figure 1:** Case vehicle's southbound travel path in northbound lane while passing other vehicle (case photo #02)

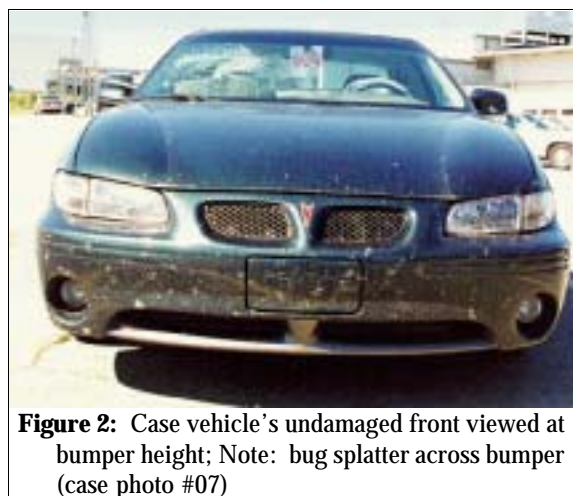
**Figure 2:** Case vehicle's undamaged front viewed at bumper height; Note: bug splatter across bumper (case photo #07)

Inspection of the case vehicle's exterior revealed no deformation to the front (**Figure 2** above) or side planes. A close inspection to the case vehicle's undercarriage did reveal three indentations (**Figures 3** and **4** above and **Figures 5** and **6**), the most severe being approximately 1 centimeter deep (0.4 inches) to the tail pipe (**Figure 4** above). The indentations appeared to be along the same longitudinal line, most likely having occurred at the same time by the same object. The three contacts appeared to have occurred fairly recently having no rust but only dirt on them (**Figure 4** above and **Figures 5** and **6**). The only other damage observed consisted of normal scratches and scrapes to the air dam, primarily to the right side, from contact with one or more concrete parking stop blocks.

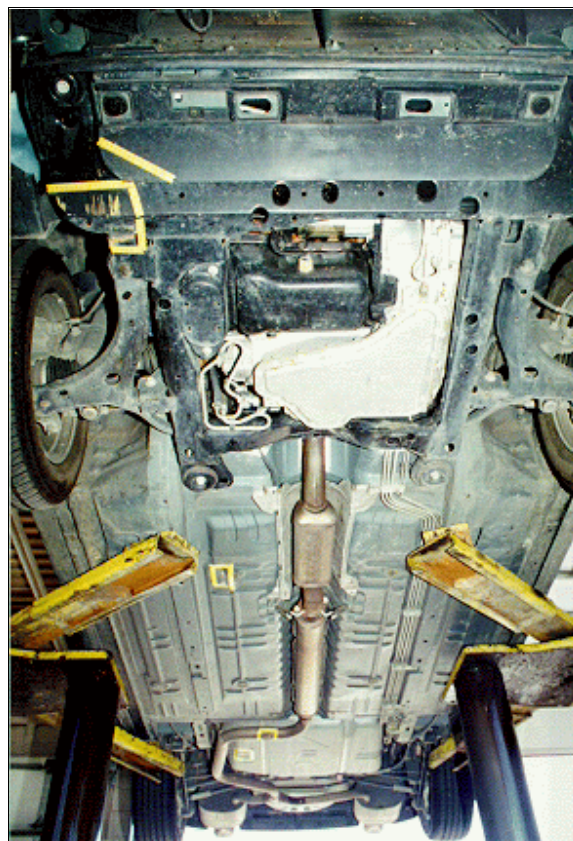
**Figure 3:** Vertical view of case vehicle's undercarriage with tape highlighting areas of minor contact (case photo #14)

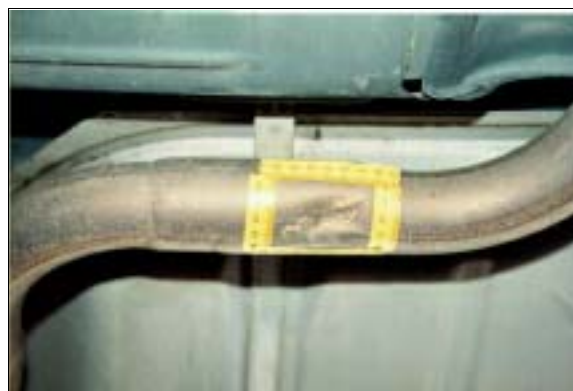
**Figure 4:** Close-up view of most severe dent to case vehicle's undercarriage, specifically the tail pipe (case photo #22)

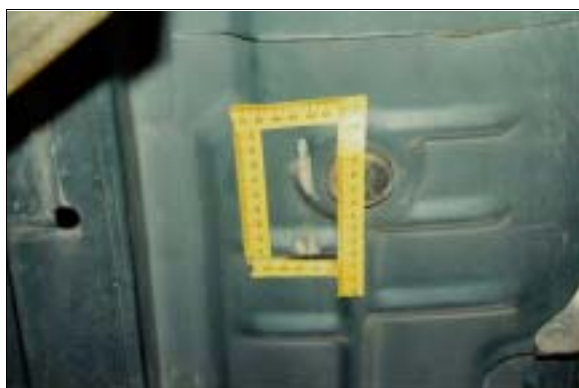
**Figure 5:** Contact mark to case vehicle's right undercarriage, forward of center (case photo #19)

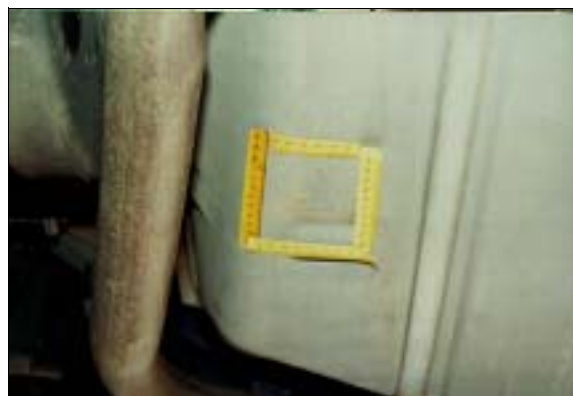
**Figure 6:** Close-up of minor contact to case vehicle's gas tank (case photo #20)

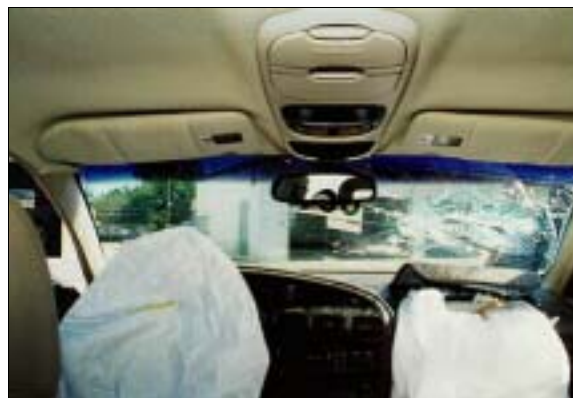
Concerning the case vehicle's redesigned supplemental restraints, an inspection of the driver air bag module's cover flaps revealed that the cover flaps opened at the designated tear points, and there was no evidence of damage to the cover flaps. Inspection of the driver's air bag revealed a 3 x 5 centimeter (1.2 x 2.0 inch) makeup transfer to the center portion near the top (**Figure 7**). There were also black patterned transfers to the bottom portion from the underside of the cover flaps. The front right passenger's air bag was located in the top of the instrument panel. An inspection of the air bag module's cover flap and air bag revealed that the cover flap opened at the designated tear points, and there was evidence of damage to the cover flaps (**Figure 7**) from striking and cracking the windshield. The driver's air bag was designed without any tethers, and the front right passenger's air bag was designed with two tethers, each 7.5 centimeters (3.0 inches) wide. The driver's air bag had two vent ports, approximately 2.5 centimeters (1.0 inches) in diameter, located at the 9 and 3 o'clock positions. The deployed driver's air bag was round with a diameter of 65 centimeters (25.6 inches). The front right passenger air bag had two vent ports, approximately 3.5 centimeters (1.4 inches) in diameter, located at the 10 and 2 o'clock positions. The deployed front right air bag was rectangular with a height of approximately 51 centimeters (20.1 inches) and a width of approximately 59 centimeters (23.2 inches).

**Figure 7:** Case vehicle's deployed air bags; Note: make-up smear (tape) to driver air bag and deformation to front right air bag module's cover flap from striking the windshield (case photo #27)
