**TRANSPORTATION SCIENCES
CRASH RESEARCH SECTION**

**CALSPAN ON-SITE SCHOOL BUS CRASH INVESTIGATION
CALSPAN CASE NO. CA98-022
SCHOOL BUS CHASSIS: 1993 GMC VANDURA 3500
BODY: THOMAS BUILT MINOTOUR
LOCATION: TENNESSEE
CRASH DATE: MARCH, 1998**

Contract No.
DTNH22-94-D-07058

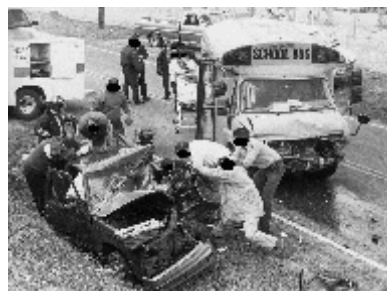
Figure 1. On-scene view of the crash site.

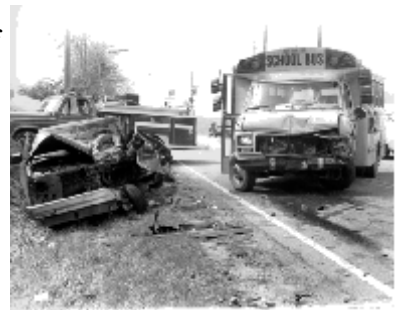
The momentum of the pickup truck rotated the bus approximately 122 degrees in a counterclockwise (CCW) direction and displaced its center of gravity approximately 2.1 m (7.0) rearward of its at-impact position. The bus came to rest diagonally across the eastbound travel lane, facing in an easterly direction with its left rear (dual) tires positioned on the yellow centerlines of the roadway. The pickup truck was displaced in a CCW direction as a result of the engagement with the bus and departed the south roadedge. The right rear quarter panel area of the pickup truck impacted an earth embankment as the vehicle entered the shallow ditch that was adjacent to the south shoulder. The impact redirected the vehicle in a clockwise direction as the right front tire came to rest in the mud at the base of the embankment. The pickup truck came to rest approximately 9.9 m (32.4') east of its at impact position, facing in a easterly direction parallel to the roadway. The final rest positions are documented in **Figure 4**.

Figure 4. Final rest position of the involved vehicles.

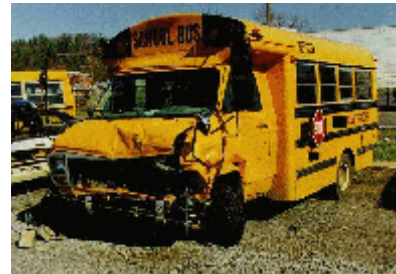
The school bus sustained moderately severe frontal damage as a result of its off-set, frontal impact configuration with the 1993 GMC Sonoma pickup truck. The direct contact damage began 79.4 cm (31.25") right of center and extended 166.4 cm (65.5") to the left front bumper corner. A Collision Deformation Classification (CDC) of 01-FDEW-3 (**Figure 5**) was assigned to the frontal damage. The combined induced and direct contact damage (Field L) was 163.2 cm (64.25") which involved the entire frontal area. It should be noted that the direct contact damage was measured along the profile of the damage pattern while the Field L was documented parallel to the measurement reference line. Maximum crush was 51.7 cm (20.4") located at the left front corner of the front bumper (**Figure 6**). The crush profile at bumper level was as follows: C1 = 51.7 cm (20.4"), C2 = 40.6 cm (16.0"), C3 = 31.6 cm (12.4"), C4 = 20.3 cm (8.0"), C5 = 4.8 cm (1.9"), C6 = 0 cm. The lateral component of the 1 o'clock impact force resulted in lateral displacement of the frontal structure. The left front bumper corner was displaced approximately 7.6 cm (3.0") left while the right corner was displaced approximately 15.2 cm (6.0").

Figure 5. Frontal damage to the school bus.

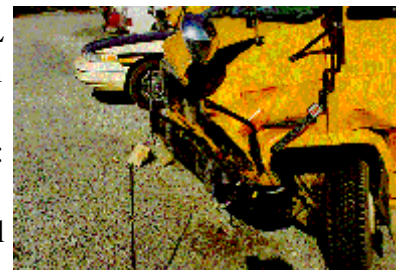
Figure 6. Profile view documenting the frontal crush profile.

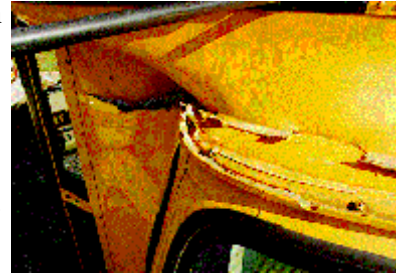
The aluminum school bus body was blended into the body of the van based cut-a-way chassis with a fiberglass filler panel that surrounded the windshield header and the right door area of the bus. Due to the structural crush at the left corner area of the Vandura chassis and the left lateral displacement of the frontal structure, partial separation of the fiberglass panels occurred. The fiberglass roof panel at the header fractured surrounding the nine No. 10 gauge x 15.9 cm (0.625") coarse thread sheetmetal screws. The cab area of the bus was displaced laterally left which resulted in minimal separation at the left A-pillar/header juncture. The full width of the filler panel at the header separated to a maximum of 8.2 cm (3.25") at the right side juncture point. In addition, the adjoining filler panel between the OEM width of the cab and the extended width of the bus body was fractured at the height of the right roof side rail. The fracture line was horizontal, however, the separation was not sufficient for occupant ejection. The separations are documented in **Figure 7**.

Figure 7. Fracture/separation of the fiberglass filler panels.

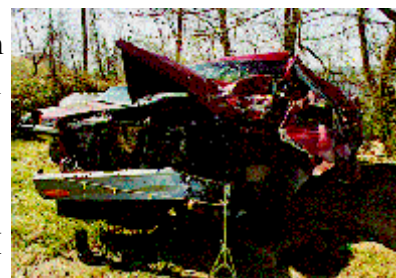
Figure 8. Frontal damage to the GMC pickup truck.

truck. These included a maximum crush value of 103.5 cm (40.75") at the left corner of the hood face and a rear displacement value of 29.8 cm (11.75") at the mid left upper A-pillar. The A-pillar deformation resulted from contact against the hood of the school bus. The CDC for the initial damage profile was 12-FLEK-5, utilizing the K conversion rule of CDC. The secondary engagement CDC for the "K conversion" was 10-LYAW-4. The damage profile is documented in **Figure 8**.

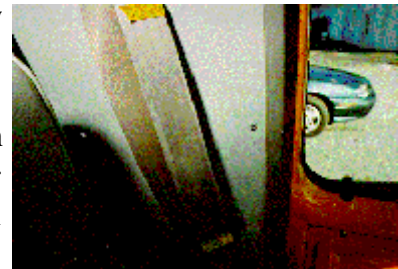
At impact, the driver responded to the 01 o'clock impact force by initiating a trajectory that was forward and to her right. During this trajectory, the bus was rotated rapidly in a counterclockwise direction. The driver loaded the manual belt webbing which resulted in a contusion across her right hip and soreness over the sternum and the left anterior ribs. Her loading force against the belt webbing produced an elongated D-ring transfer on the belt webbing that began 39.4 cm (15.5") above the stop button on the webbing and extended 28.2 cm (11.1") upward across the full width of the webbing (**Figure 15**).

Figure 15. D-ring transfer on the shoulder belt webbing.

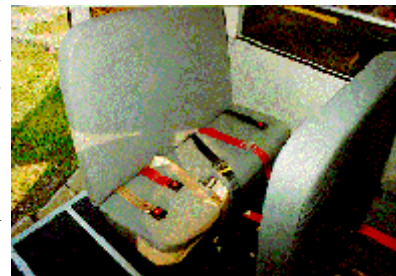
The 4 year old female passenger seated in the fourth row, left outboard position was restrained by the manual lap belt system (**Figure 16**). In response to the frontal impact force, she impacted the left side of her face on the base of the window frame at the side wall of the bus. As a result of the contact, the child sustained a 2 cm laceration of the left face adjacent to the left eye, extending onto the cheek. This laceration required 2 sutures which were removed four days following the crash. This child also sustained abrasions over the left ankle and the left distal fibula that resulted from probable contact with the front seat back support and/or the left side wall of the bus. Her mother reported that she had a slight discharge from the left ear, however, the treating physician ruled out possible injury. She was released approximately 3 hours following her arrival to the local hospital.

Figure 16. Left side, fourth row, seat configuration.
