Remote Investigation of a Crash Involving
a Non-available (removed) air bag
Dynamic Science, Inc. / Case Number:DS98023
1995 Honda Civic
Oregon
August 1998

1. Report No. DS98023		2. Government Accession No.		3. Recipient Catalog No.	
4. Title and Subtitle In-Depth Accident Investigation				5. Report Date November, 1998

Description:	This case was initiated in response to a report of a removed air bag-related driver fatality. This case is being conducted as a remote investigation. The NHTSA was made aware of the case via a newspaper article.
Investigation Type:	Remote
Crash Location:	Oregon
Crash Date:	August 1998
Notification Date:	August 27, 1998
Field Work Completed:	NA

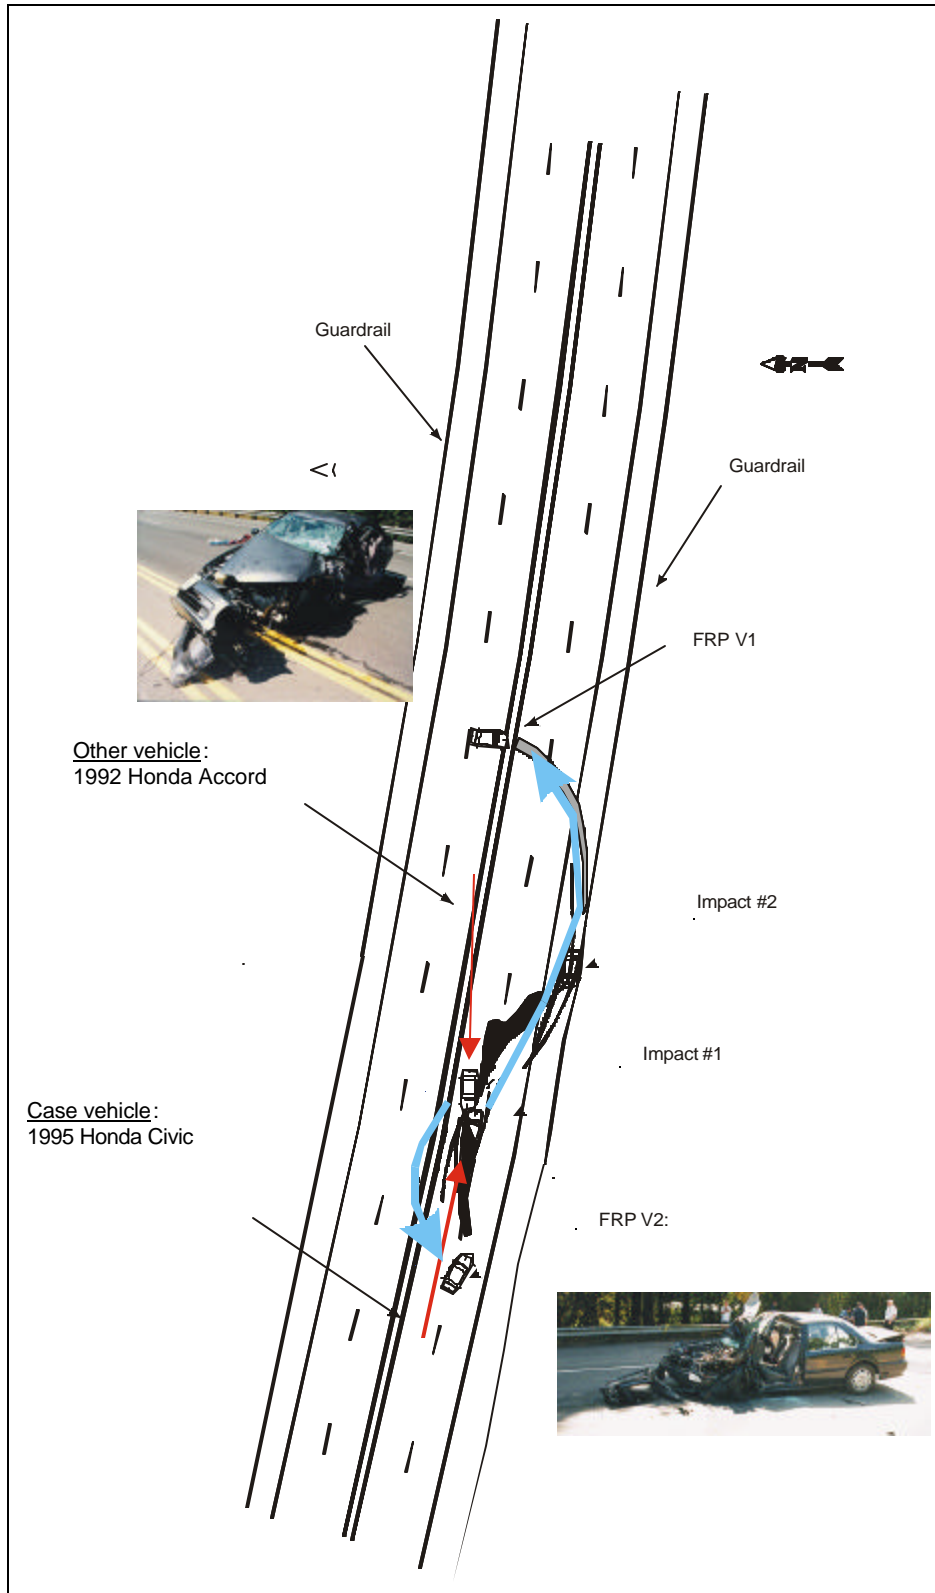
Figure 1. Modified police diagram

Just prior to the crash, the other vehicle crossed the painted centerline and entered the path of the case vehicle. The vehicles struck head-on, with the left front of the other vehicle engaging the left front and then the left side of the case vehicle. The driver's side air bag in the other vehicle deployed at this point. The front of the other vehicle continued in contact with the case vehicle, engaging both the driver's door and the left passenger door. After impact, the other vehicle rotated counterclockwise and came to rest approximately 17.9 m (59 ft) west of the impact area facing east. After impact, the case vehicle rotated counterclockwise and traveled in a southeasterly direction and struck a metal guardrail. The guardrail was 17.6 m (58 ft) from the impact area. The guardrail redirected the case vehicle, and it began traveling in a northeast direction and came to rest in the second westbound lane, facing south, approximately 27.1 m (89 ft) from the guardrail impact.

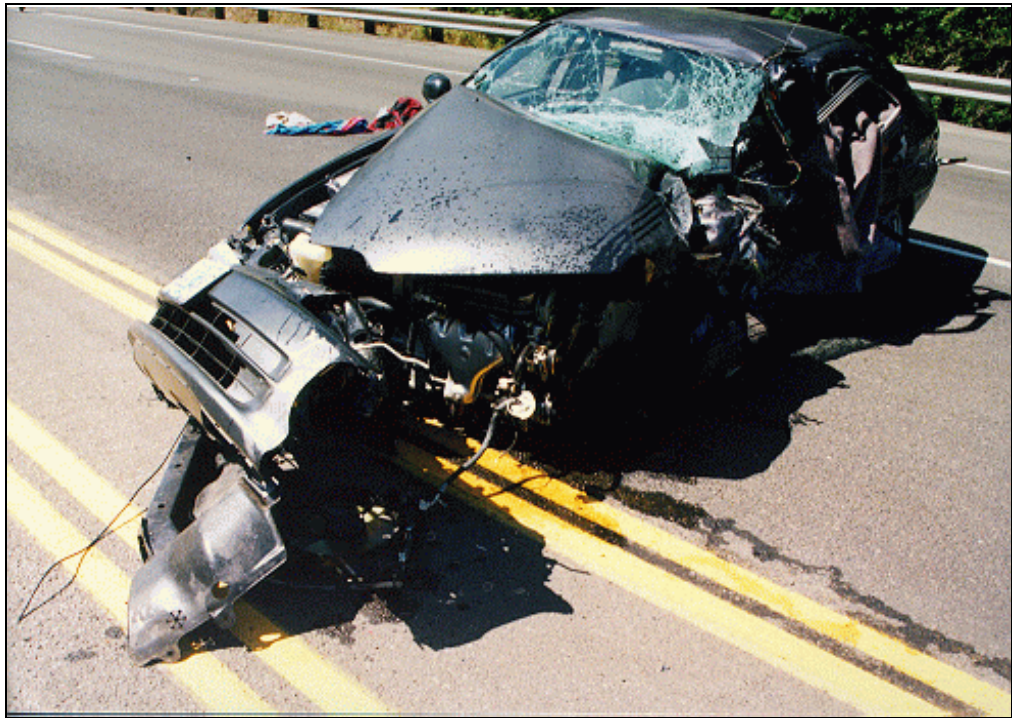
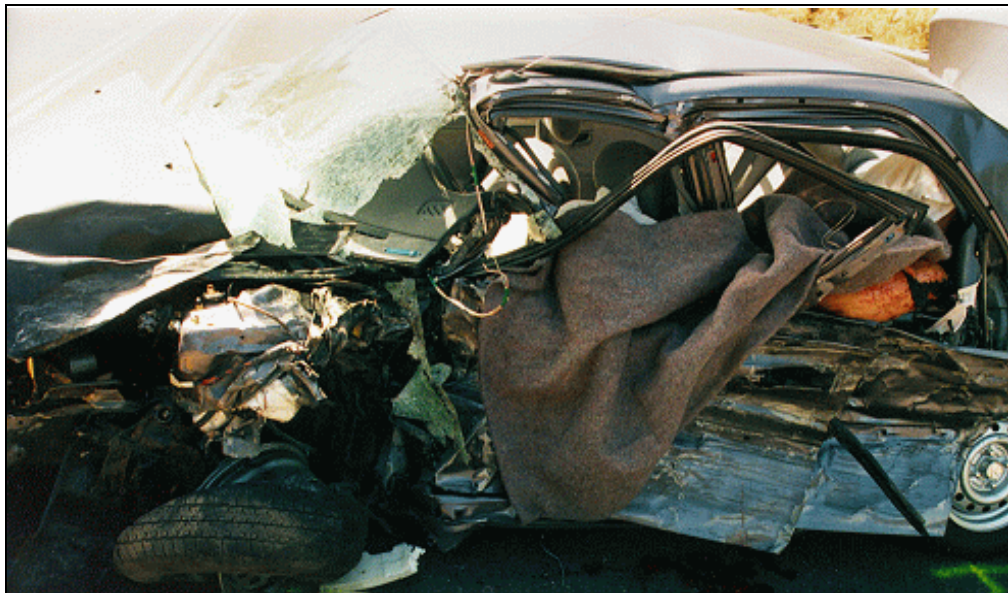
Figure 2. Exterior, case vehicle

Description:	1995 Honda Civic four-door	
VIN:	JHMEG8640SSxxxxxx	
Odometer:	Unknown	
Engine:	Unknown	
Reported Defects:	None noted	
Cargo:	None noted	
Damage Description:	<p>This vehicle had extensive damage to the driver's side fender and doors. Contact damage appears to have initiated from the left front corner of the vehicle, with additional contact damage to the driver's side doors of the vehicle. The vehicle had induced damage / buckling rear and upward at the A pillar area of the roof. It had induced damage to the passenger side doors, displacing them / "springing" them. The front cowling was torn free and there was extensive intrusion into the engine and the passenger compartment. The dash area was displaced rearward and towards the center of the compartment. The driver's seat appeared to be broken from its mount and twisted outwardly at approximately 20-30 degrees.</p>	
CDC:	12FLEE9	
Delta V:	Total	55.6 km/h (34.6 mph) ²

Longitudinal	-55.4 km/h (-34.4 mph)
	Latitudinal	4.8 km/h (3.0 mph)
	Energy	246,365 joules (181,819 ft-lbs)

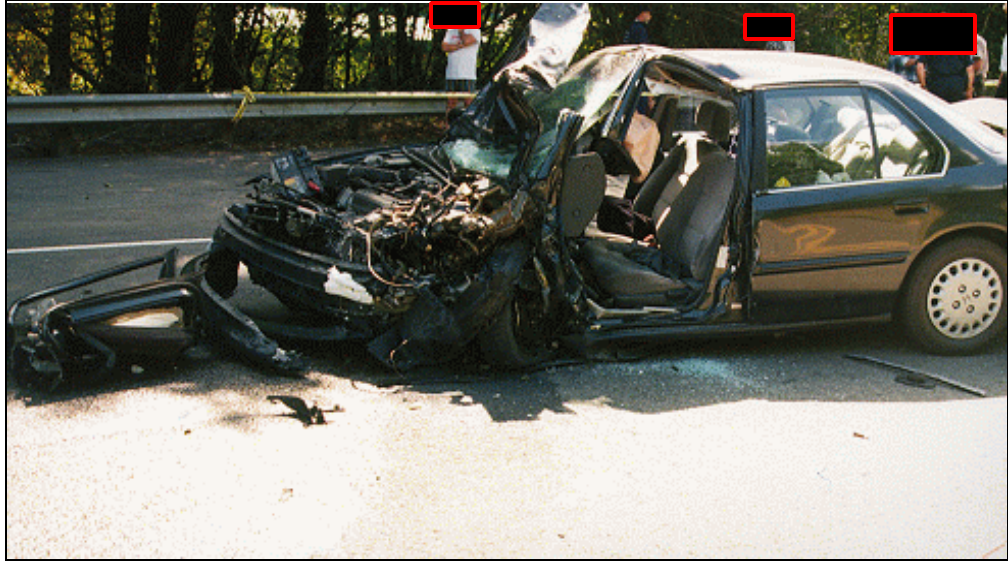
Figure 4. Exterior, other vehicle

Description:	1992 Honda Accord four-door, 5-speed manual transmission	
VIN:	1HGCB755XNAxxxxxxx	
Odometer:	Unknown	
Engine:	Unknown	
Reported Defects:	None noted	
Cargo:	Hiking gear, backpack, golf clubs	
Damage Description:	Extensive damage to front driver's side fender area. Contact damage appears to have begun to the left of the center-line at the front end and intruded into the engine compartment and seating area at a slight angle. Induced damage was present in the roof, trunk, and both sides of the vehicle. The left rear door was displaced rearward and showed signs of buckling. The roof was buckled back and upward from the left A pillar. The engine and firewall had intruded into the passenger compartment.	
CDC:	12FYEW3	
Delta V:	Total	58.7 km/h (36.5 mph)
	Longitudinal	-58.5 km/h (36.4 mph)
	Latitudinal	5.1 km/h (3.2 mph)
	Energy	119,105 joules (87,900 ft-lbs)
